Draft Final Report • National Institute of Standards and Technology (NIST)

of the May 22, 2011,
Tornado in
Joplin, Missouri

NIST NCSTAR 3 (Draft)

November 2013

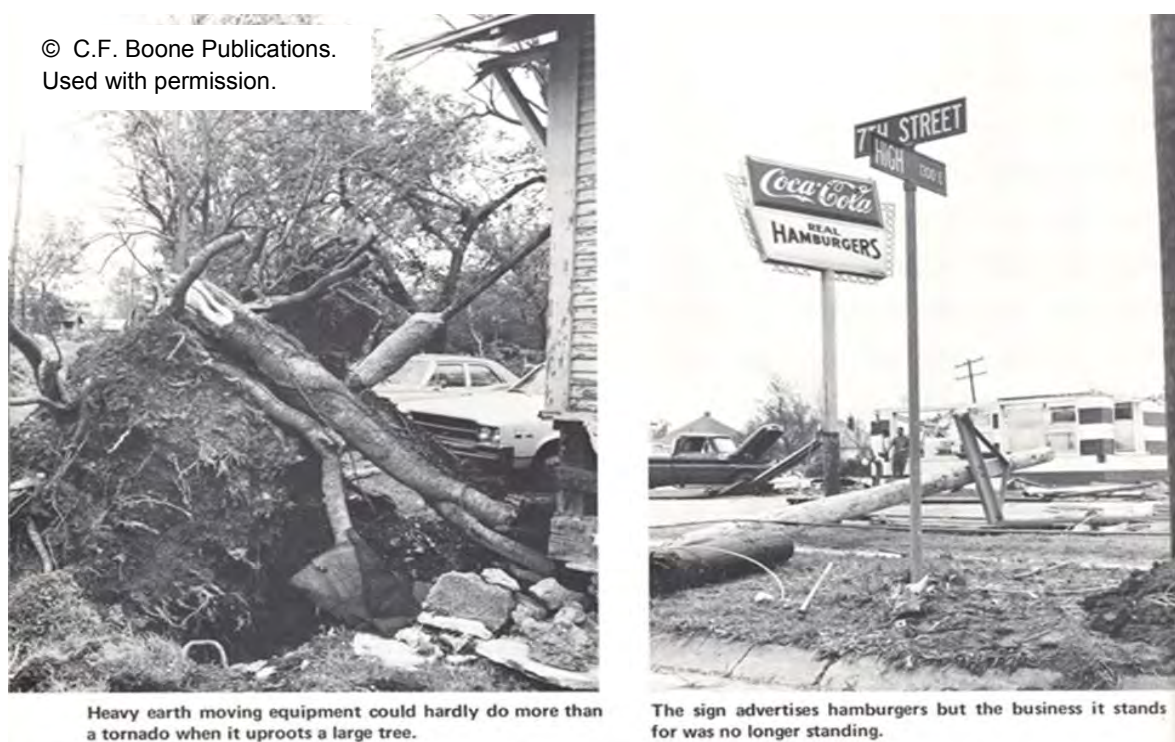
Figure 1–3. Damage from the 1971 Joplin tornado.³¹

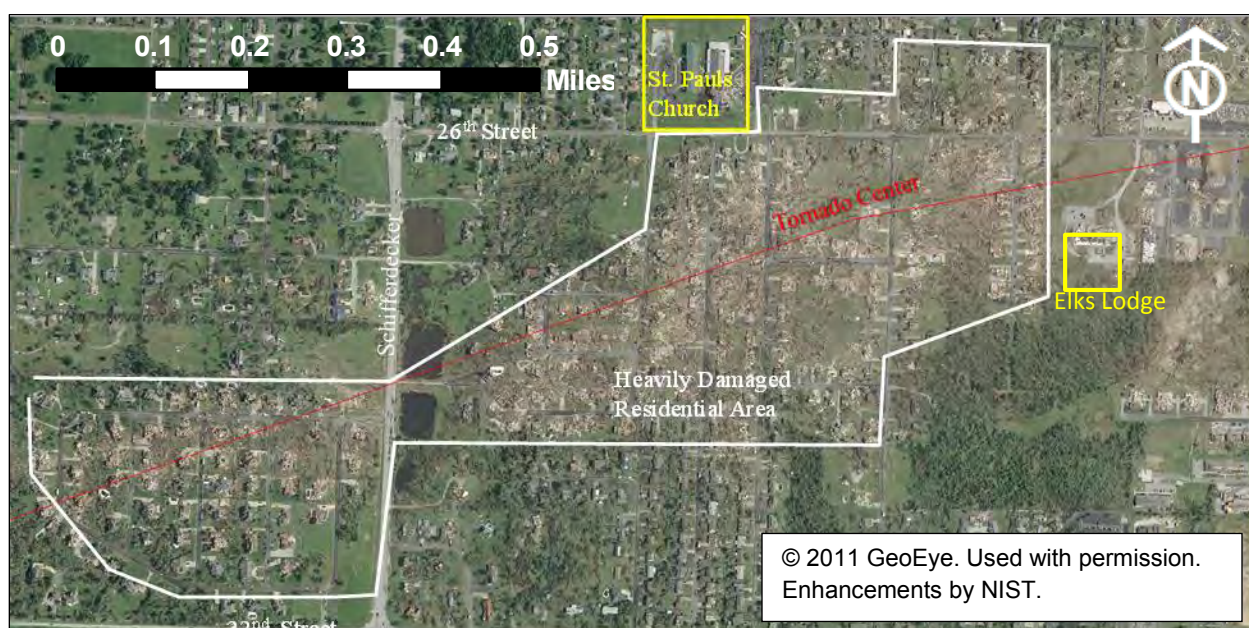
Figure 1–5. Damage on the west side of Joplin.

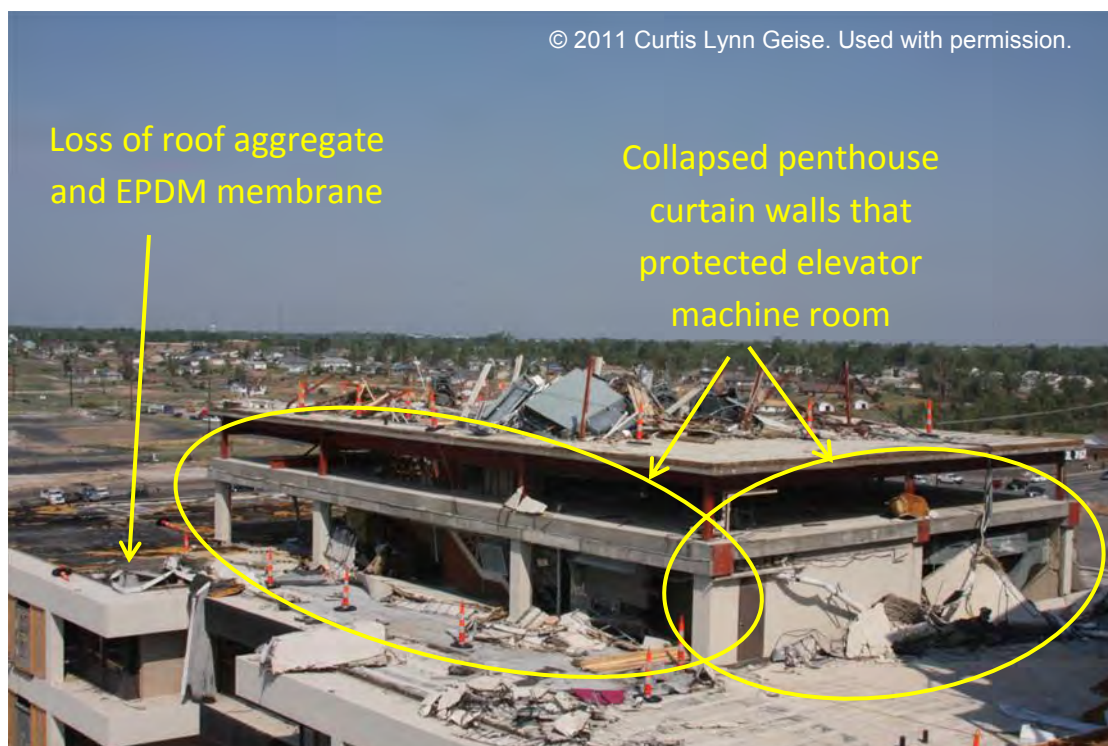
Figure 3–12. Damage to roof and penthouse walls of West Tower.

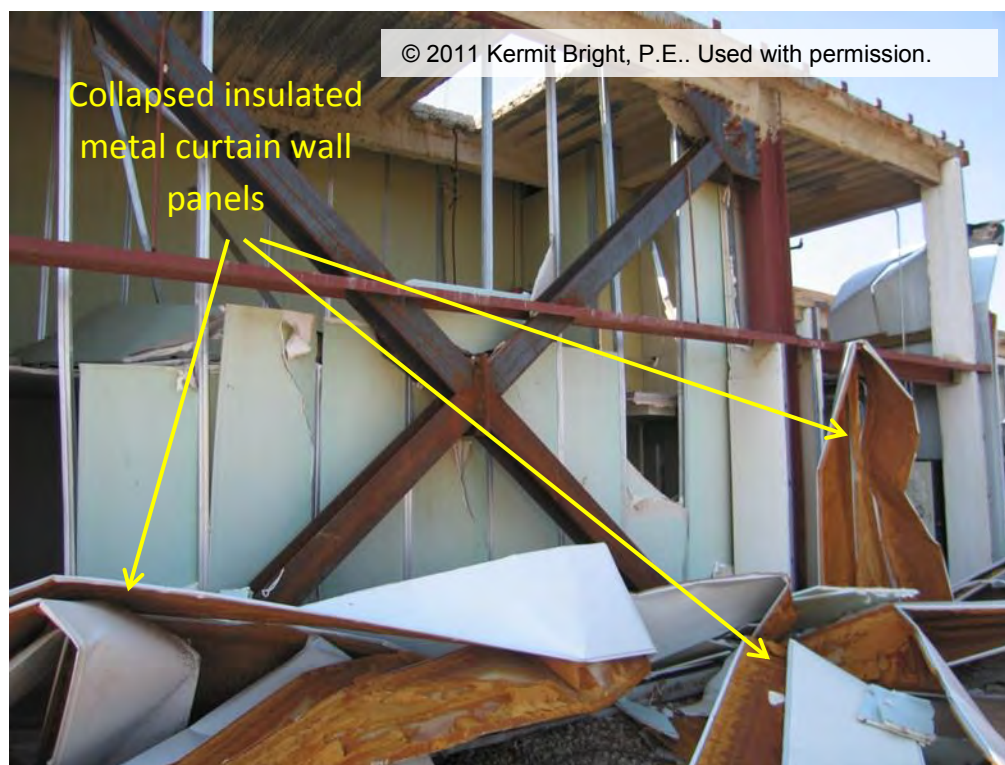
Figure 3–17. Missing/collapsed vertical insulated metal curtain wall panels of East Tower penthouse.

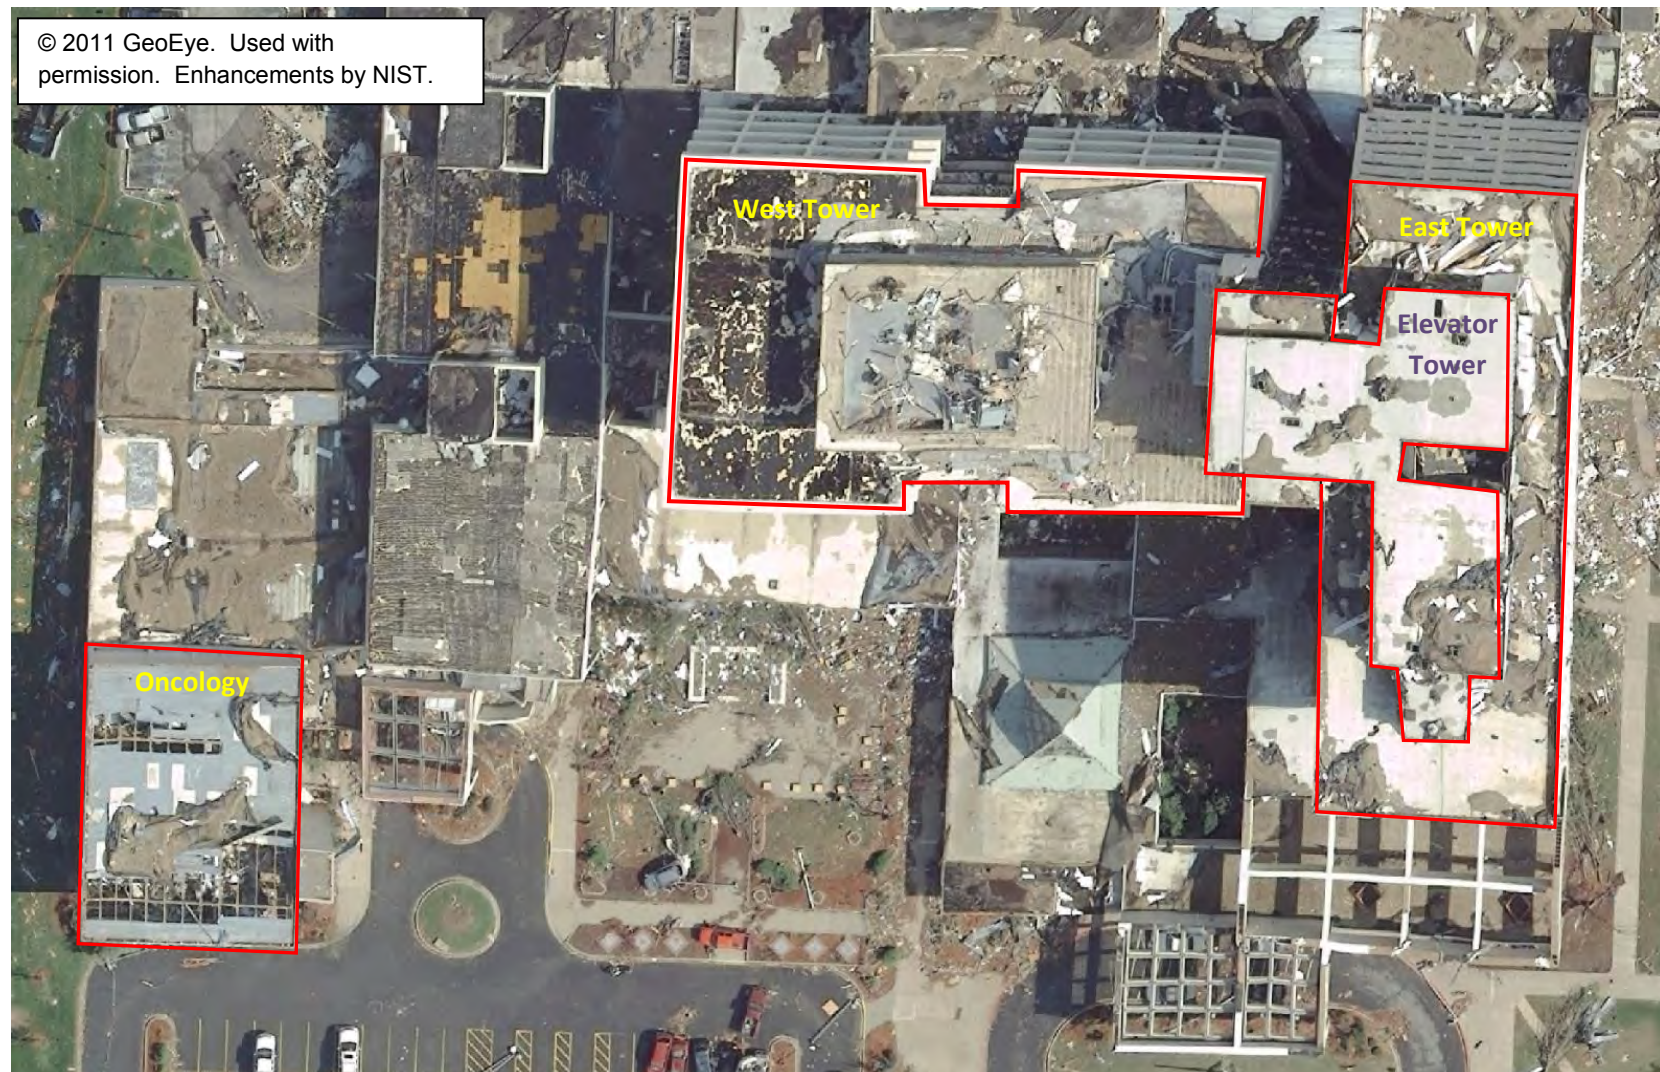
Figure 3–19. Overview of West, East, and Elevator Towers and Oncology Clinic Building showing that most of the aggregates that were used as roof ballast on these buildings are missing.

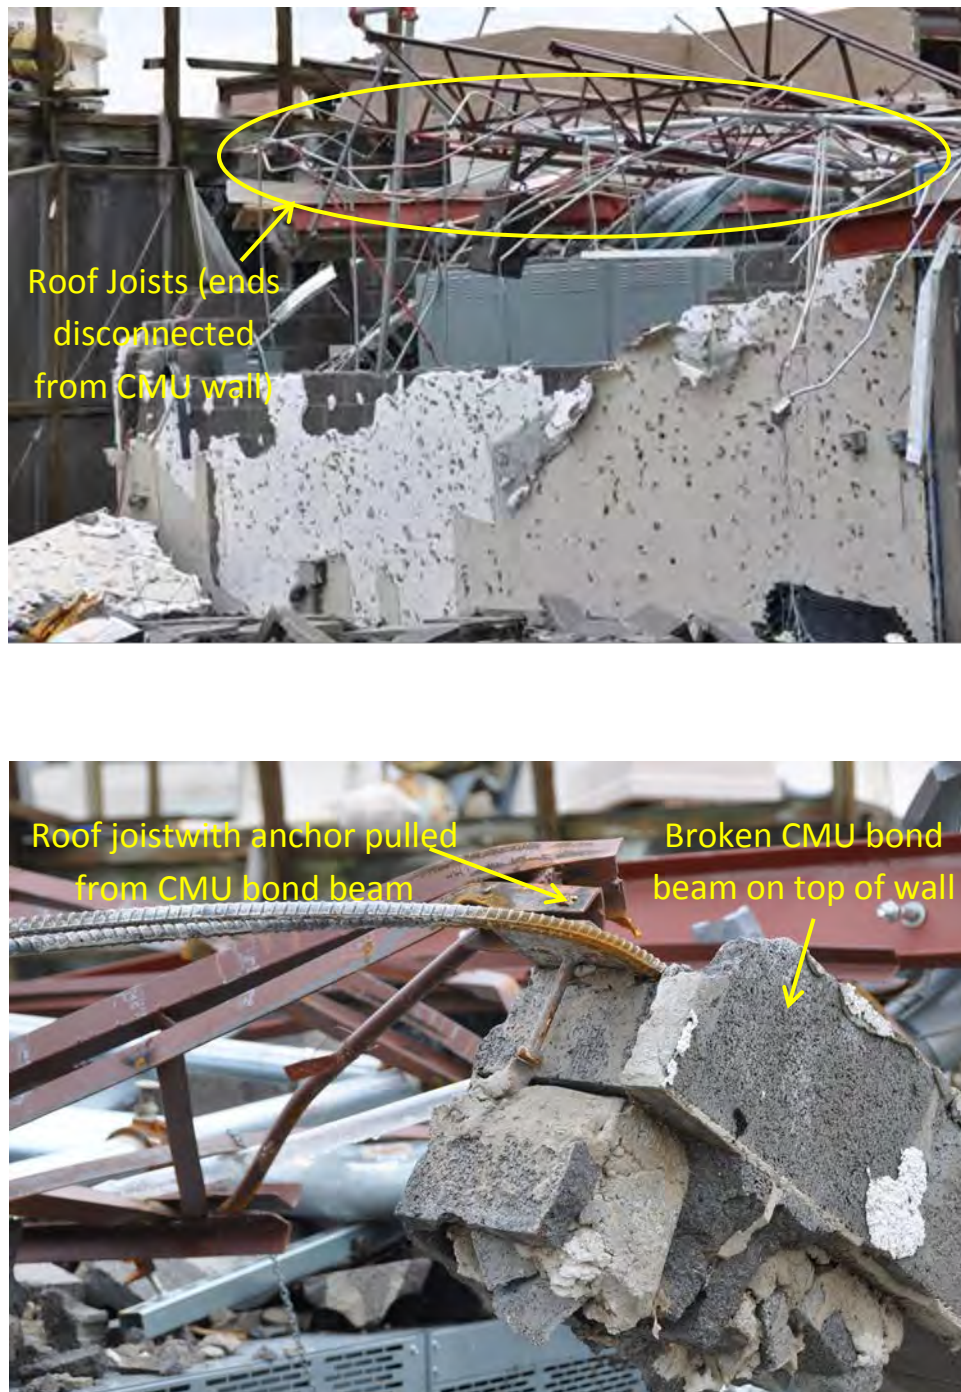
Figure 3–22. Failure details at Emergency Generator Building.

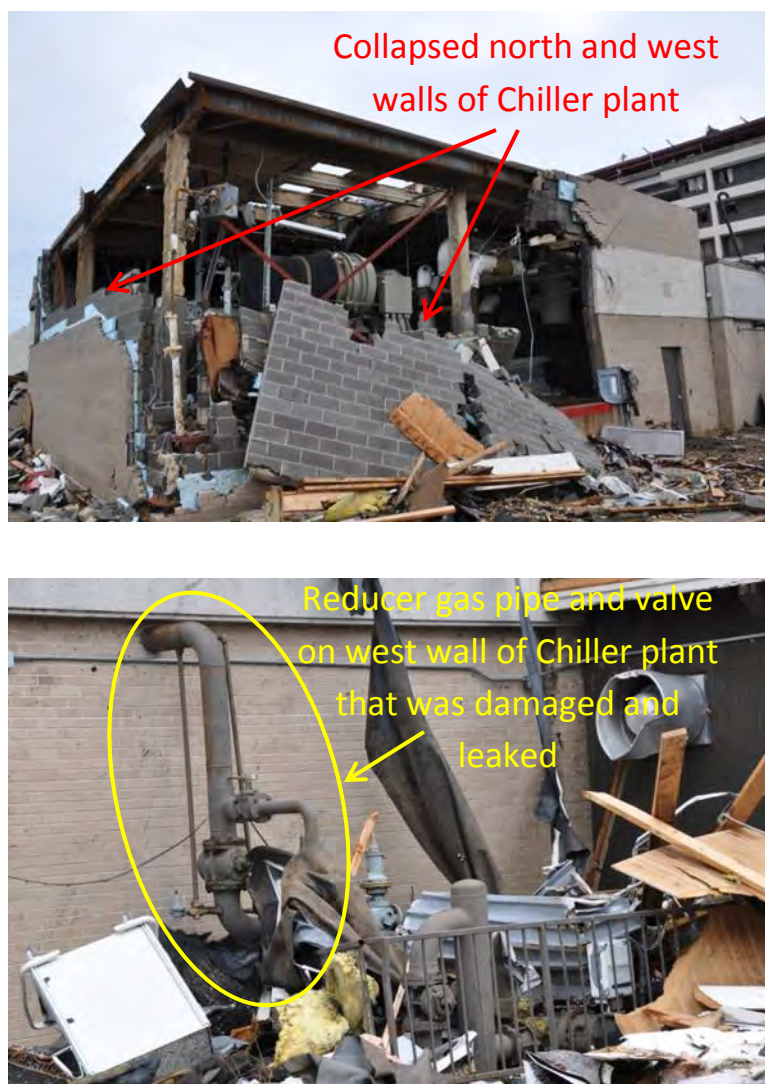
Figure 3–23. Views of damage sustained at the Chiller Plant.

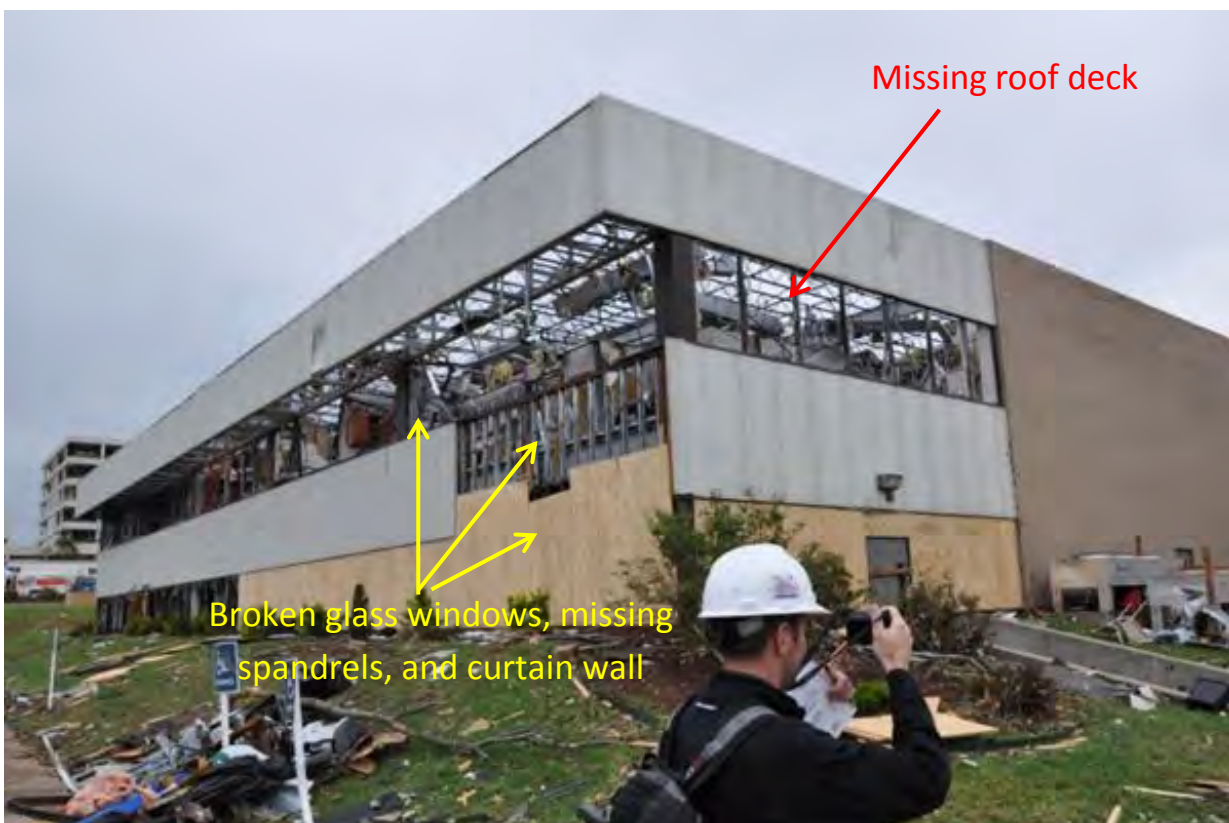
Figure 3–28. View of damage to envelope of Medical Office Building 1.

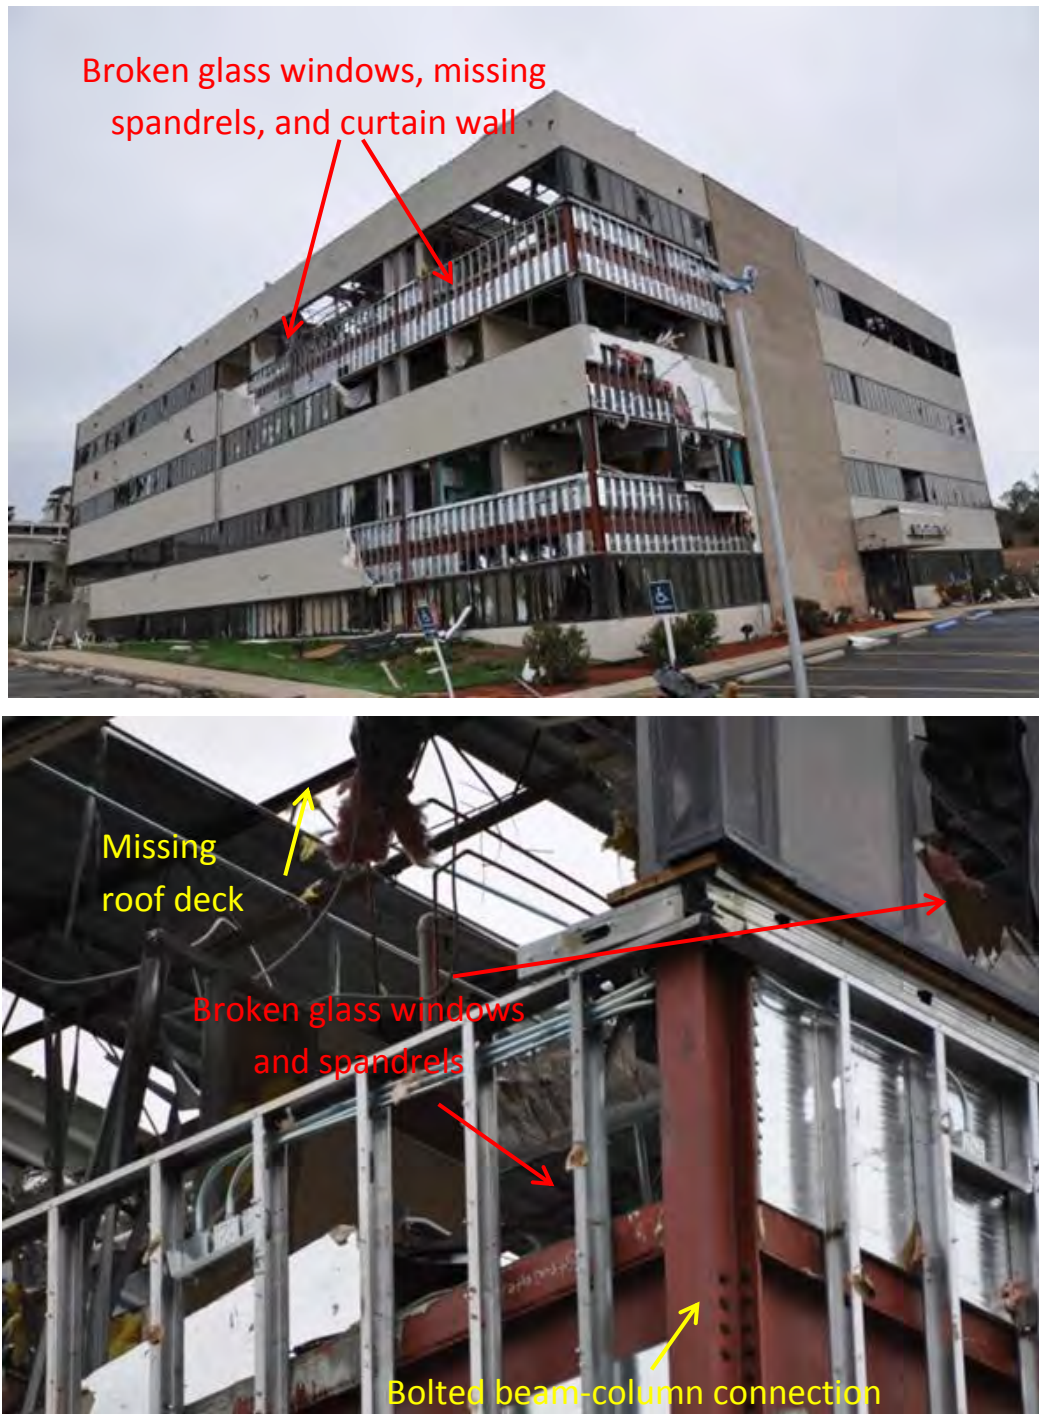
Figure 3–29. Views of (top) damage to envelope of Medical Office Building 2 and (bottom) portion of the steel frame system (bolted beam–column connection).

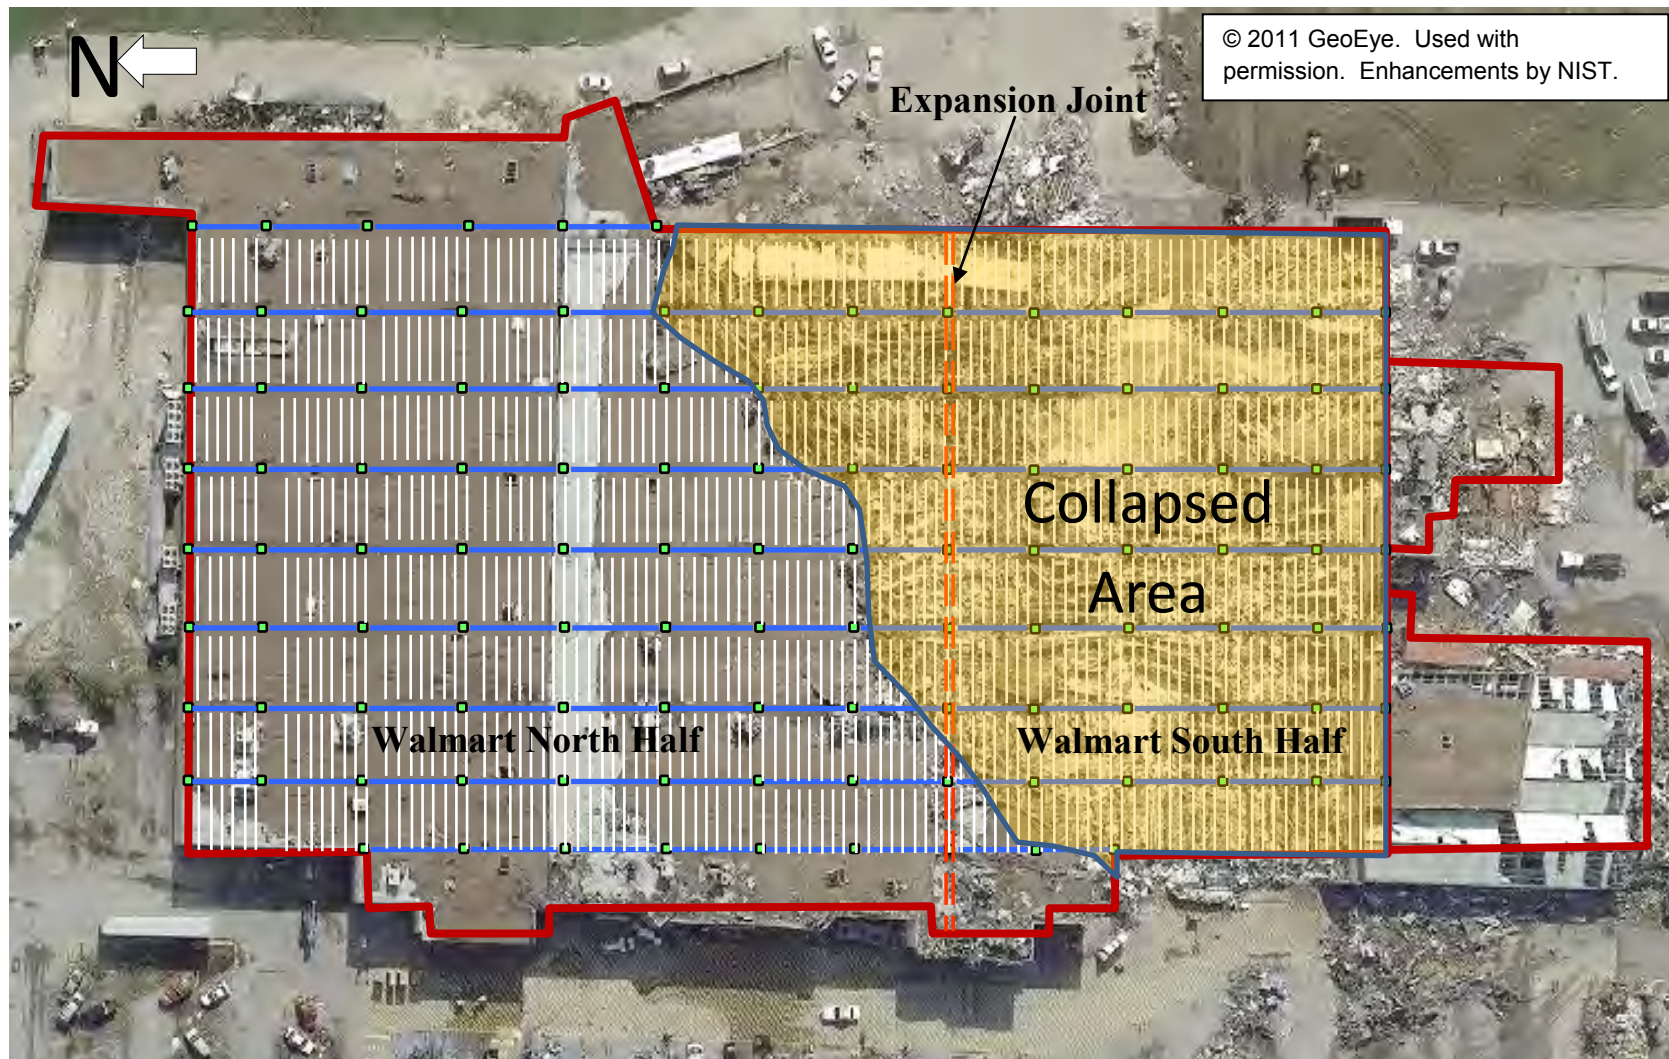
Figure 3–34. Aerial view of Walmart outlining southern half of building collapsed by the tornado.

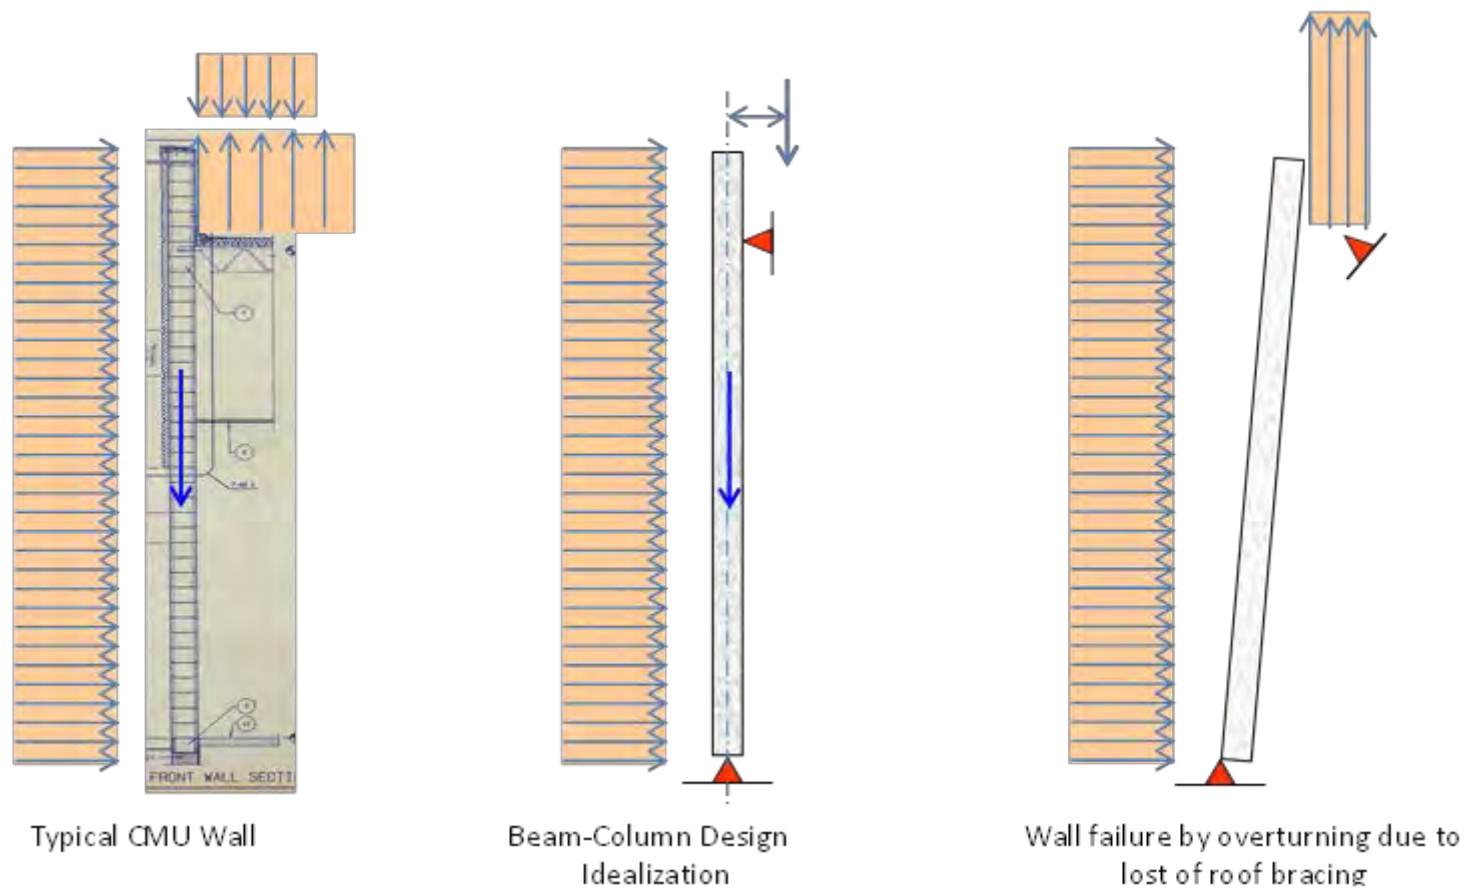
Figure 3–41. Typical loading and design conditions for BTS building and possible failure mode.

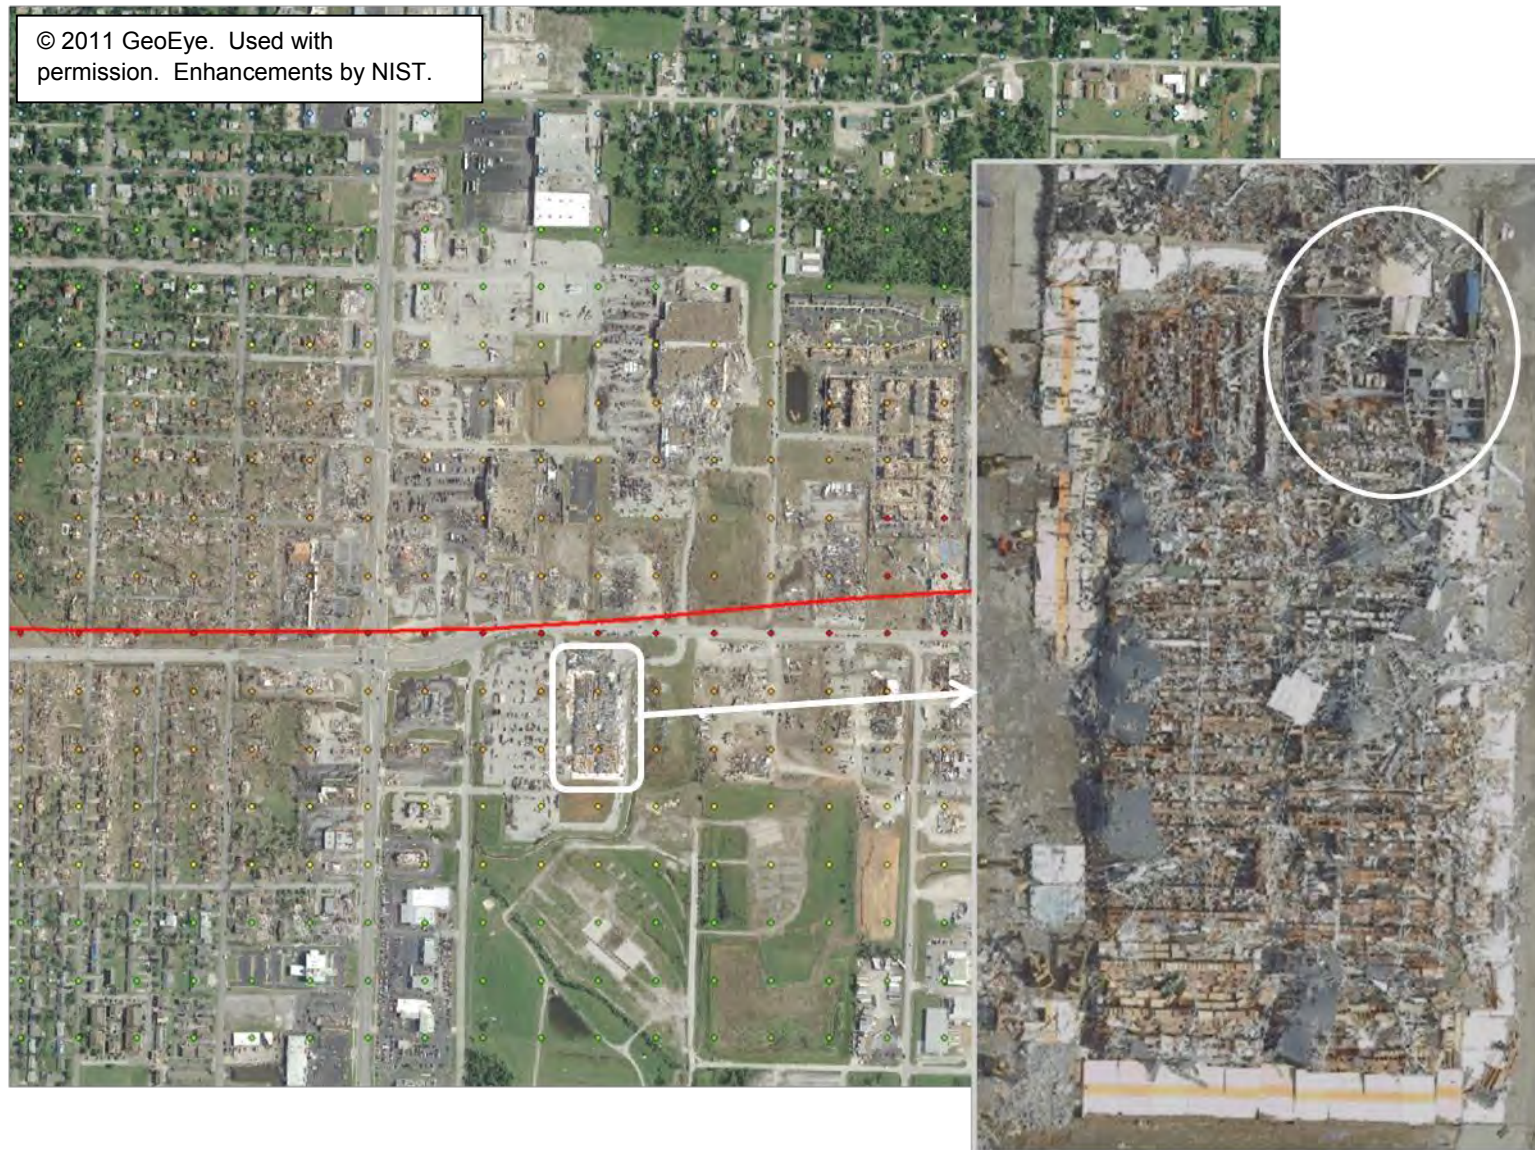
Figure 3–42. Aerial views of Home Depot in relation to the tornado damage path (red line denotes center of damage path). Note the loss of all roof decks due to wind uplift.

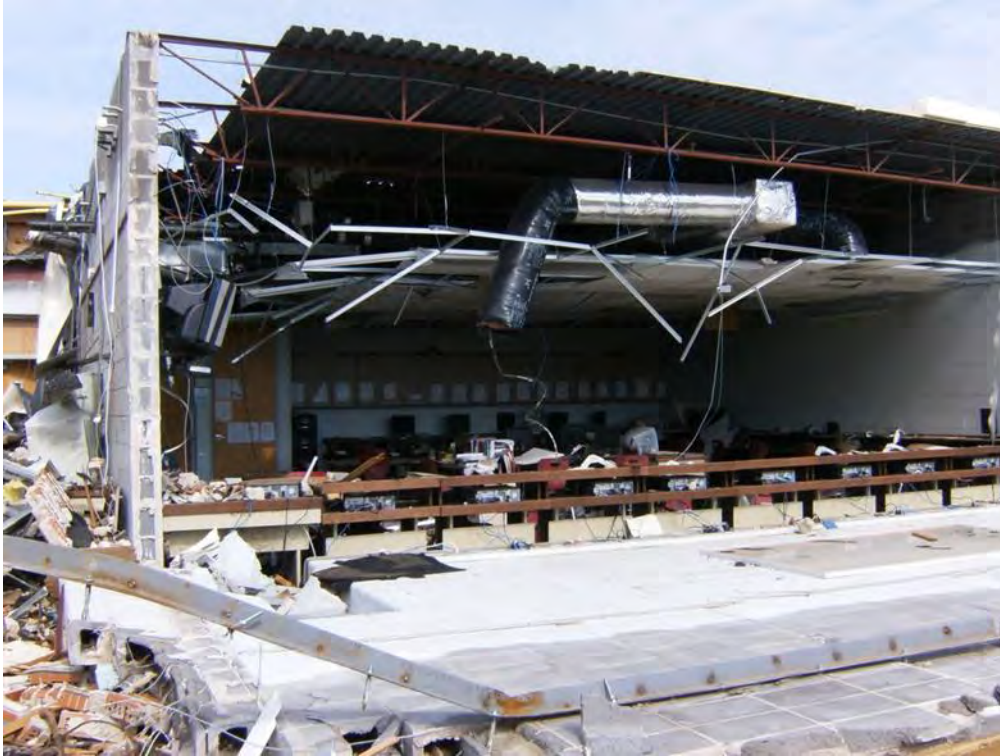
Figure 3–72. Collapse of CMU wall due to loss of lateral roof bracing.

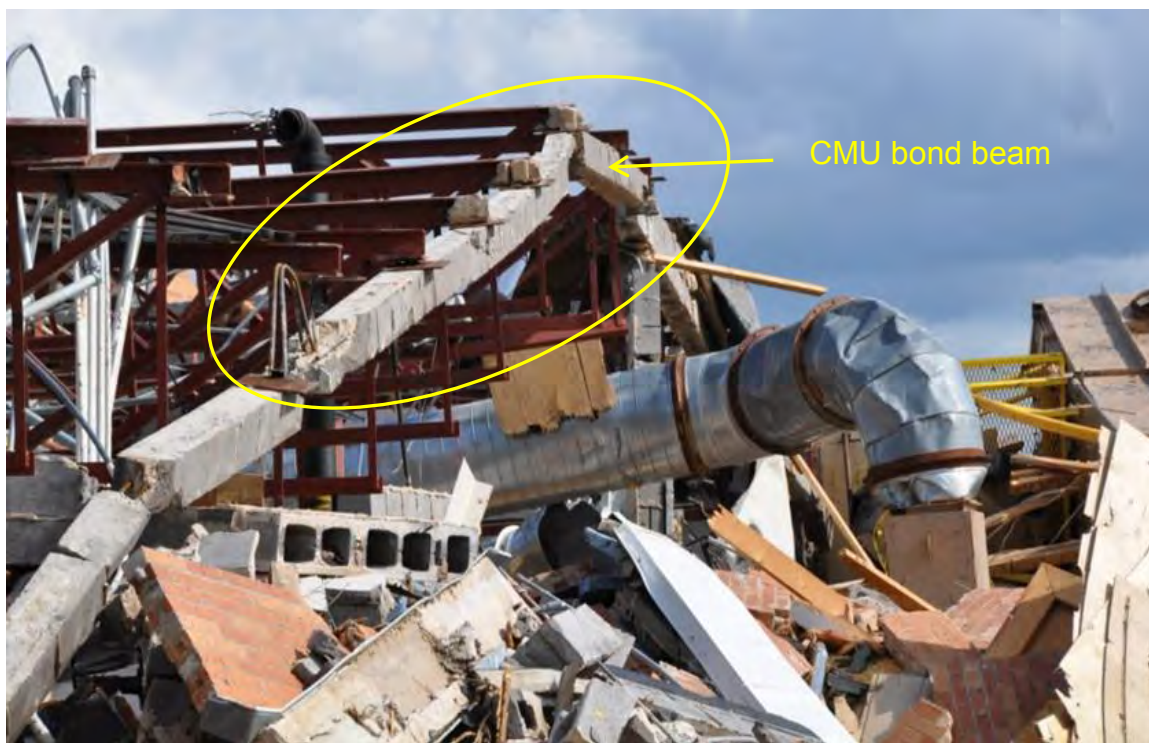
Figure 3–77. Steel roof joists, with missing roof decks, remained connected to CMU bond beam. Bond beam remained continuous, but was disconnected from the CMU walls along the bond line between the two CMU courses at the top of the wall.

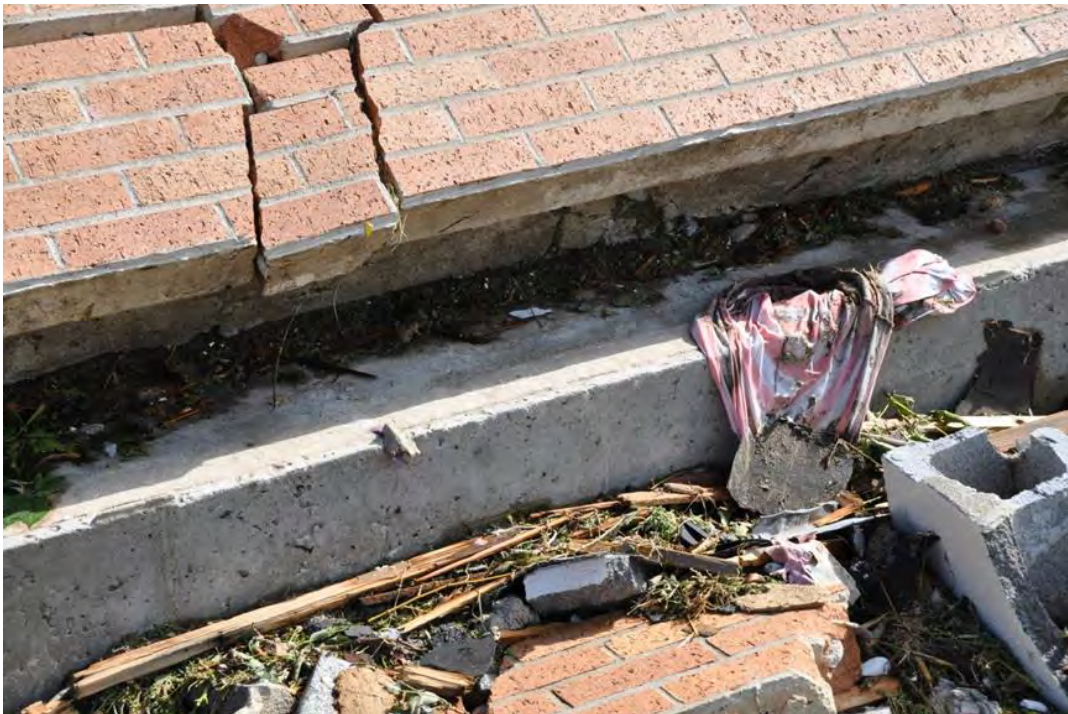
Figure 3-79. Perimeter CMU wall that collapsed after loss of roof lateral bracing (note lack of reinforcing dowels connecting wall to concrete footing).

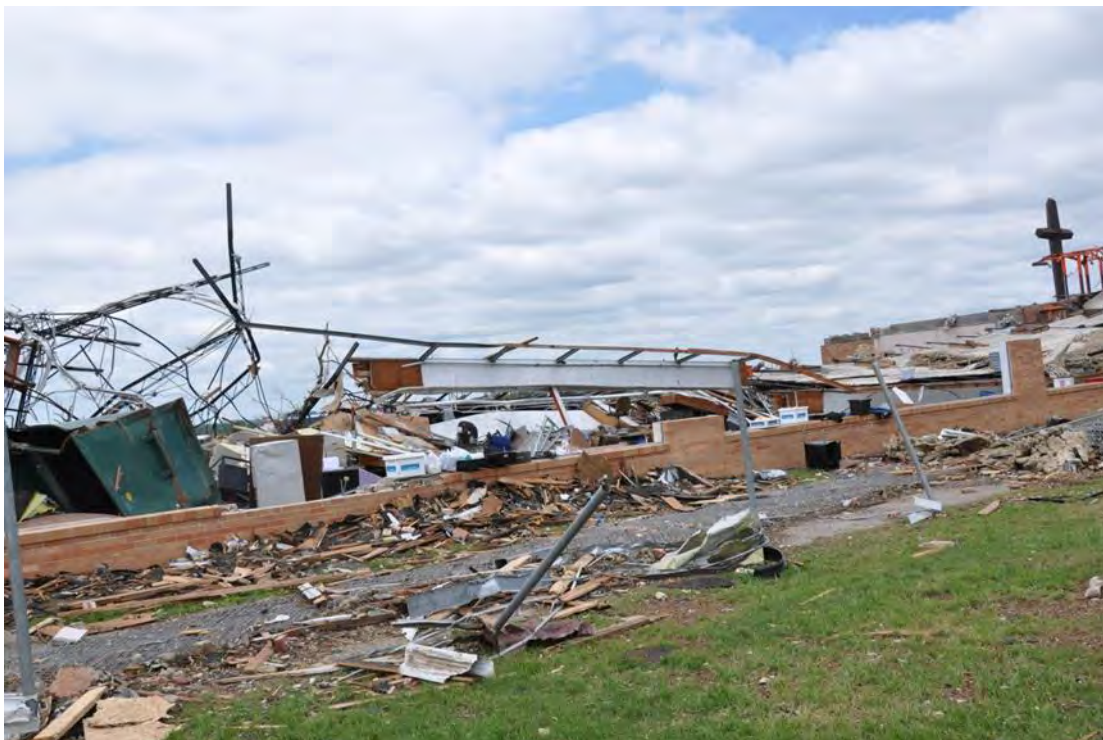
Figure 3–83. Section of building at St. Mary’s Catholic Elementary school with collapsed perimeter CMU walls.

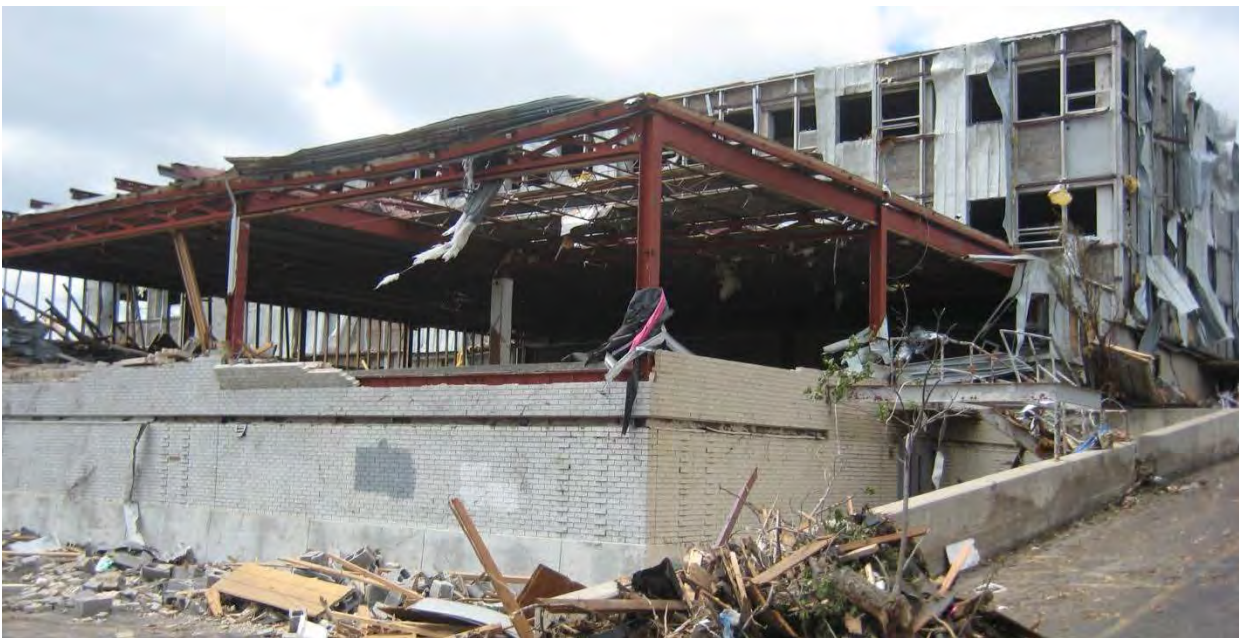
Figure 3–88. Significant damage to the envelope and minor damage to the MWFRS of the physical education section of the Ozark Center building, including (1) loss of part of steel roof decks, (2) loss of all insulating windows and steel frames on all wind-exposed sides, and (3) deformation of steel beam (likely due to debris impact).

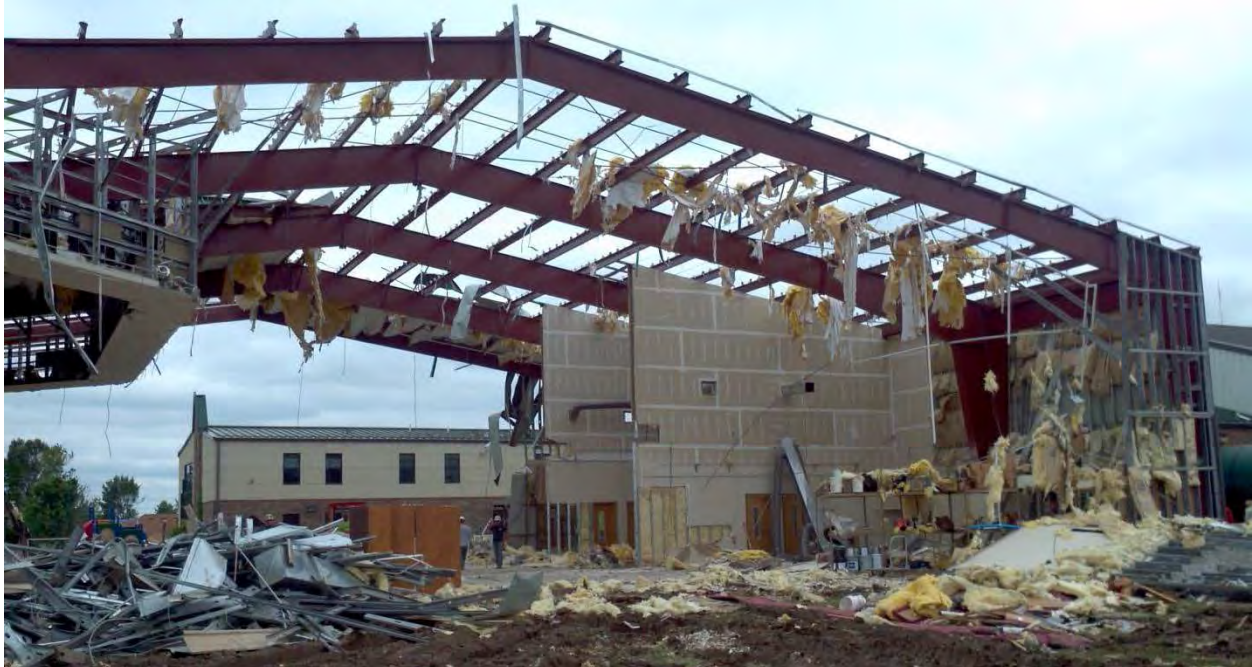
Figure 3–92. View from east of the damaged, pre–engineered steel Mass Hall building of St. Paul’s United Methodist Church.

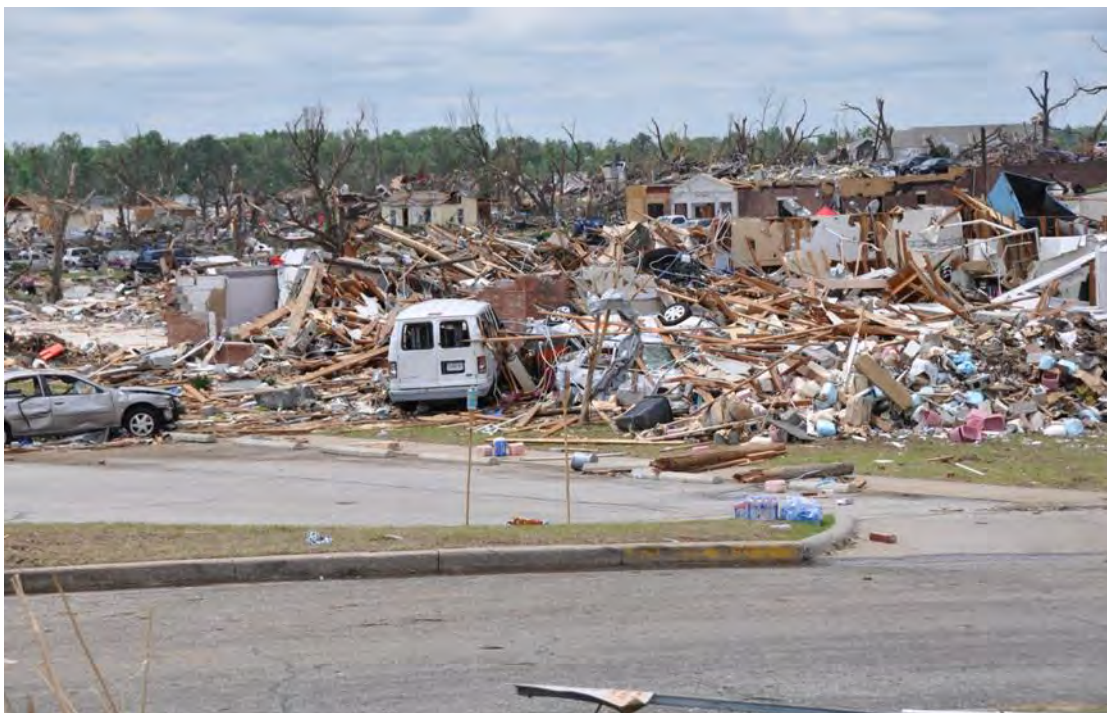
Figure 3–104. Collapsed Greenbriar Nursing Home (viewed from the east) with missing roof system and collapsed exterior CMU walls. Note debris from building materials as well as other sources (automobiles) in all interior areas of the facility.

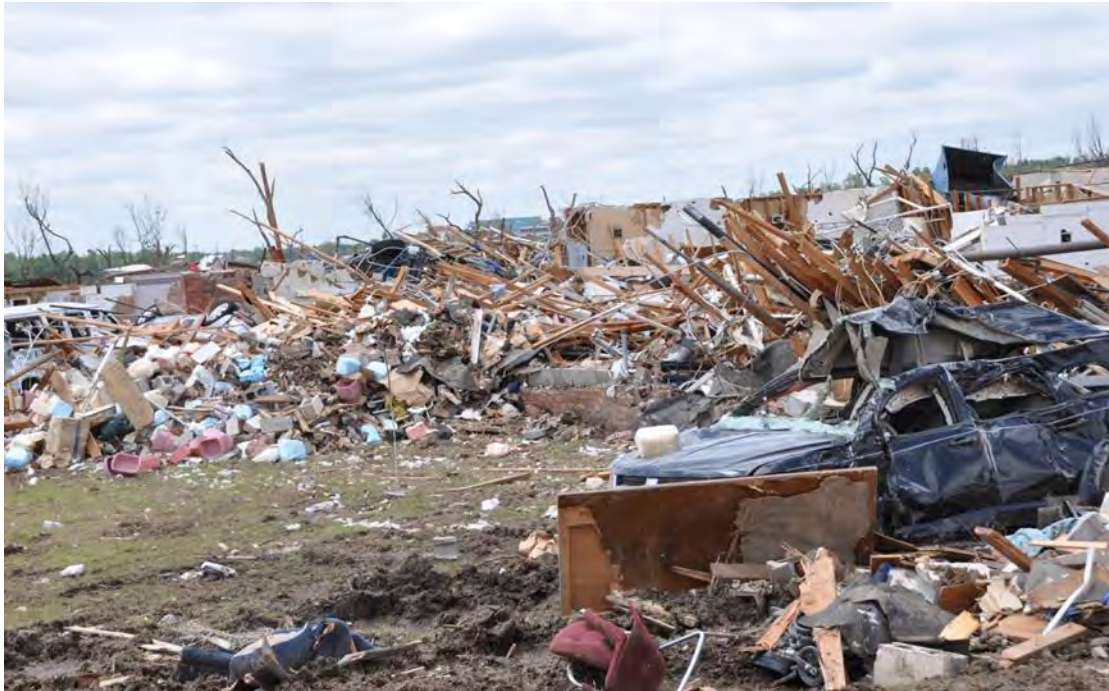
Figure 3–105. Collapsed Greenbriar Nursing Home.

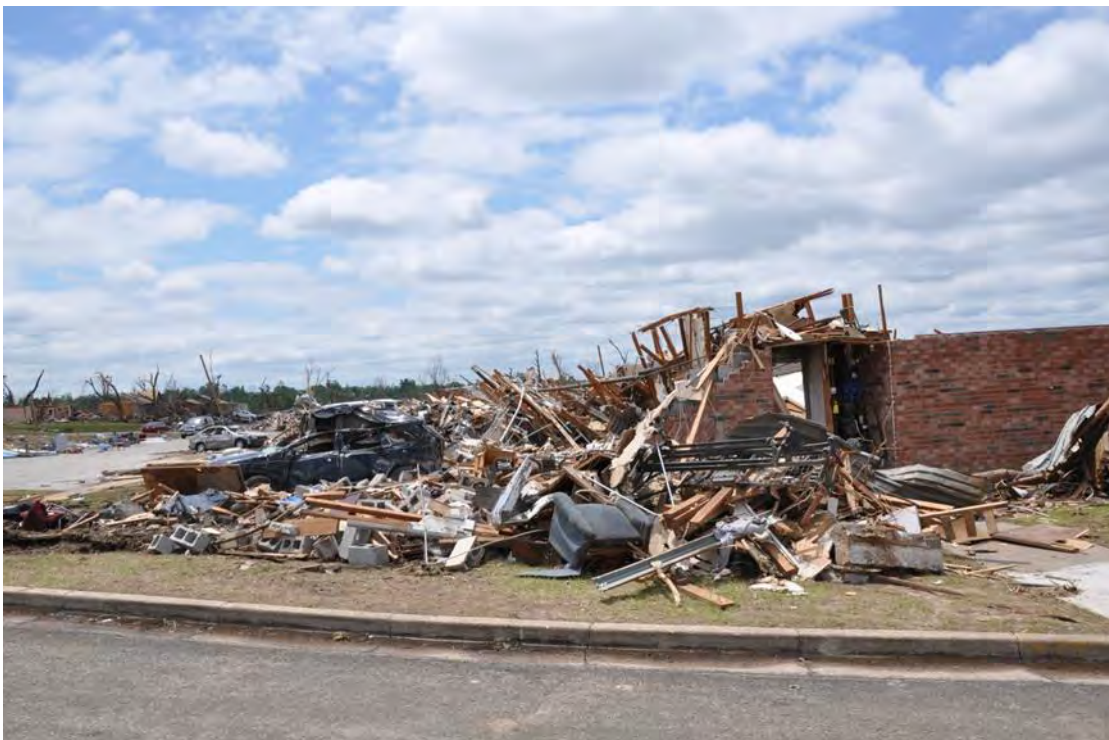
Figure 3–106. Collapsed Greenbriar Nursing Home (viewed from the north) showing the portion of the north wing's exterior wall that did not collapse.
