Draft Final Report • National Institute of Standards and Technology (NIST)

of the May 22, 2011,
Tornado in
Joplin, Missouri

NIST NCSTAR 3 (Draft)

November 2013

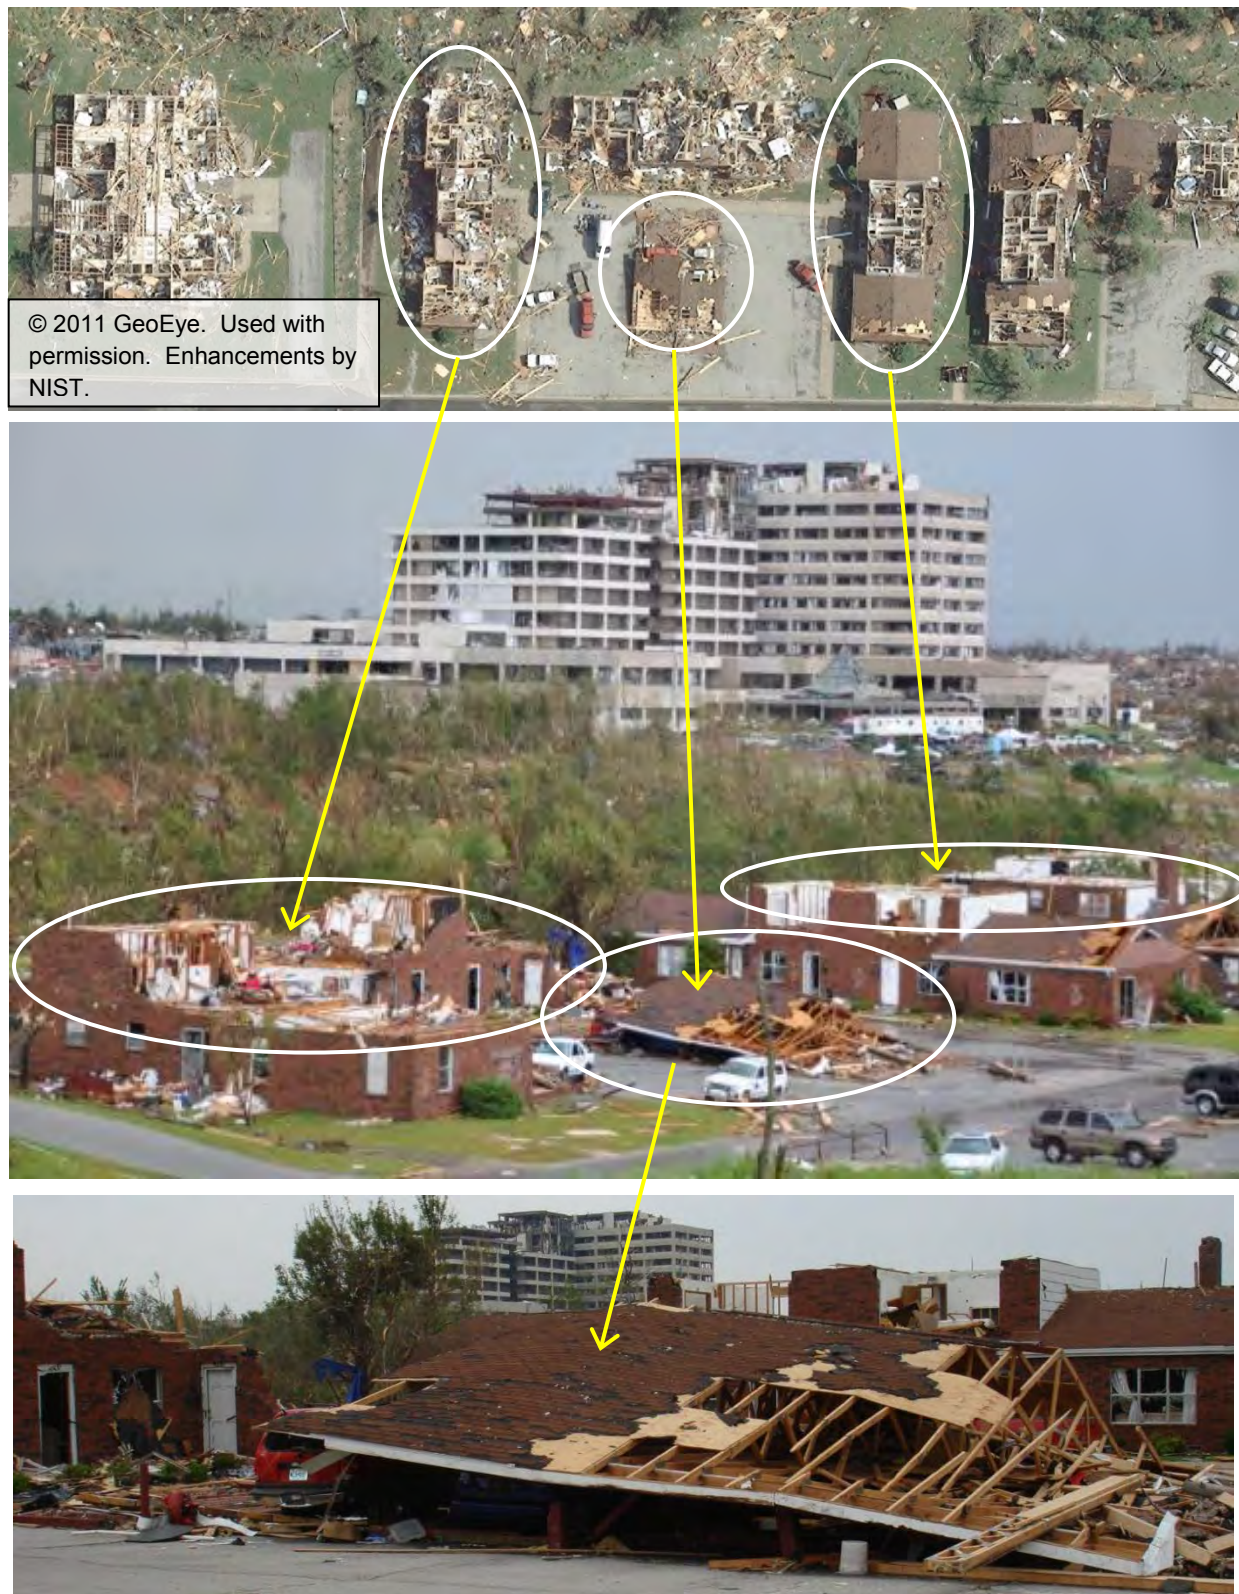
Figure 3–113. Residential failure due to disconnection of entire roof system (roof-to-wall connection failure due to wind uplift).

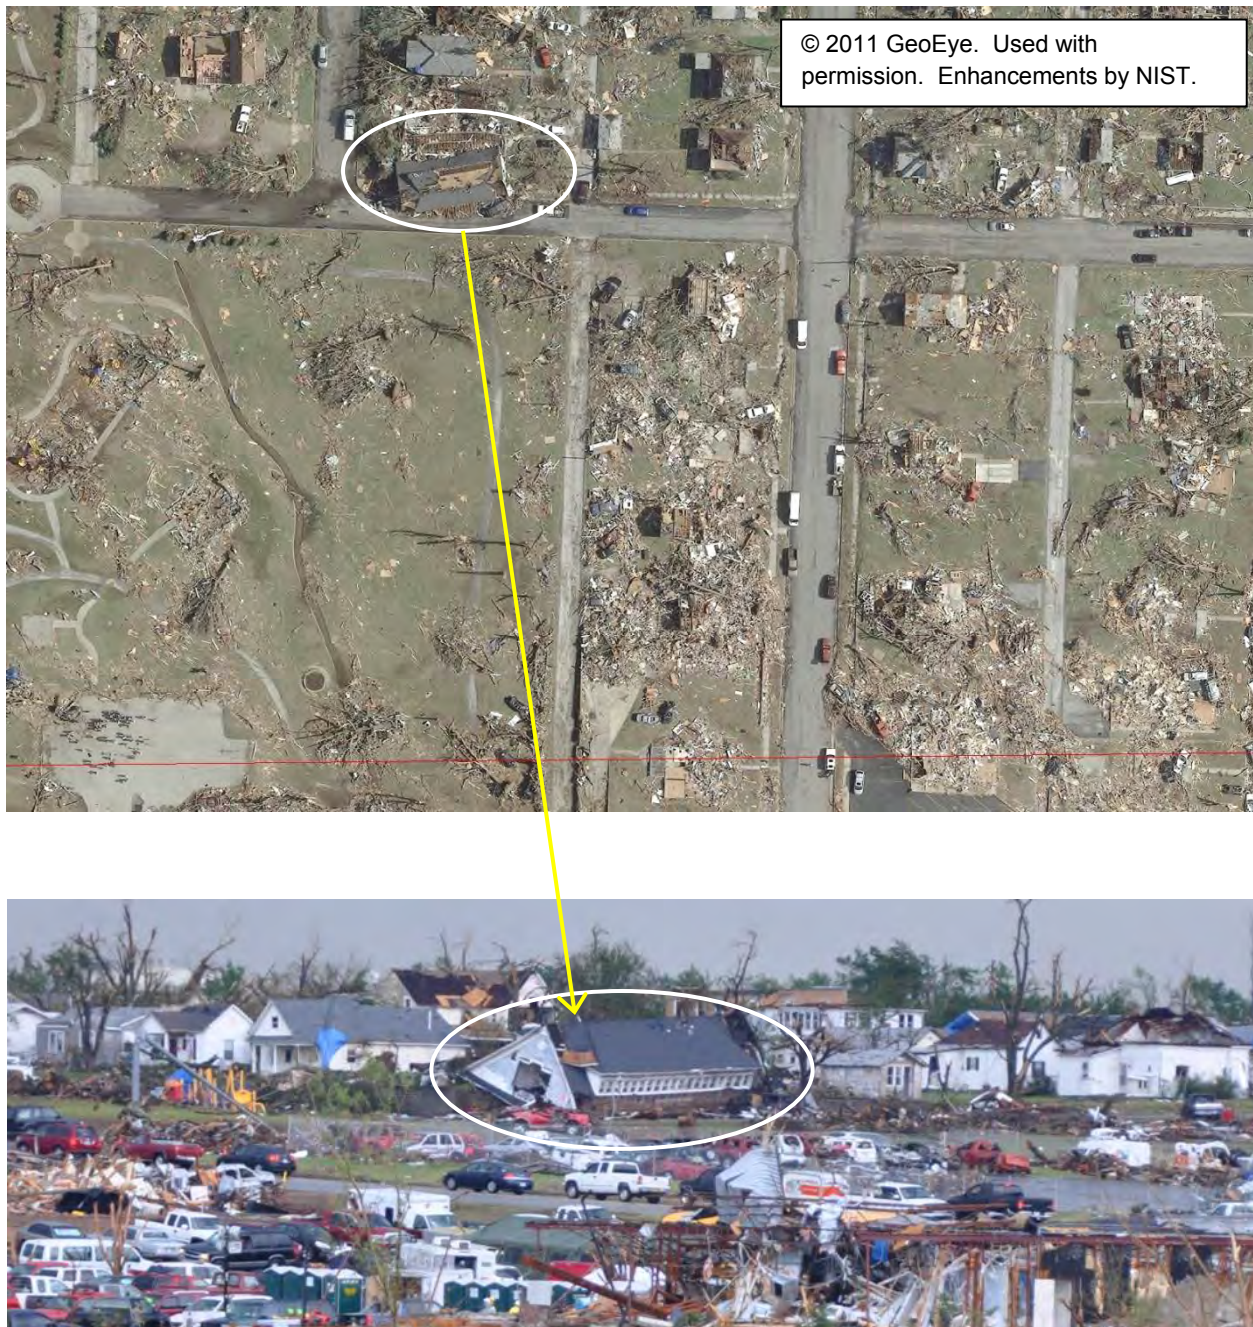
Figure 3–114. Failure of first-story-to-foundation wall connection. Entire roof and first floor shifted off of lower story (directly north of SJRMC).

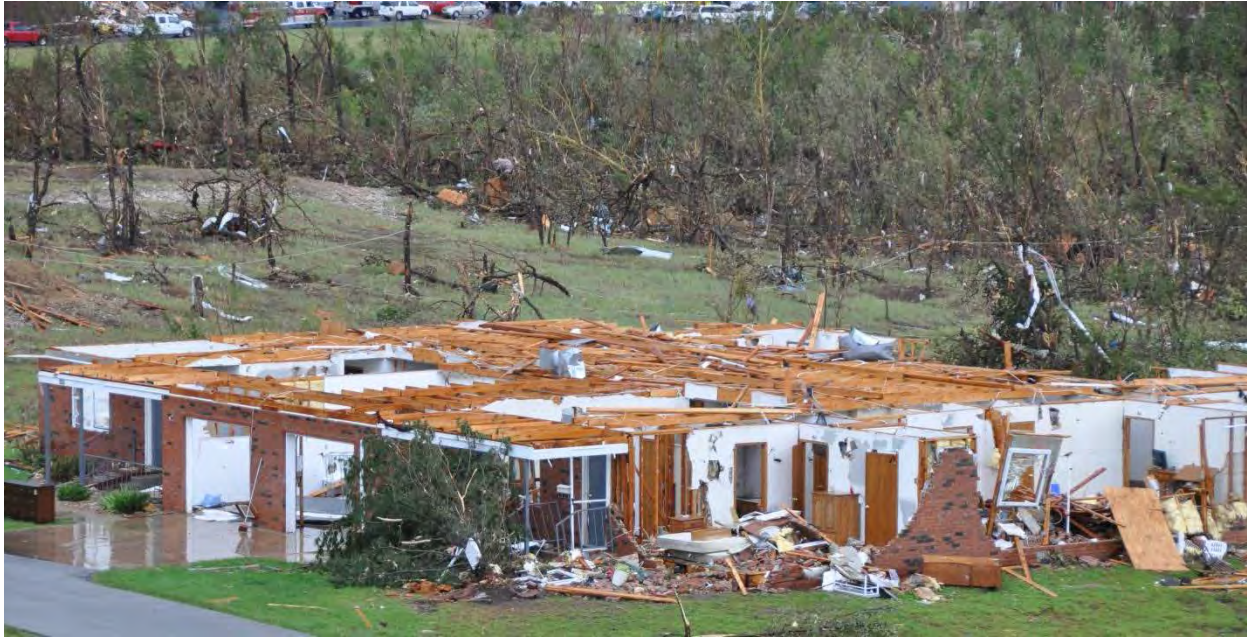
Figure 3-115. Disconnection and loss of entire roof system.

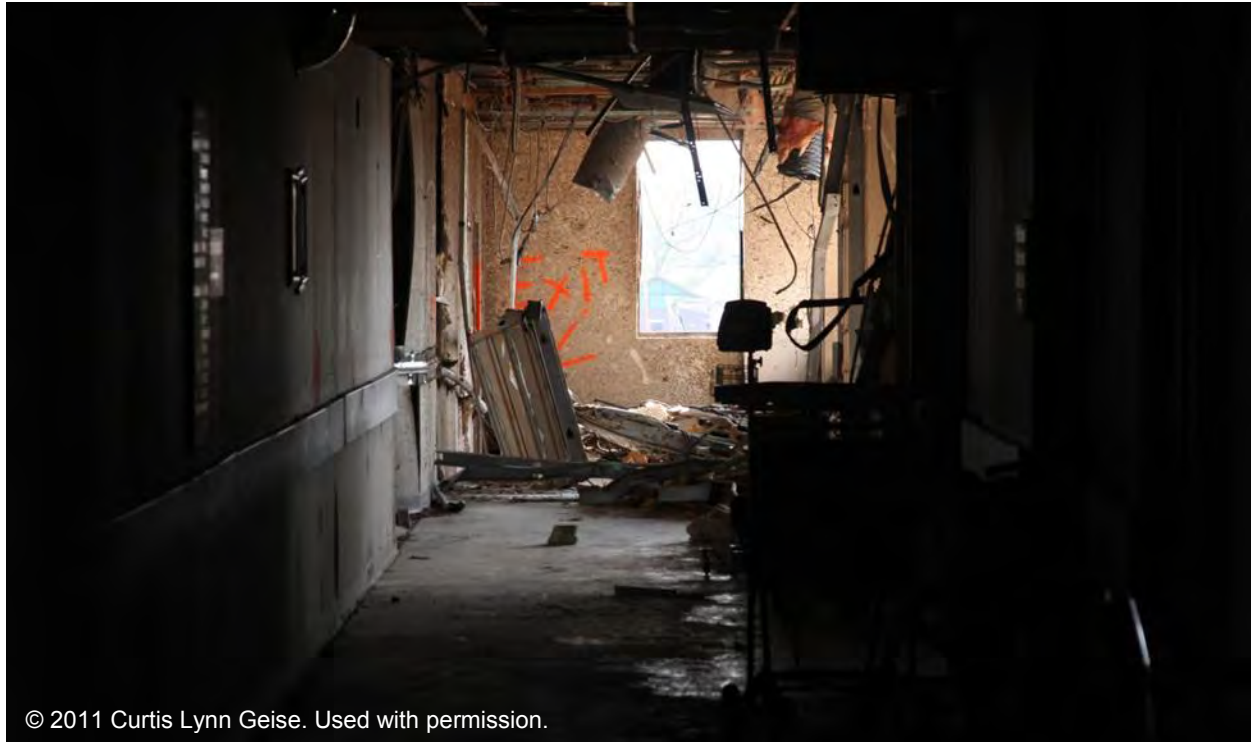
Figure 3–126. View of a typical hallway with damaged interior (ceiling, walls, and debris); hallways were used as designated refuge areas in SJRMC’s East and West Towers.

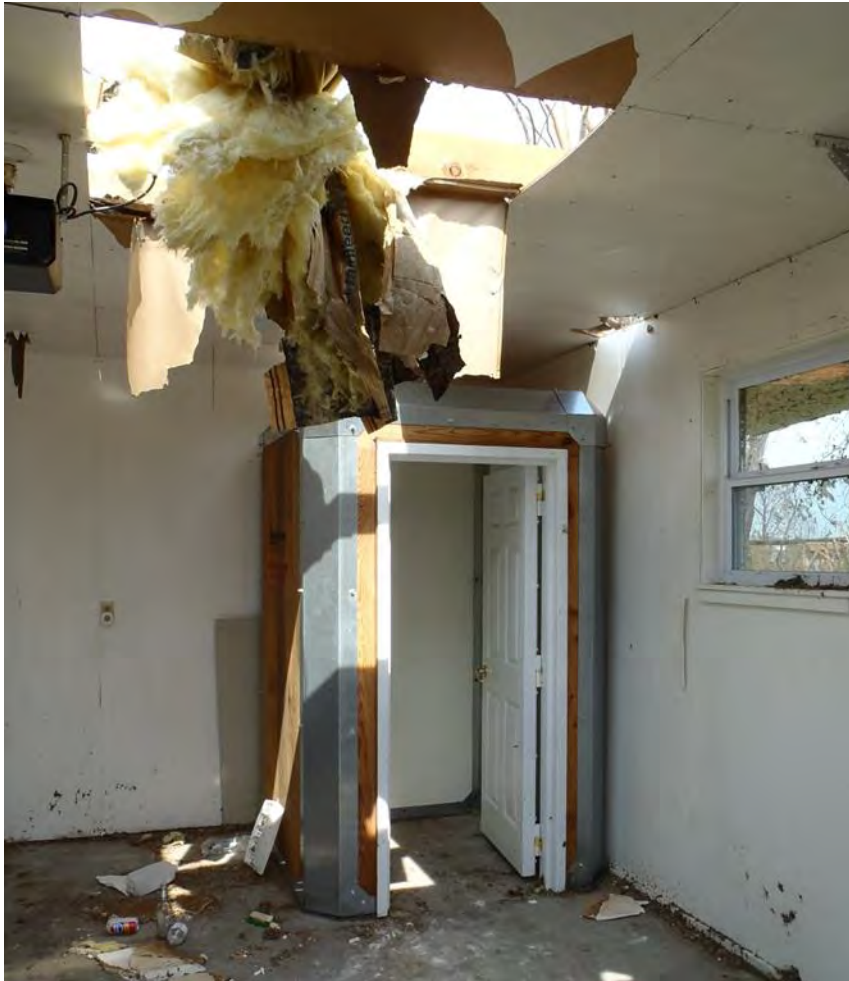
Figure 3–129. Above-ground Kevlar storm shelter bolted to concrete garage floor in residence that was damaged during the tornado.

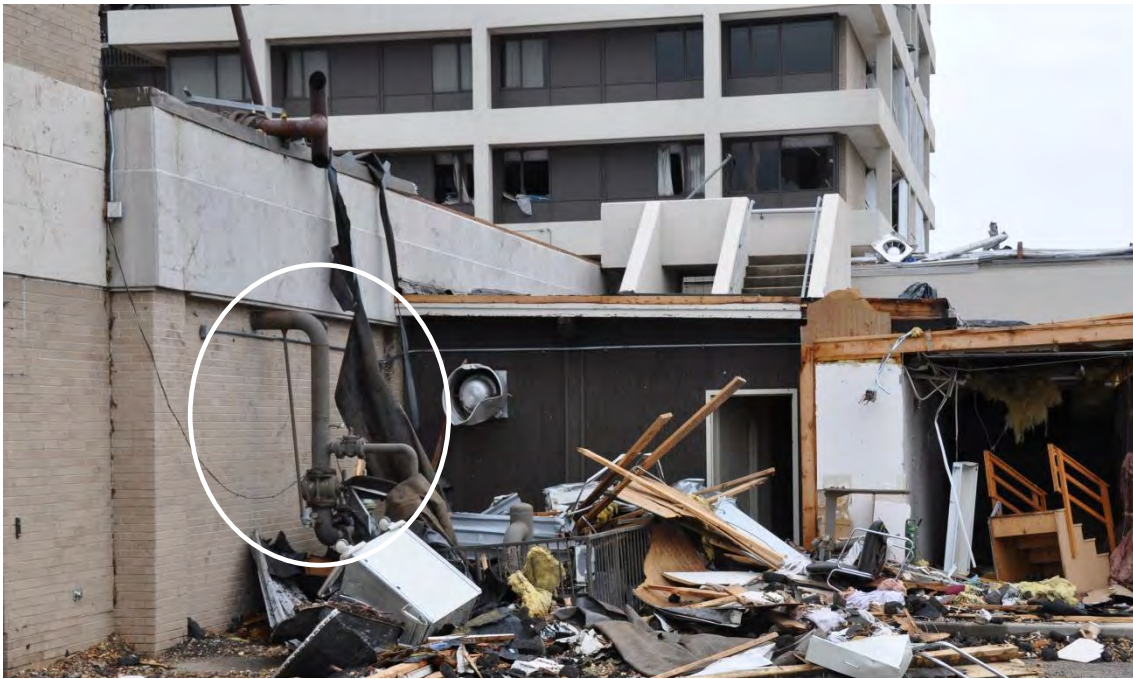
Figure 3-132. High-pressure gas reducer valve at SJRMC that was damaged and leaked.
