Draft Final Report • National Institute of Standards and Technology (NIST)

of the May 22, 2011,
Tornado in
Joplin, Missouri

NIST NCSTAR 3 (Draft)

November 2013

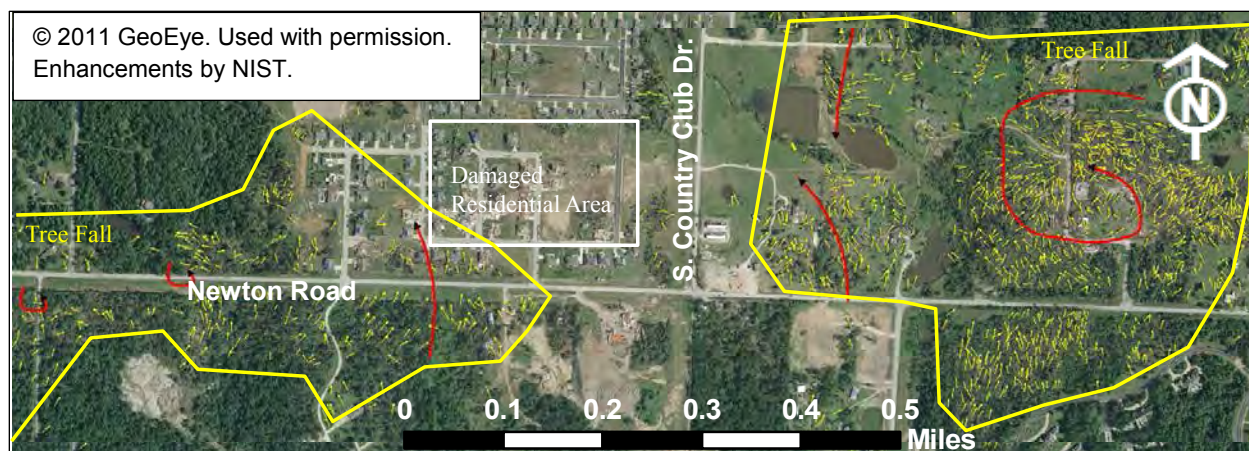
Figure 1–4. Initial damage in the Joplin tornado. Yellow arrows indicate directions of treefall. Possible multiple vortices shown by red arrows.

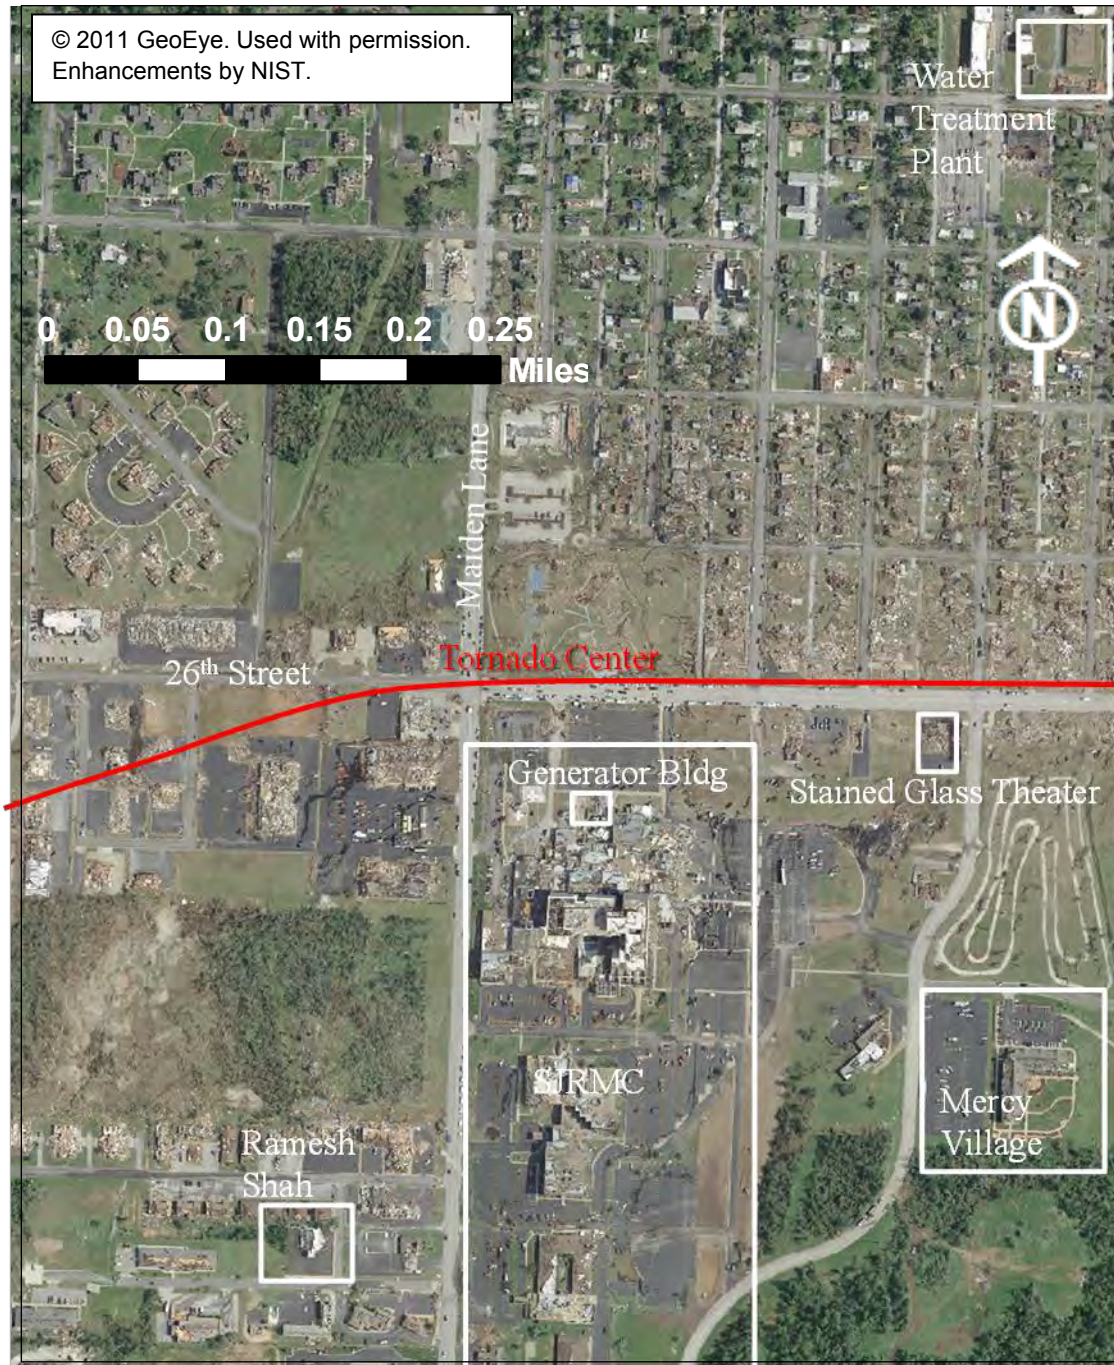
Figure 1-6 . Aerial photo showing damage to SJRMC and the surrounding area.

A total of 14 lives were lost at SJRMC as a result of the tornado. Due to the significant damage sustained by all of the buildings, Mercy, the parent organization of SJRMC, decided to raze the entire facility beginning in January 2012. This represented an insured loss estimated at \$600 million.³⁵

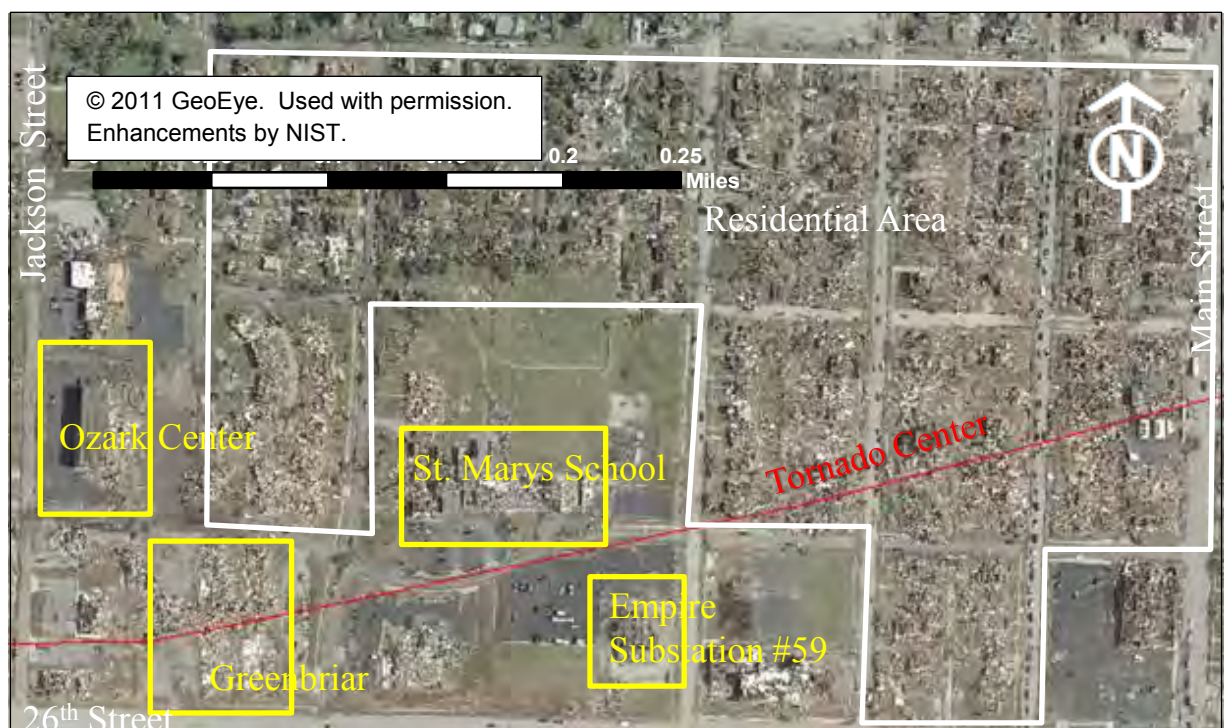
Figure 1–7. Aerial photo showing locations of the Ozark Center for Autism, Greenbriar Nursing Home, St. Mary’s Catholic Elementary School, and EDE substation 59 (from west to east). Residential area is outlined in white.

Empire District Electric (EDE) substation 59 was located adjacent to St. Mary’s School and in close proximity to the tornado center line. This steel-framed substation, which delivered electrical power to residences and businesses in the vicinity, including SJRMC, was completely destroyed. It was one of six power substations impacted by the event. The destruction of this substation and the extensive damage to other electrical transmission and distribution systems resulted in a loss of power to more than 20,000 EDE customers located inside and outside of the tornado-damaged area. The tornado also wreaked havoc on water and gas distribution systems. It caused thousands of small leaks in residential and fire water-service lines and a subsequent sharp drop in water pressure in the area. Additionally, there was extensive damage to gas mains and meters, which resulted in numerous gas leaks in the affected area.

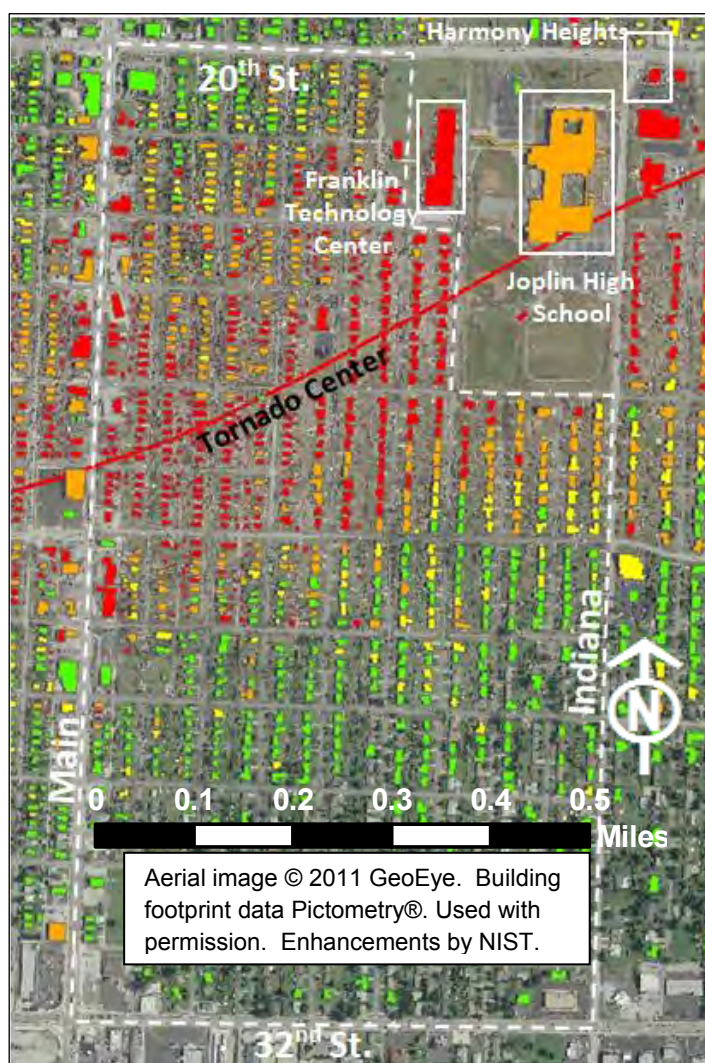
Figure 1–8. Aerial photo showing the locations of a heavily damaged residential area, Franklin Technology Center, Joplin High School, and Harmony Heights Baptist Church. The color of each building footprint shows the level of damage to that structure.

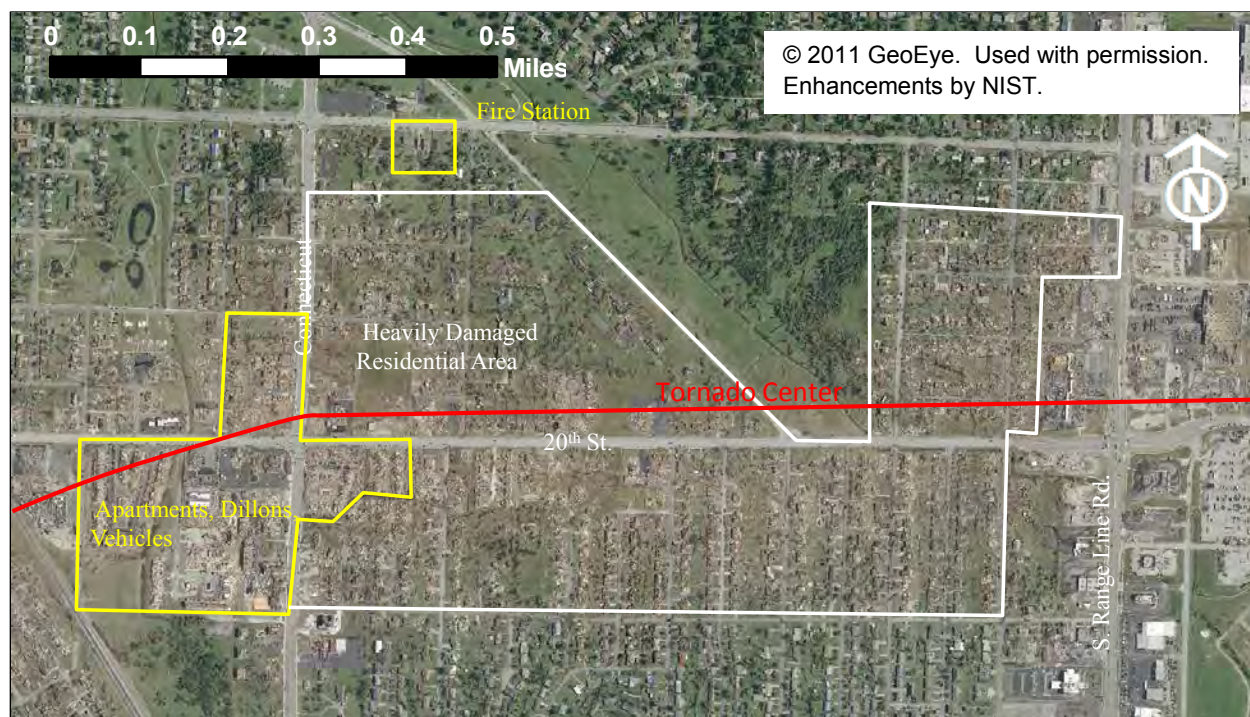
Figure 1–9. Aerial photo of damaged residential areas (including apartment complexes) in Joplin near the intersection of 20th and Connecticut.

A number of apartment complexes were located in this area, including Somerset Apartments, Connecticut Pointe Apartments, and Hampshire Terrace. In the Somerset complex, a survivor recalled evacuating her apartment and taking refuge underneath the building's staircase with her neighbors, rather than remaining inside her garden-style apartment. Her complex, along with Connecticut Pointe and Hampshire Terrace, were significantly damaged in this storm. All 12 of the fatalities that occurred in apartments during the tornado happened in these three complexes, and all were from impact-related causes.

residential area to the north and south of 20th Street. Six fatalities occurred in homes within this area, which is outlined in Fig. 1–9.

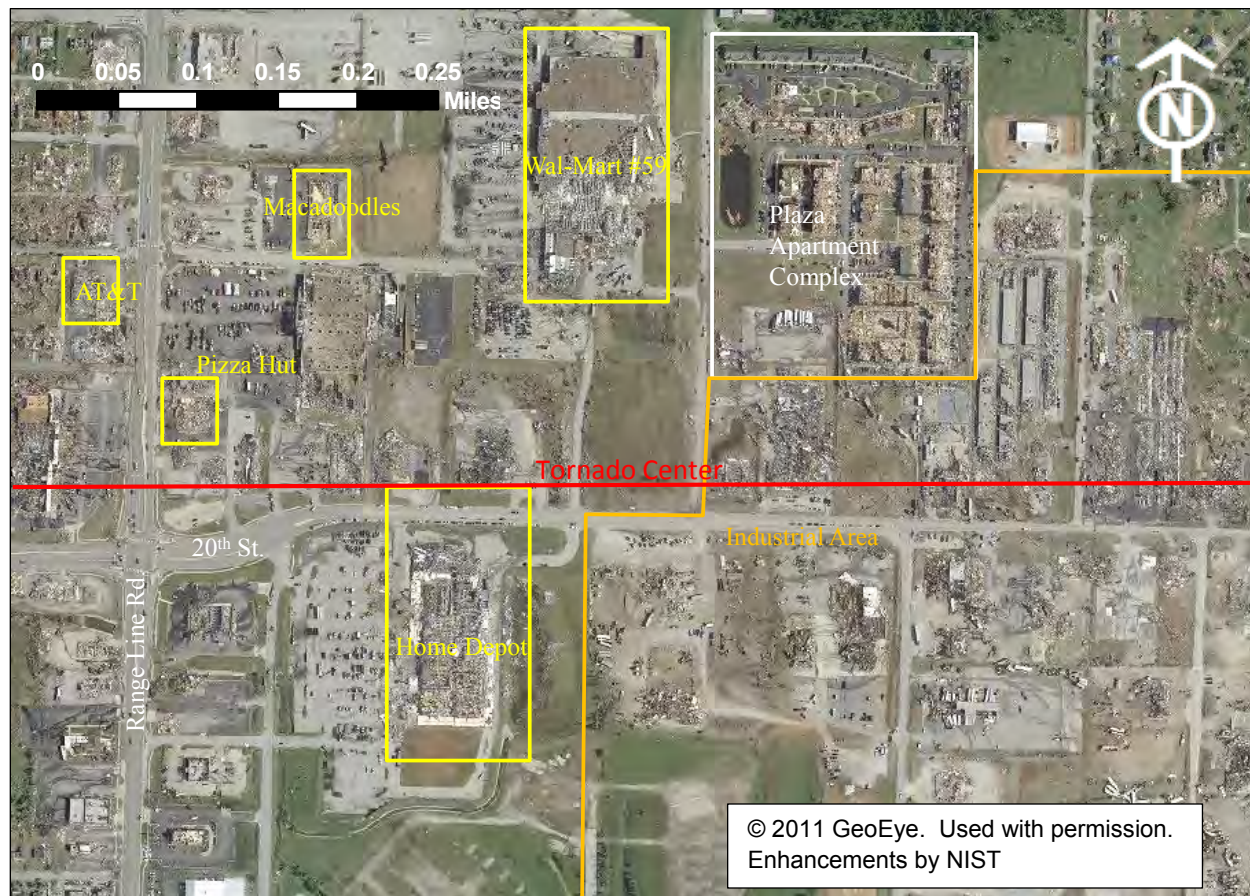
Figure 1–10. Aerial photo showing damage to a commercial area on the eastern side of Joplin near the intersection of Range Line Road and 20th Street.

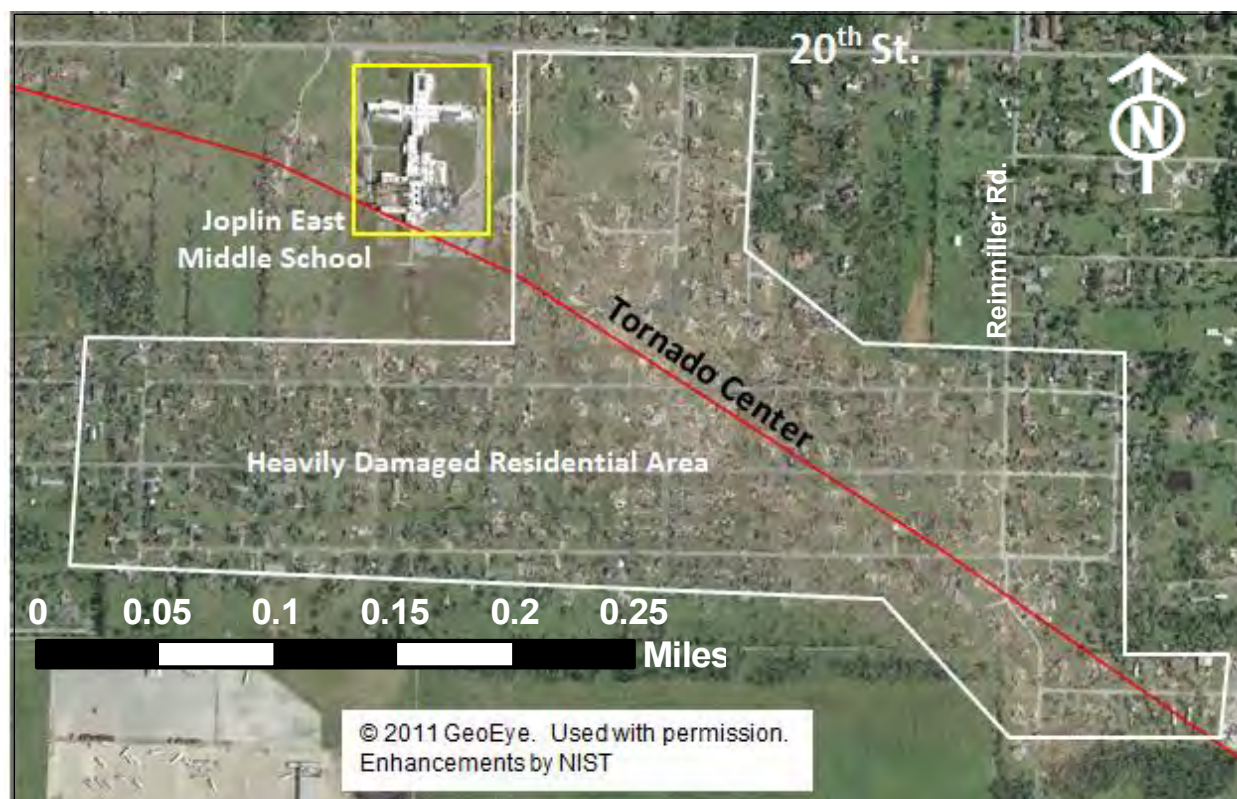
Figure 1–11. Aerial photo of damage to a residential area and Joplin East Middle School.

the area as the winds strengthened. Video footage of the gymnasium, on the south side of the school, showed ceiling lights swaying and bits of roofing material, including panels of metal roof decking, falling onto the gym floor as the winds began to increase. Later footage showed that failed roof trusses had fallen onto the gym floor and the western wall of the gymnasium had collapsed toward the interior of the building.

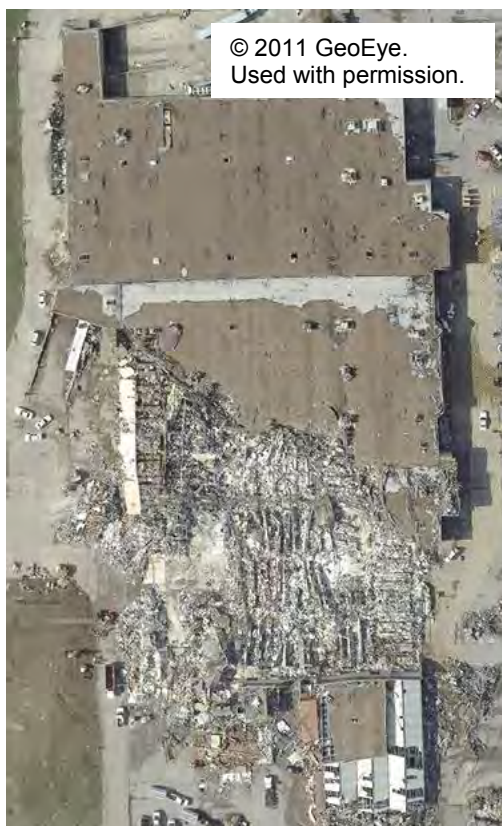
One example that demonstrates the challenges in assigning definitive DODs for large structures involves the Walmart (Store #59) located at 1501 South Range Line Road in Joplin. This large building was 573 feet (175 meters) long, oriented along a north–south axis. The building was located north of the center line of the tornado track. The southern part of the building, which was closer to the center of the tornado, suffered extensive damage, while the northern part of the building experienced much less damage as shown by the aerial photo in Fig. 2–13.

Figure 2–13. Aerial photo of Walmart Store #59 showing extensive damage to the southern (bottom) half of the building.

Under the EF scale guidance, this type of building is classified as DI 12, a “Large, Isolated Retail Building.” However, which DOD should be selected is less than clear. The structure could fall into either DOD 6, “inward or outward collapse of exterior walls,” which occurred in the southern half of the building, or DOD 7, “complete destruction of all or large sections of the building,” which could apply based on Figure 2–13. However a ground level picture (Fig. 2–14), reveals that some of the southern portion of the structure remained in place and suggests a DOD less than 7. The expected wind speeds (and lower/upper bounds) for DOD 6 and DOD 7 for DI 12 are 118 mph (98/158) and 147 mph (110/201), respectively. Consequently, assigning a specific DOD and an associated wind speed becomes somewhat subjective. Since the damage to the Walmart clearly exceeded DOD 6 and didn’t quite meet DOD 7 for a portion of the building, a point estimate of 140 mph \pm 15 mph was assigned. This made the estimated lower bound 125 mph, a value that could still account for DOD 6 while falling within the bounds of DOD 7. The upper bound, 155 mph, still falls within the range of DOD 6 wind speeds, and sits squarely within the wind speed range associated with DOD 7.

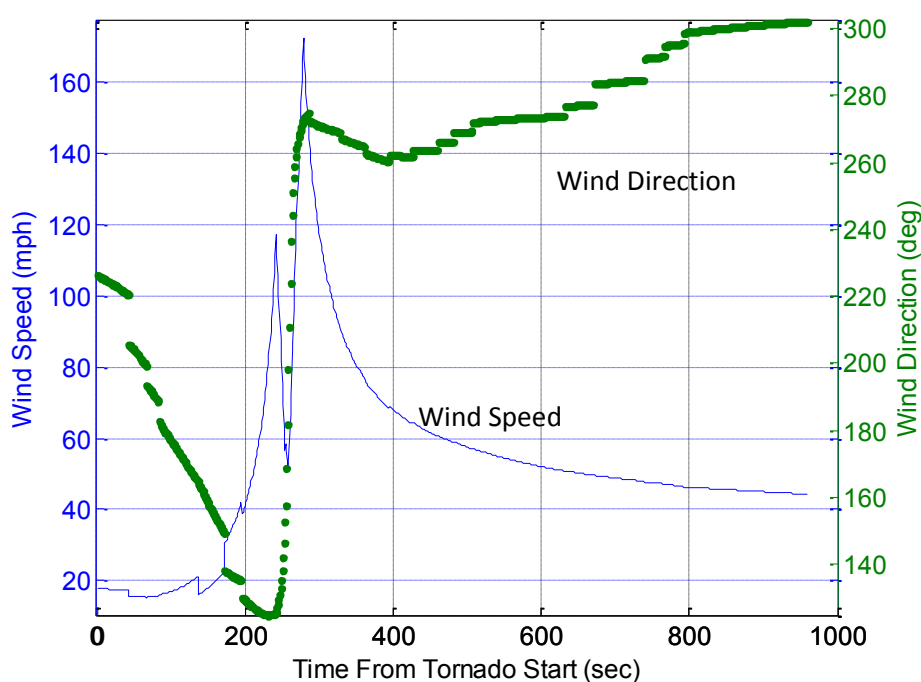
Figure 2–22 provides a closer examination of Fig. 2–20 using best estimated wind speeds. This location was within the *RMW* (likely in the corner flow region or Region III as illustrated from a general case in Fig. 2–9). According to the model, this grid point was near the possible “eye” of the tornado. As the

tornado approached wind speeds increased to approximately 115 mph to 120 mph then dropped rapidly to speeds below 60 mph when the tornado center was near, and increased on the back side of the tornado to a maximum of approximately 175 mph. Between the first and second peaks, the wind direction shifted nearly 180 degrees in approximately 30 seconds to 40 seconds. Time histories for every grid point with best estimated wind speed and direction values (and more information on the wind field modeling process) will be available through the NIST Disaster and Failure Studies Event Data Repository web site (http://www.nist.gov/el/disasterstudies/repository_home.cfm) when the Joplin Tornado Repository is completed. Best estimated time histories nearest to structures surveyed by NIST can be found in Appendix E. These time histories were also used to study both structural (Chapter 3) and human (Chapter 4) responses to the Joplin tornado.

Figure 2–22. Example of a modeled best estimate of tornado wind speed and direction time history associated with the Joplin tornado (X = 2.1, Y = 0.45).

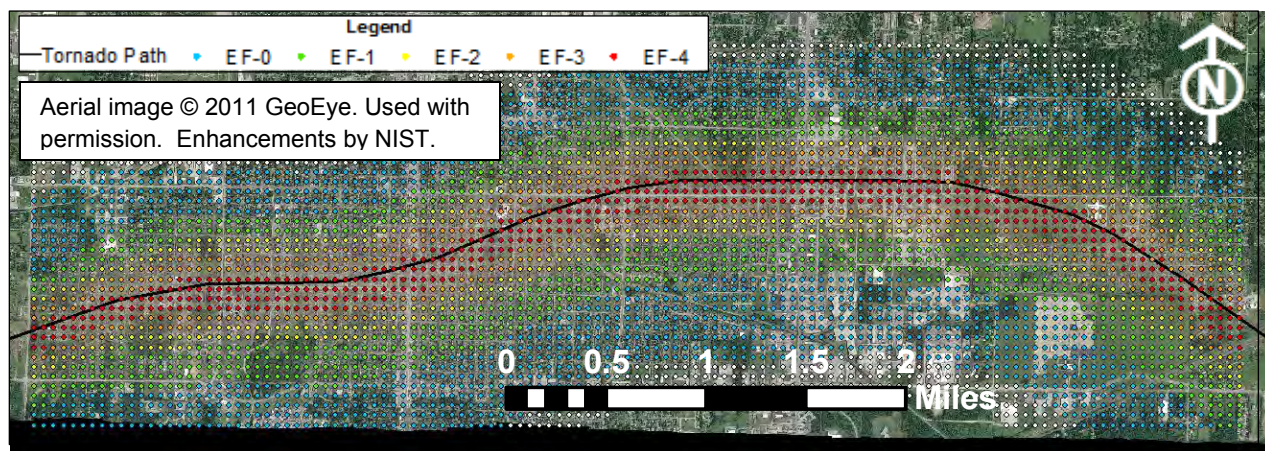
From the maximum wind speed information, two shapefiles were created in ArcGIS. The first shapefile shows the grid points in the wind field estimation colored by their best estimated maximum wind speed value. This wind field estimation is illustrated in Fig. 2–23. The coloration is based on wind speed ranges outlined in the EF Scale. The second shapefile was created by drawing polygons around areas that were within the wind speed ranges prescribed by the EF Scale. These polygons are shown in Fig. 2–24.

Figure 2–23. Estimated maximum wind speed grid points from tornado wind field model grid points grouped by EF Scale. The solid black line represents the estimated tornado center. The area in the figure is approximately 6.2 miles west to east and 2.0 miles north to south.

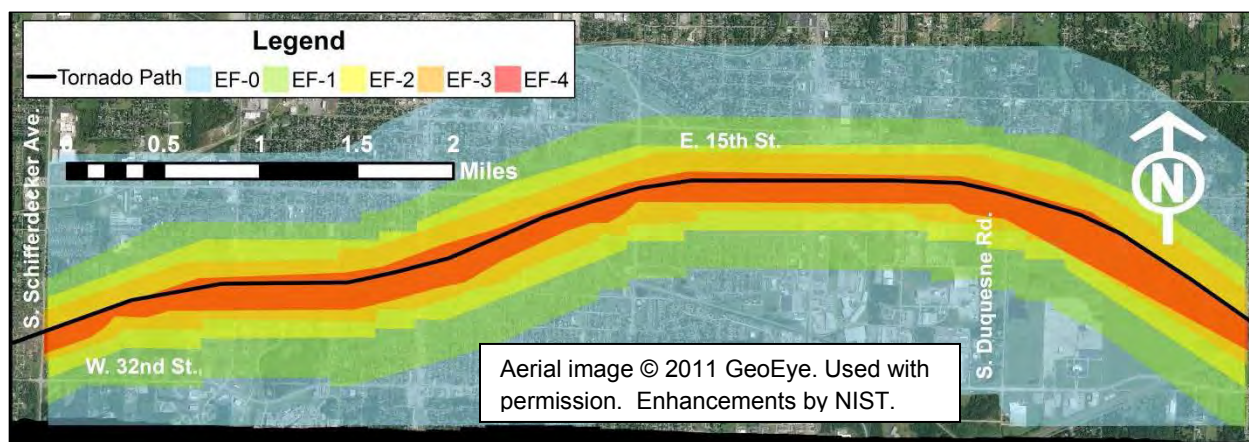
Figure 2–24. Estimated maximum wind speed polygons from tornado wind field model grouped by EF Scale. The solid black line represents the estimated tornado center. The area in the figure is approximately 6.2 miles west to east and 2.0 miles north to south.

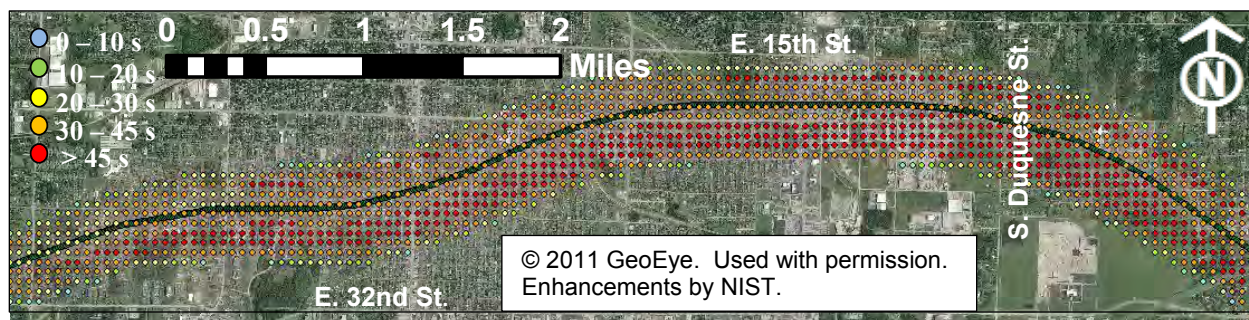
The duration of damaging winds can play a significant role in overall damage states (Kopp and Morrison 2011). Figure 2–26 shows the estimated amount of time that the modeled wind speeds were at an EF–2 level or above (≥ 49.2 m/s or 110 mph). Each time step that was at or above the EF–2 level was summed to estimate the duration. The best estimated longest duration of EF–2 or greater wind speeds in the Joplin tornado was approximately 67 seconds, with a range of 33 seconds to 107 seconds considering the uncertainty in the input parameter values used in the wind field model. The longest duration of damaging

Figure 2–26. Best estimate of duration of wind speeds greater than or equal to EF–2 (≥ 110 mph). Green line shows estimated tornado center. The area in the figure is approximately 6.2 miles west to east and 2.0 miles north to south.

wind speeds was mainly south of the estimated tornado center shown in Fig. 2–26. The majority of areas that experienced any EF–2 or greater wind speeds encountered over 30 seconds of such winds due to the structure of the wind field.

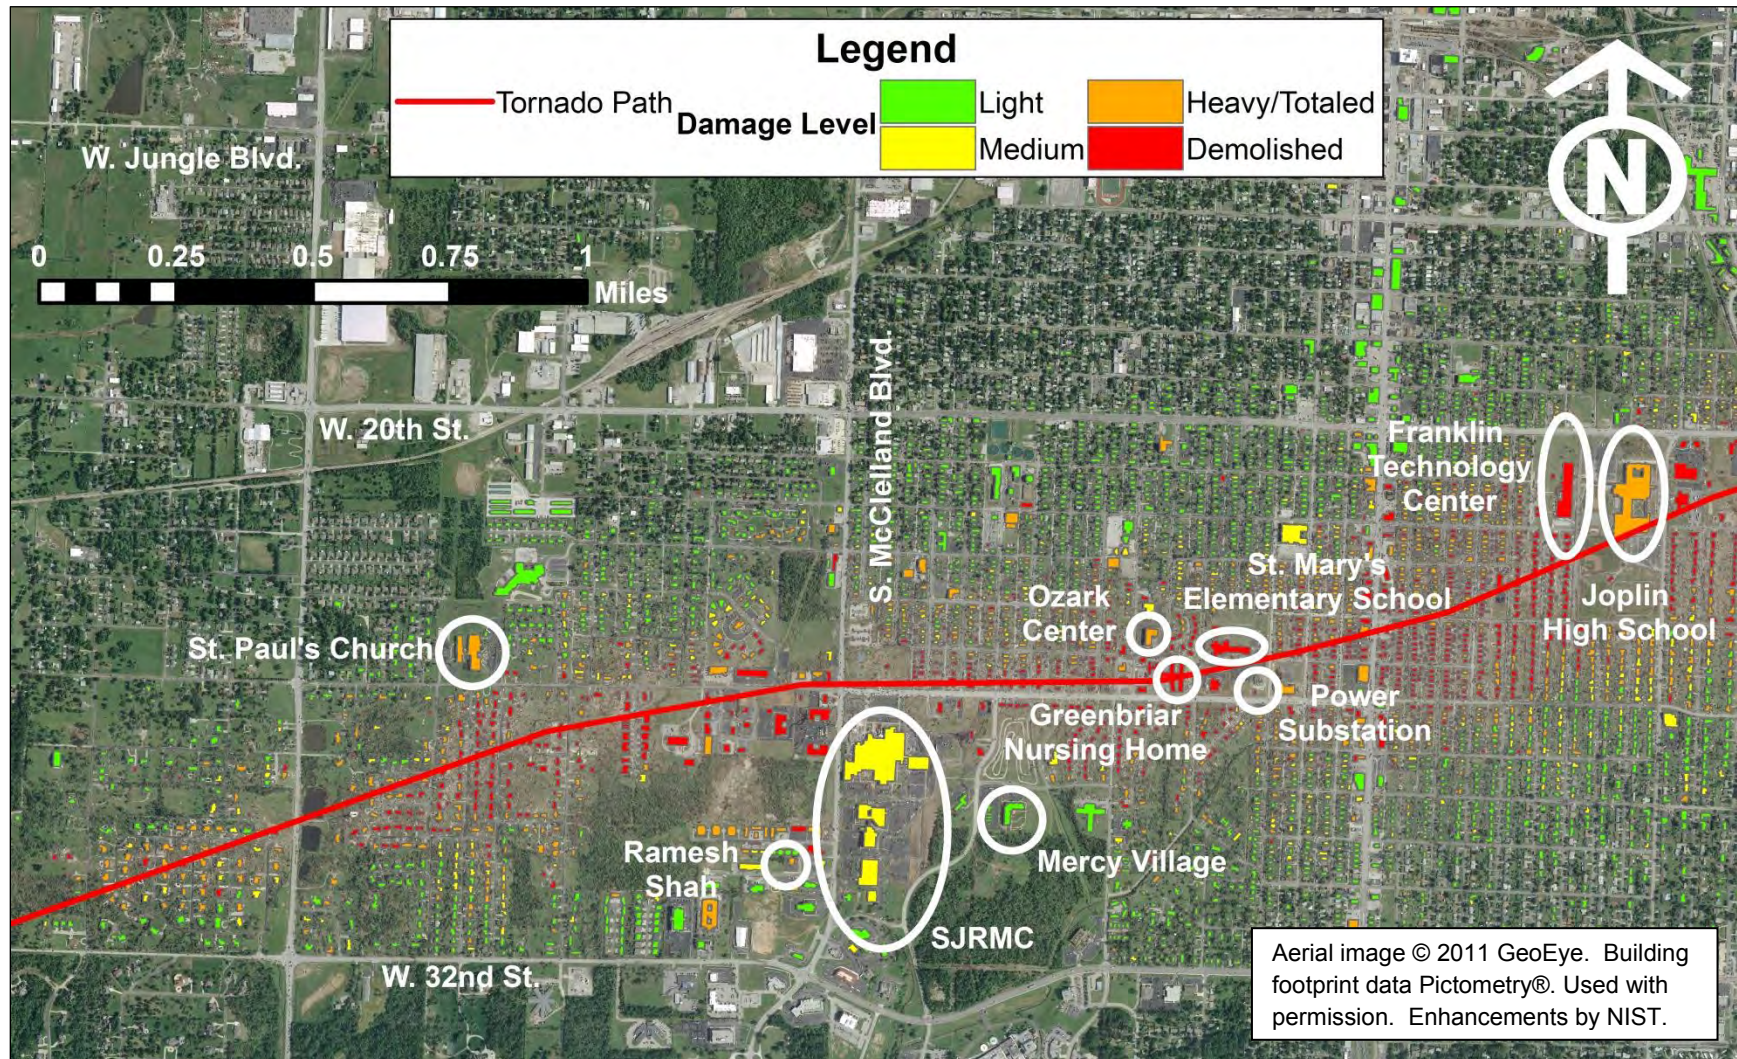
Figure 3–1. Westernmost (earliest) segment of the tornado path through Joplin, showing locations of facilities surveyed by NIST relative to the estimated center line of the tornado damage path (red solid line). The color coded building footprints indicate the estimated level of damage to individual structures (see legend above).

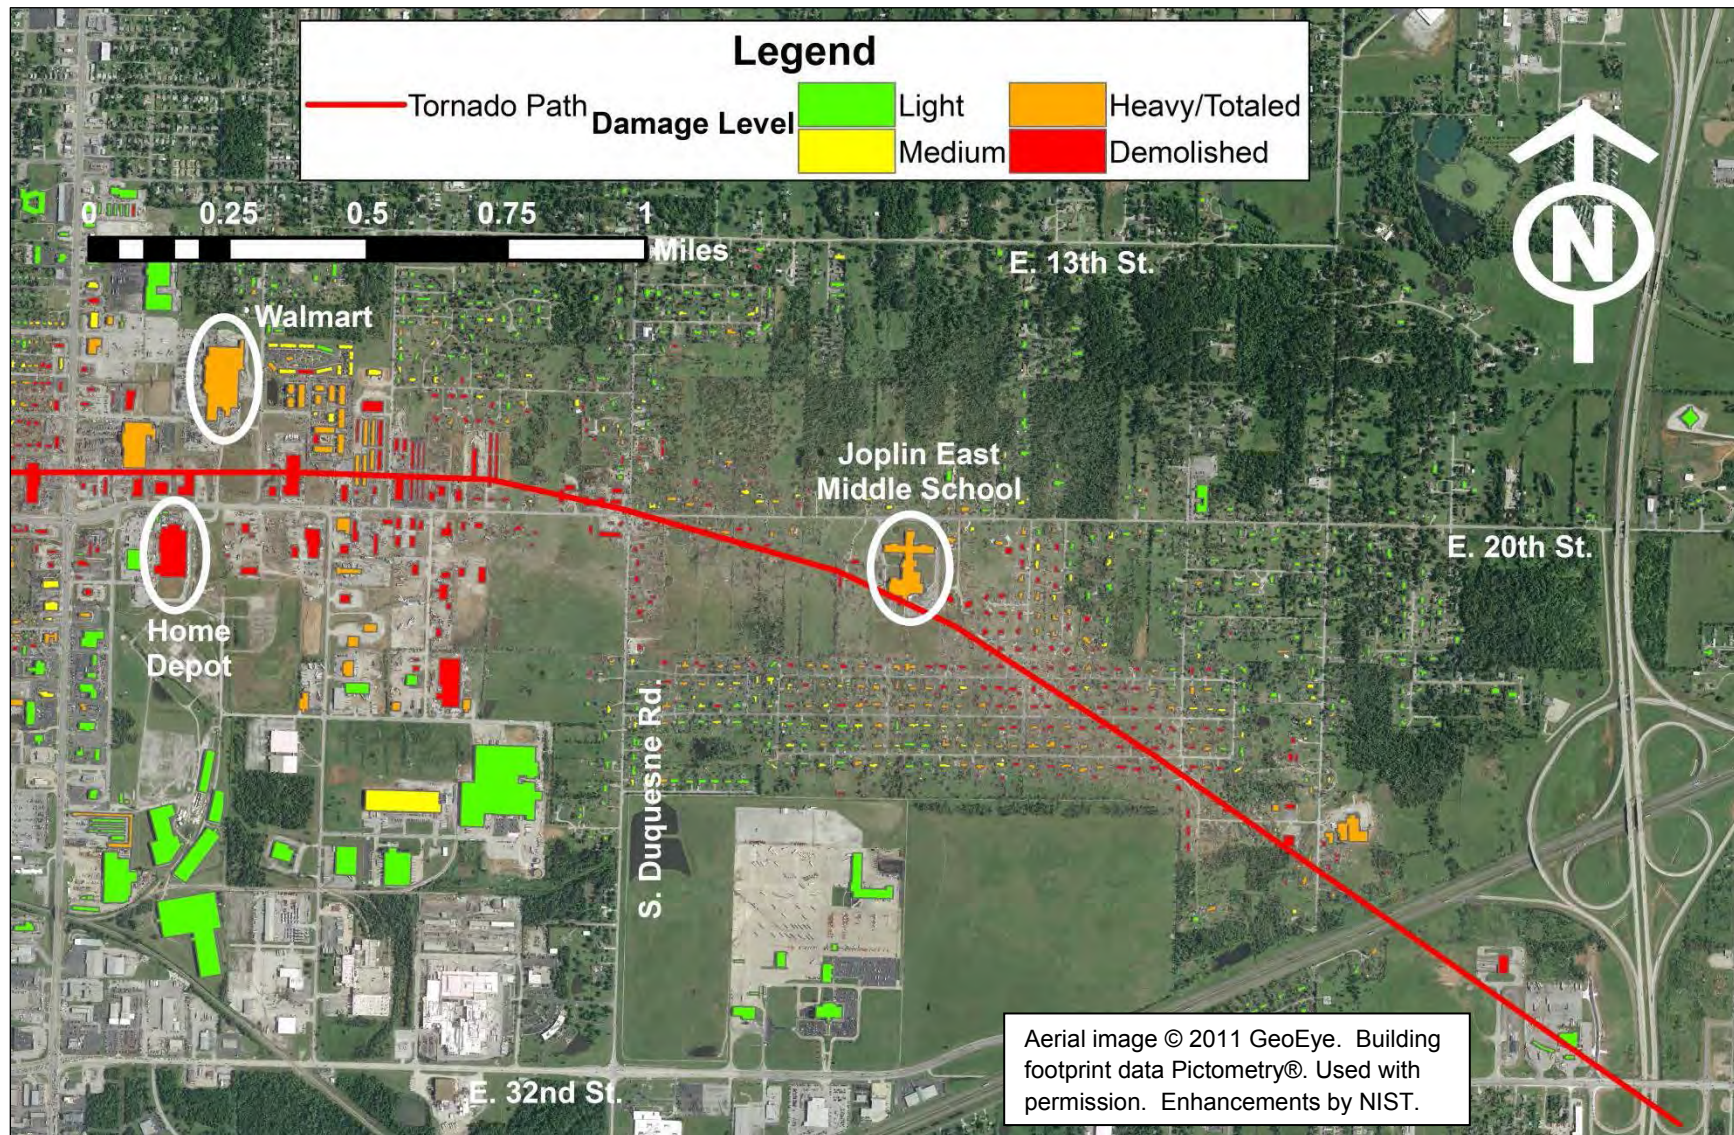
Figure 3–3. Easternmost segment of the tornado path through Joplin, showing locations of facilities surveyed by NIST relative to the estimated center line of the tornado damage path (red solid line). The color coded building footprints indicate the estimated level of damage to individual structures (see legend above).

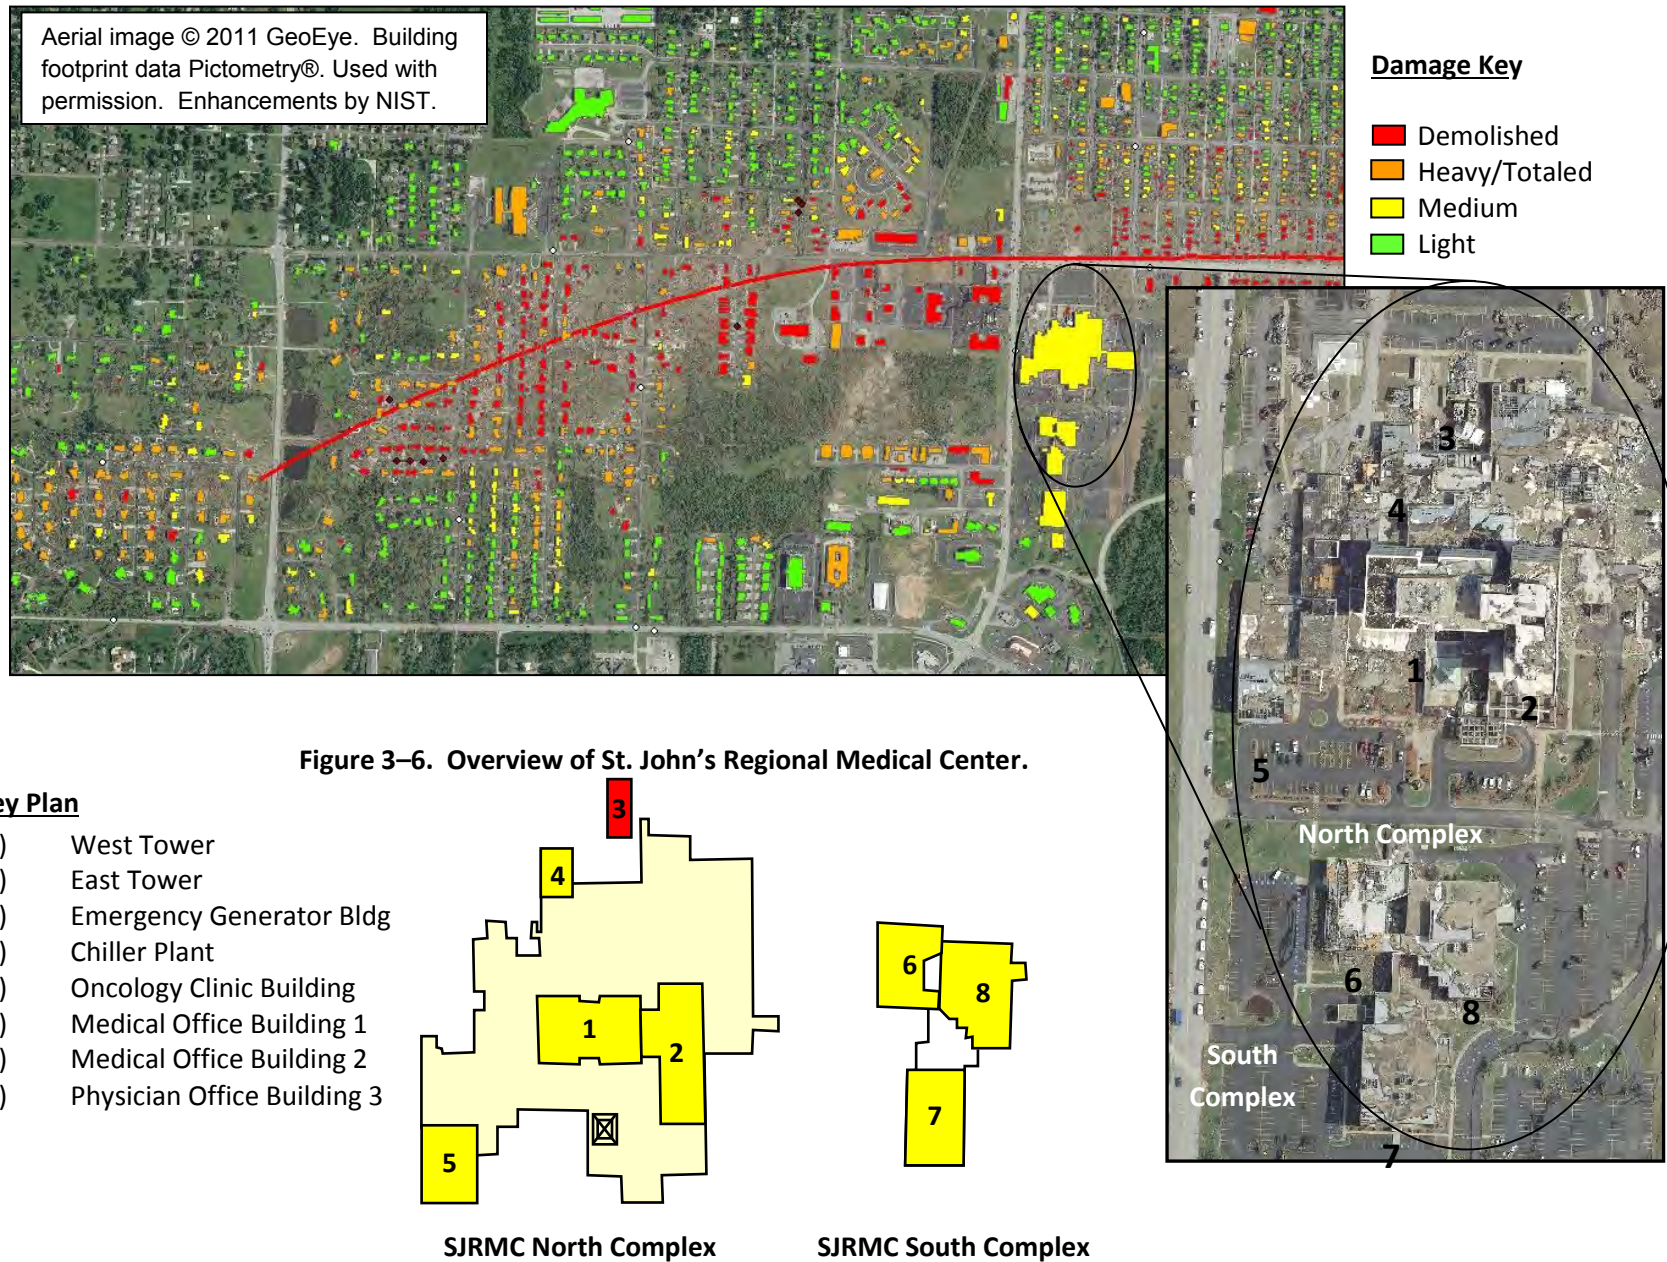
The SJRMC buildings were color-coded on Figure 3-6 based on damage estimates by Pictometry® which showed the Emergency Generator Building as being *demolished* by the tornado and all other SJRMC buildings as having sustained *medium* damage. The Pictometry® database was one of three damage

databases obtained by NIST (the others created by the U.S. Army Corps of Engineers and the SAVE⁸⁰ Coalition). SJRMC was situated immediately to the east of a mixed commercial and residential area in which the majority of buildings were demolished by the tornado (EF-4 damage based on NIST's evaluation). Thus, it was directly downstream of the debris field that resulted from the damage to buildings in this area.

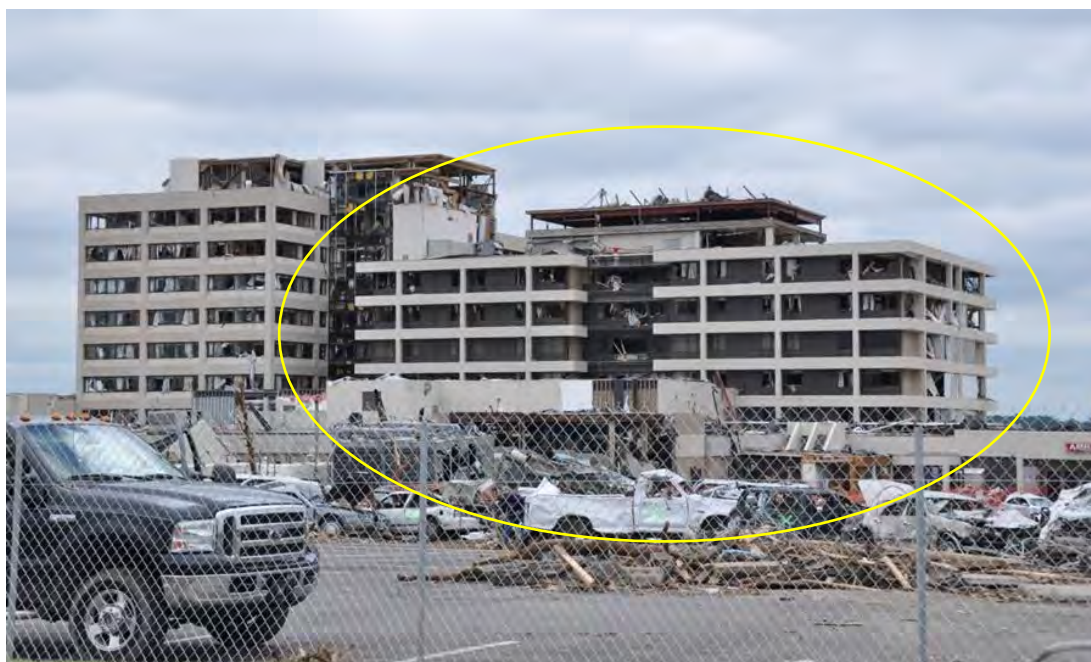
Figure 3–9. SJRMC's West Tower (north side).

Figure 3–9 shows the north-facing side of this building. Following is information about the design of the building and its performance in the tornado.

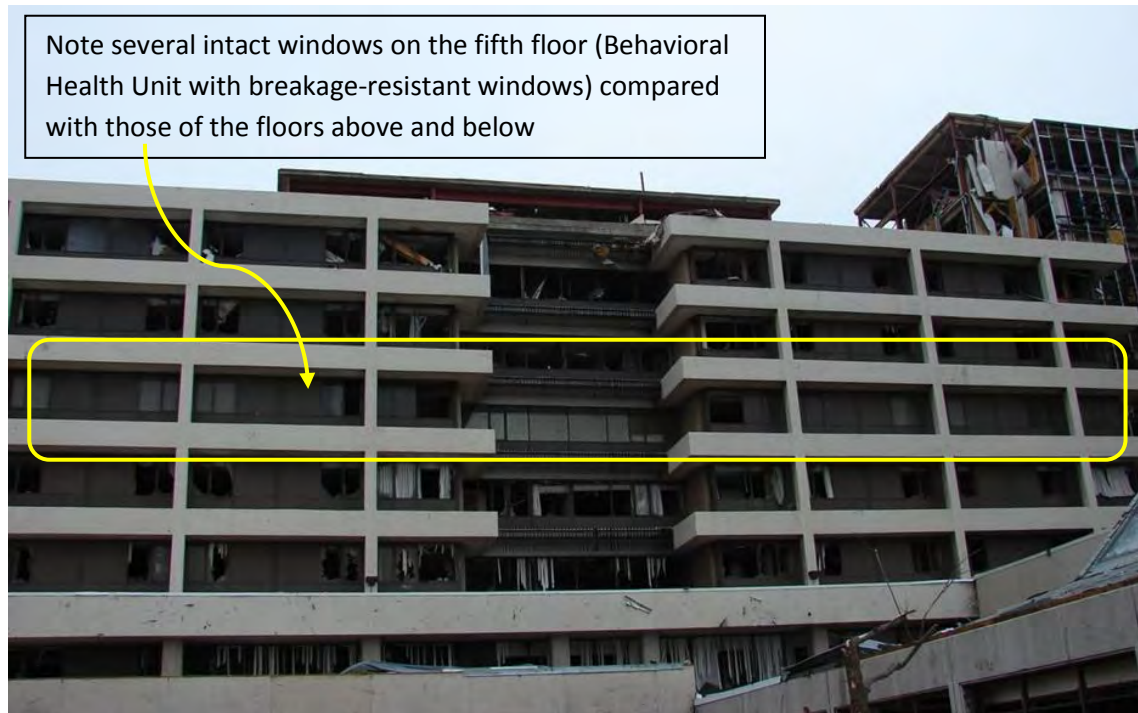
Figure 3–10. Intact windows on fifth floor of West Tower (south side).

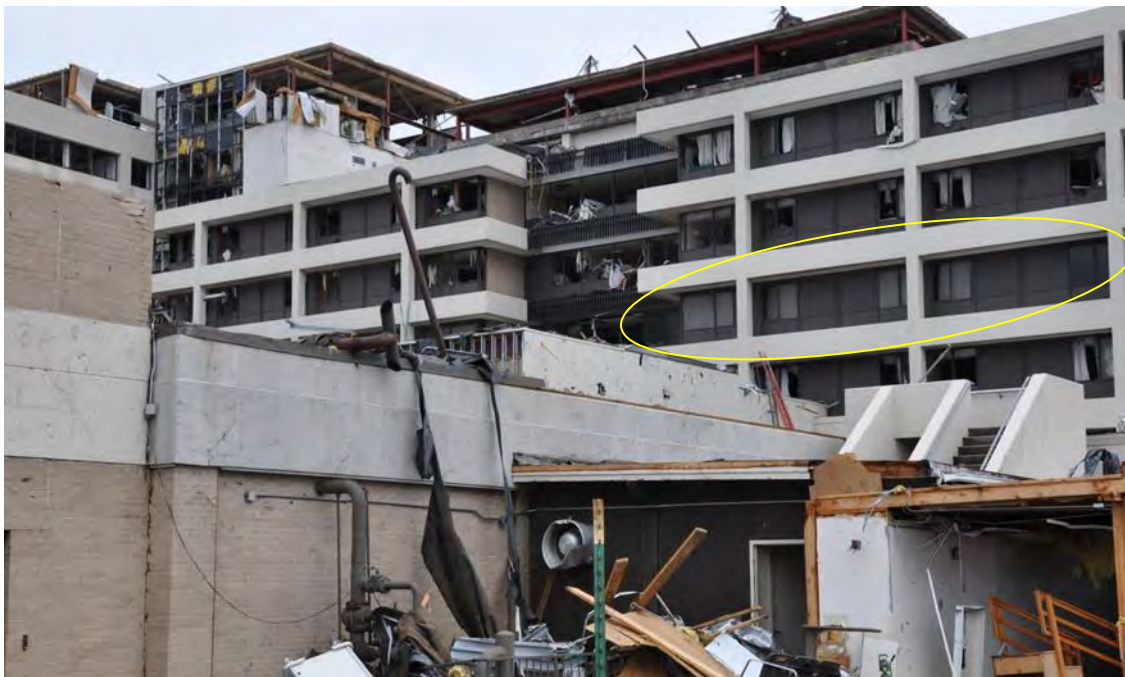
Figure 3–11. Intact windows on fifth floor of West Tower (north side).

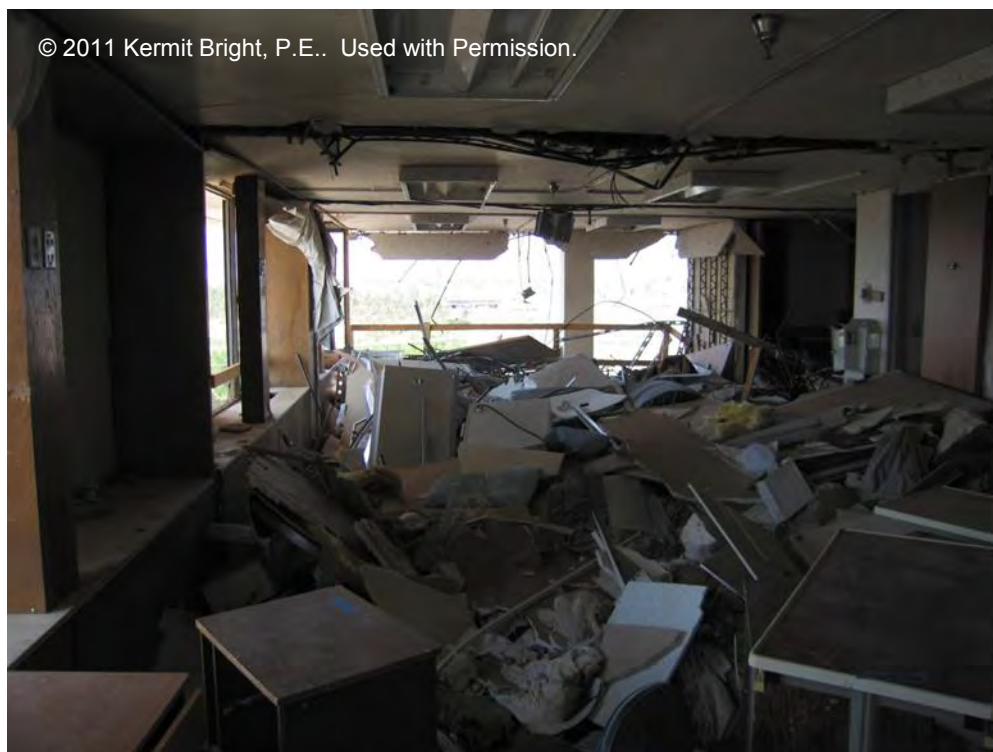
- There was significant damage to the building interior, including:
 - Breakage or collapse of interior partitions, suspended ceiling systems (hanging grid and lay-in ceiling tiles), furniture, electrical fixtures and wiring, HVAC ductwork and equipment, and other general building contents (see Fig. 3–13); and

- Infiltration of water and debris, and dislodging of building hazardous materials (asbestos on flooring material) (FM Global 2011).
- Even if electrical power had not been lost (see “Emergency Generator Building” below), the damage to the building envelope and interior would have resulted in the complete loss of functionality that occurred in this building. This is because even though there was no damage to the structural system, there was a complete loss of control over the interior environment (loss of temperature and moisture control due to the breached envelope and damage to HVAC equipment and ductwork), over illumination (broken electrical fixtures and wiring), and over mechanical vertical movement (damage to the elevator shaft gypsum-wall enclosure and elevator machine rooms). In addition, interviews of survivors conducted by NIST revealed that the damage to the building envelope and interior also presented the building occupants with significant hazards such as tripping, slipping, and electrocution (broken power lines and electrical fixtures that might have been energized if backup power had been switched).

Figure 3–13. Typical damage to the interior of West Tower.

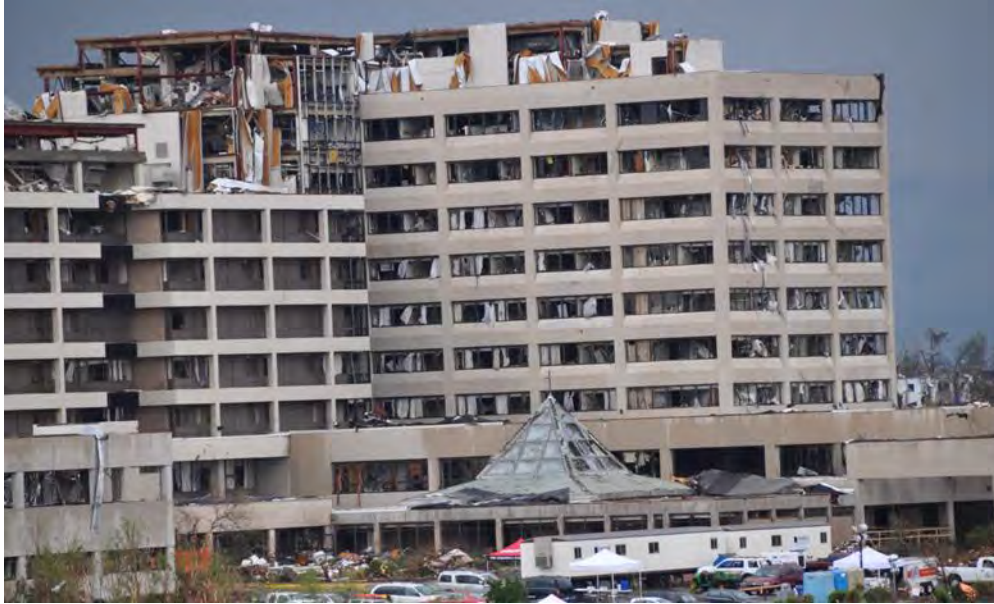
Figure 3–14. View from southwest of East Tower showing that most windows on south and west sides of building and curtain walls on connecting elevator steel frame have broken.

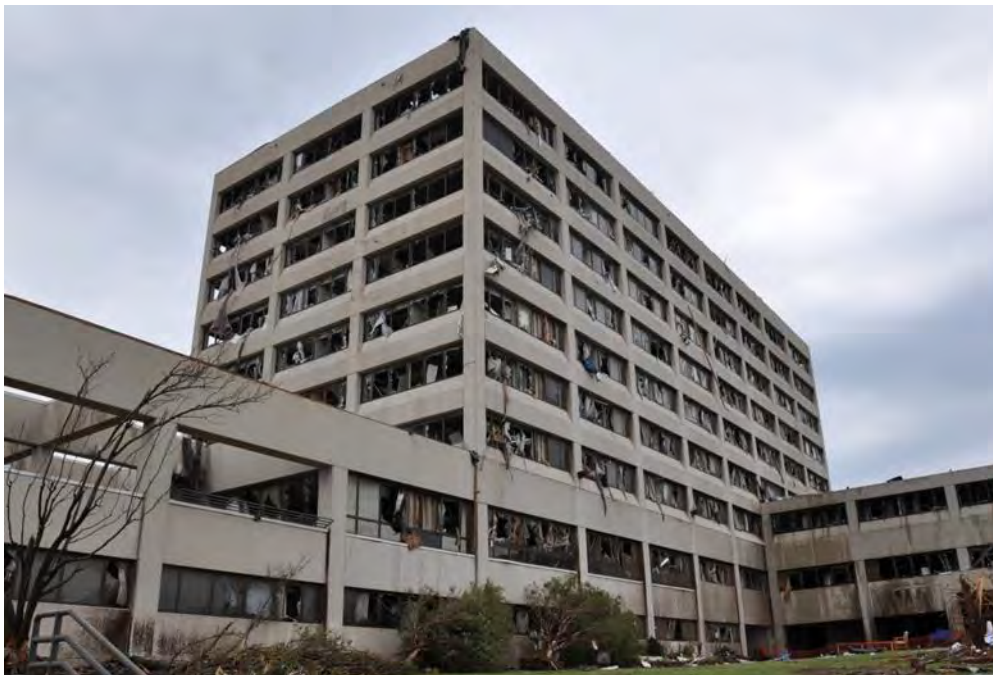
Figure 3–15. View from southeast of East Tower showing that most windows on south and east sides of building have broken.
