Draft Final Report • National Institute of Standards and Technology (NIST)

of the May 22, 2011,
Tornado in
Joplin, Missouri

NIST NCSTAR 3 (Draft)

November 2013

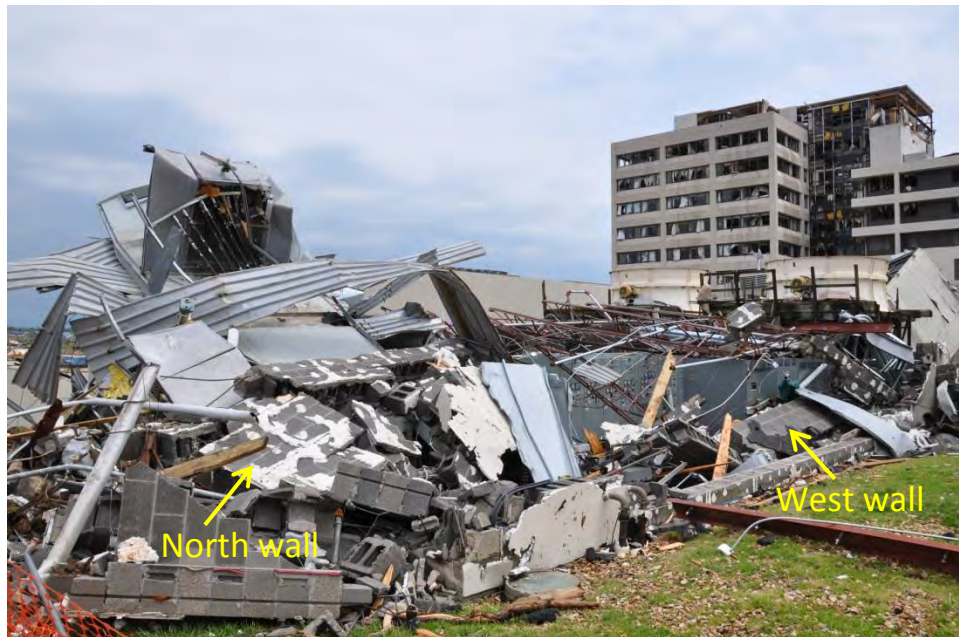
Figure 3–20. View from northwest of Emergency Generator Building. Note northward and eastward direction of wall failure, consistent with the direction of maximum wind (westerly) shown on Figure 3–7.

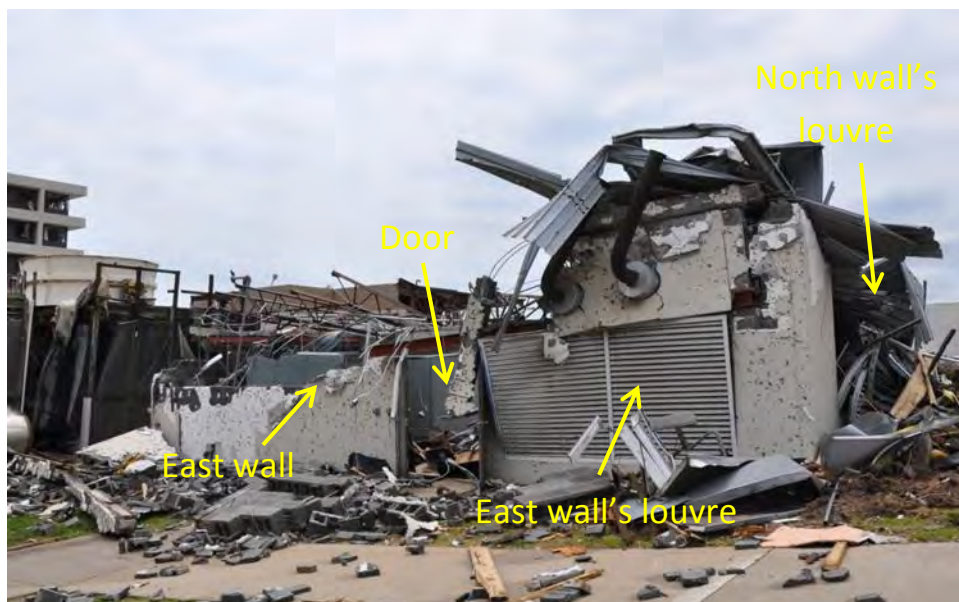
Figure 3–21. East side of Emergency Generator Building. Note eastward direction of failure on east wall (CMU wall falling outward, door opened, louver pushed outward). Also note louver on north wall pushed outward, consistent with direction of maximum westerly wind and indicative of high internal pressure.

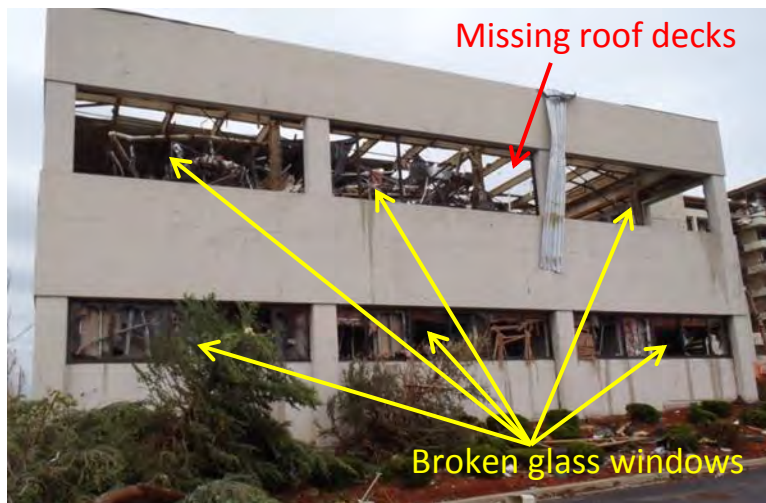
Figure 3–24. South elevation of Oncology Clinic Building showing damage to building envelope (broken glass windows, missing window frame, missing roof decks).

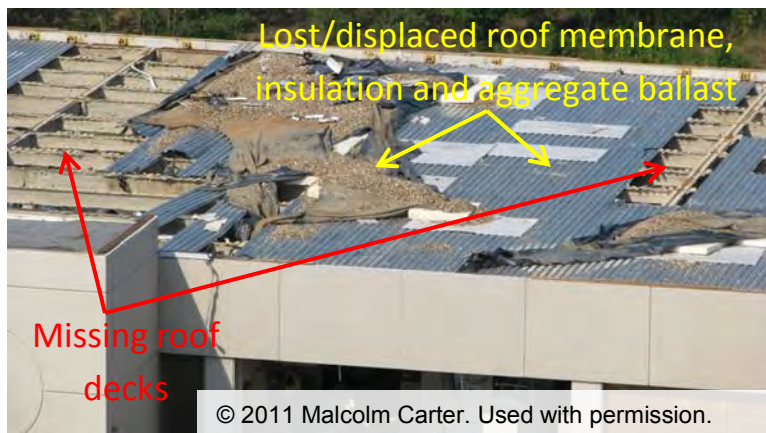
- There was no structural damage to the lateral load system (steel moment frame MWFRS) or the gravity load floor system (composite RC-on-steel deck).
- The building envelope sustained significant damage, including:
 - Breakage of all insulated glass panels and the loss of window systems (glass and aluminum frame), likely caused by both wind pressure and the impact of wind-borne debris based on site inspection, on all wind-exposed sides of the building (see Fig. 3–24).
 - Loss of several panels of steel roof deck, roof aggregate, membrane, rigid insulation, and gypsum board (see Fig. 3–25 and 3–26).

Figure 3–25. Roof of Oncology Clinic Building: missing steel deck panels, gypsum board, rigid insulation, membrane, and aggregate ballast.

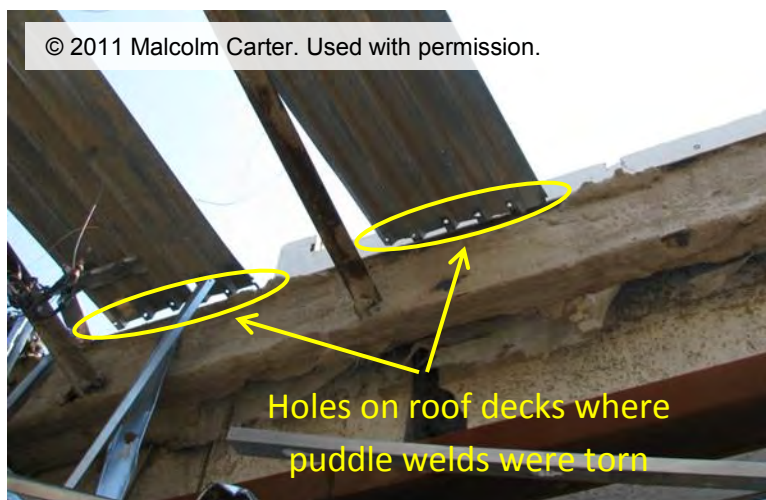
Figure 3–26. Roof of Oncology Clinic Building: failed puddle welds connecting roof deck with supporting roof beam.

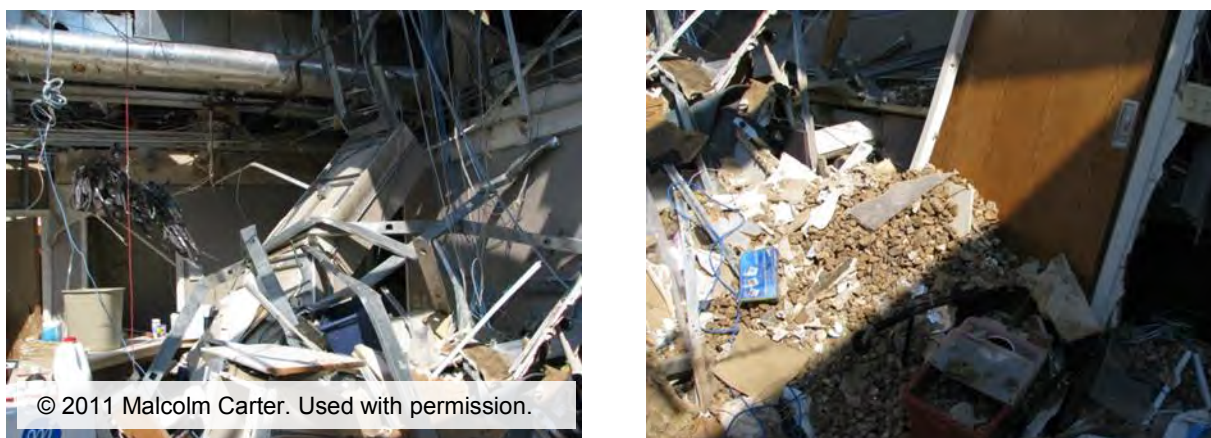
- There was significant damage to the interior of the building, including:
 - Breakage or collapse of interior partitions, metal wall studs, suspended ceiling systems (hanging grid and lay-in ceiling tiles), furniture, fixtures, and equipment (electrical fixtures and wiring, HVAC ductwork, and general building contents) (see Figure 3–27).
 - Infiltration of water and debris (including roof aggregate), and dislodging of building hazardous materials.

Figure 3–27. In Oncology Clinic Building, interior damage to ductwork, electrical wiring, suspended ceiling, interior partition/metal stud wall, furniture. Note the aggregate from roof in the interior.

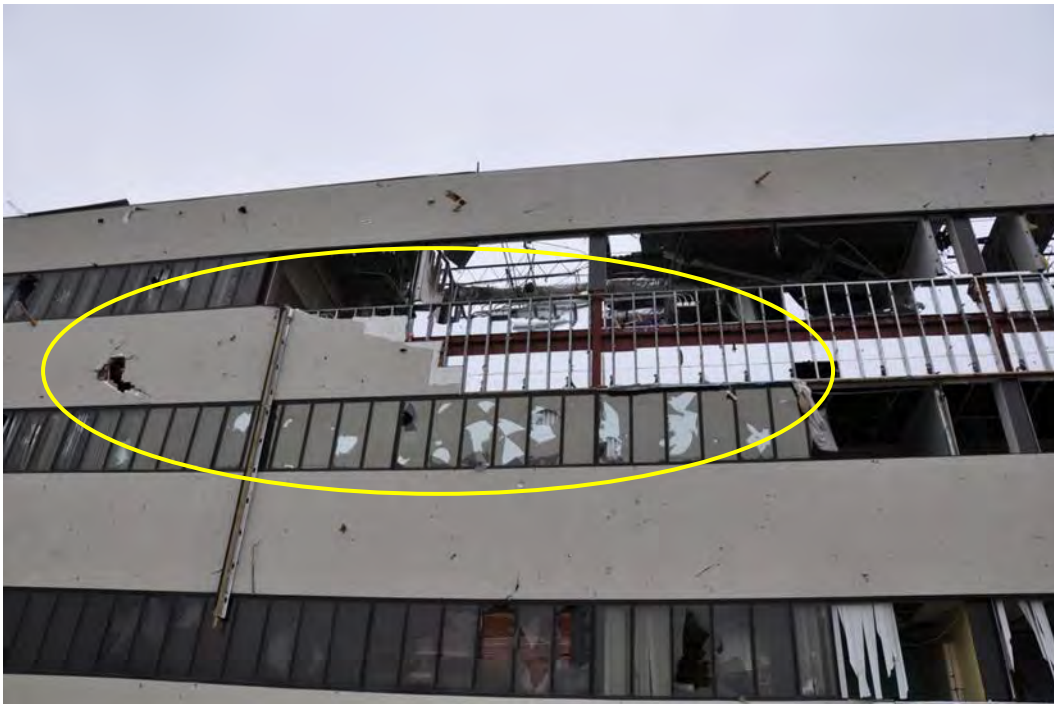
- There was no structural damage to the MWFRS (steel braced frame) or the gravity load floor system (composite RC-on-steel deck).
- The building envelope sustained significant damage, including:
 - Loss of steel roof decks and roof deck covering (horizontal envelope).
 - Breakage of curtain walls on all wind-exposed sides (broken glass windows and loss of architectural spandrel panels; see Fig. 3-29, 3-30, and 3-31).

Figure 3–30. Evidence of debris impact causing breakage of windows at Medical Office Building 2.

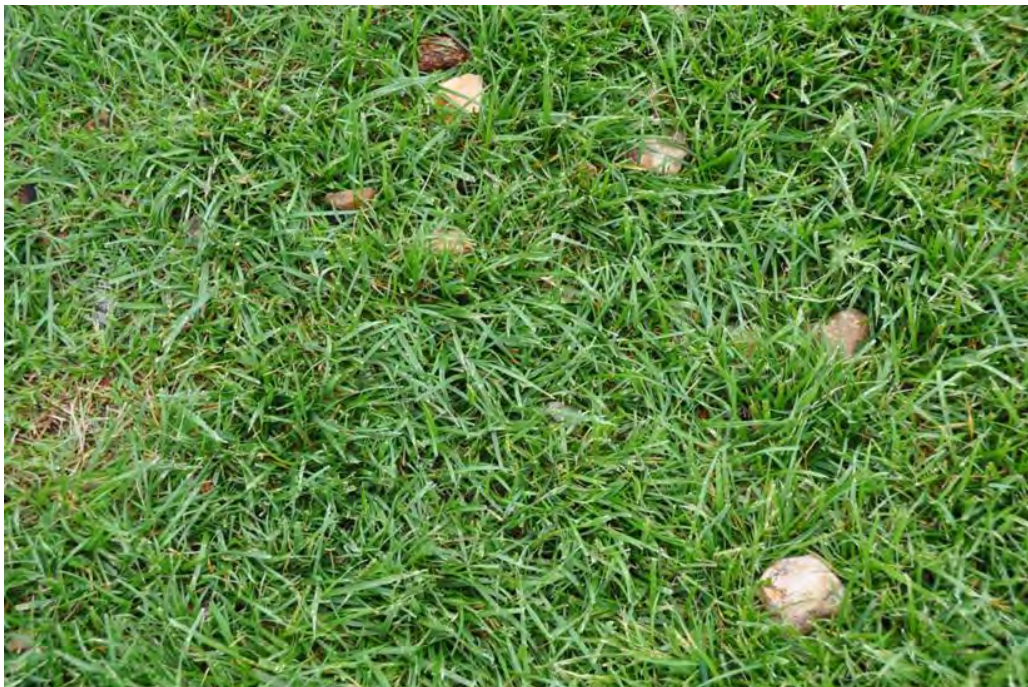
Figure 3–31. Roof aggregate ballast became wind-borne debris (on ground by Medical Office Building 2).

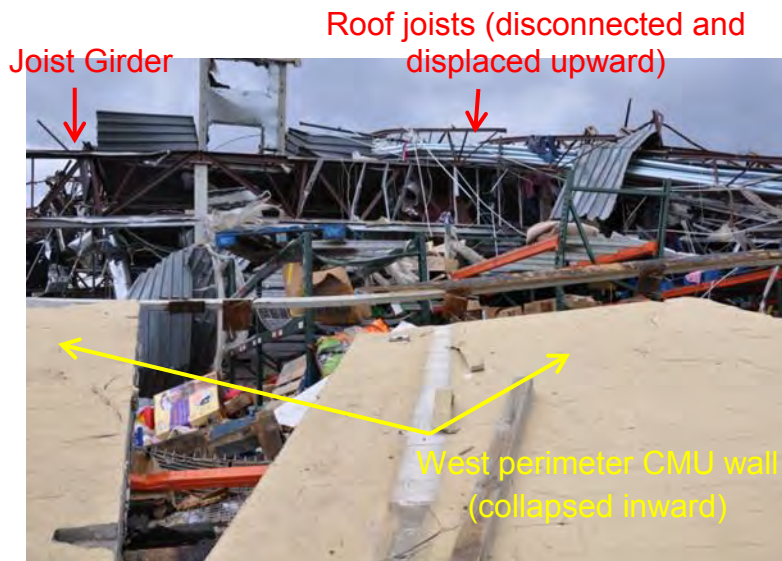
- The MWFRS of the south half of the building (perimeter walls laterally braced by roof system) completely collapsed, with:
 - The entire roof system (roof deck and roof joists) disconnected and either displaced upward or was completely blown away from the supporting joist girders and walls (evidence of wind uplift action, see Fig. 3–37 and 3–38).
 - The west and east walls (where the roof system that was supposed to provide lateral bracing was lost), and portions of the south wall, collapsed inward due to rotation at the base.
- The MWFRS of the north half partially collapsed, with:
 - A portion of the roof system (southeast corner) disconnected and either displaced upward or blown away from the supporting joist girders and walls (see Fig. 3–37 and 3–38).
 - A section of the east wall that was braced by this portion of the roof collapsed inward due to rotation at the base.

Figure 3–37. Roof system (decks and joists) missing. Some roof joists displaced upward (top chords used to be at same elevation as top chords of joist girders, but now sitting above joist girders), showing evidence of wind uplift action as primary cause of failure.

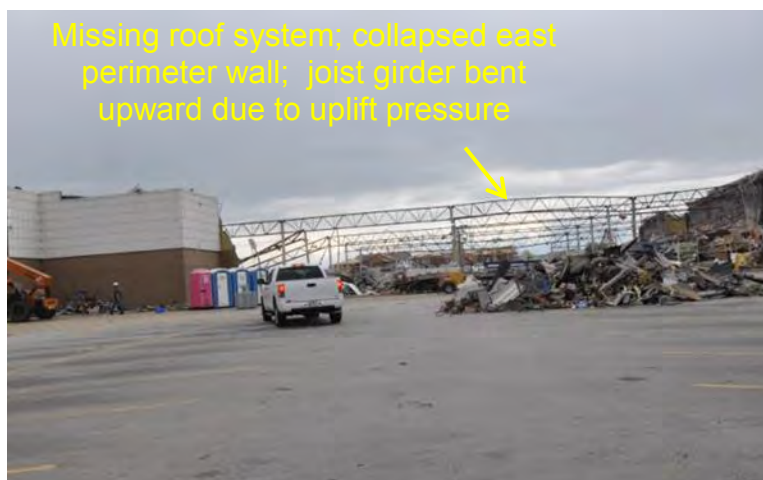
Figure 3–38. Large area of roof system shown missing. Joist girders bent upward due to uplift pressure.

- The gravity system (steel plane frames) was mostly intact, albeit damaged, with:
 - Most joist girders having remained in place and connected to the columns, although many were damaged and bent upward (again, evidence of wind uplift action prior to the failure of the roof system; see Fig. 3–38). There were a few girders that were disconnected from the columns on one end. These appeared to have been secondary failures (after loss of the roof system and therefore any lateral bracing for the girders).

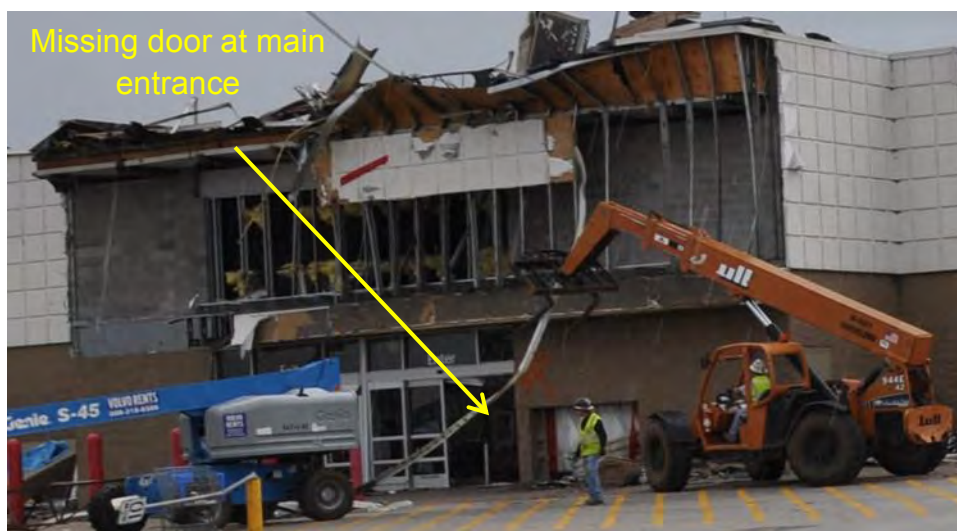
- Envelope:
 - The entryway door panels (tempered glass and aluminum frame) on the west wall were lost and there was damage to the fire-escape door on the east wall and to the store's exterior signage. These impacts were likely due primarily to wind pressure. Whole door panels, including the glass and aluminum frame, were missing. (The glass on door panels that remained appeared intact (see Fig. 3–39). This allowed wind to infiltrate the building interior and resulted in increased wind uplift pressure on the roof system.

Figure 3–39. Missing door and glass panels and damage to signage at south entrance on west wall (envelope failure allowing air infiltration to the interior and causing increased wind uplift).

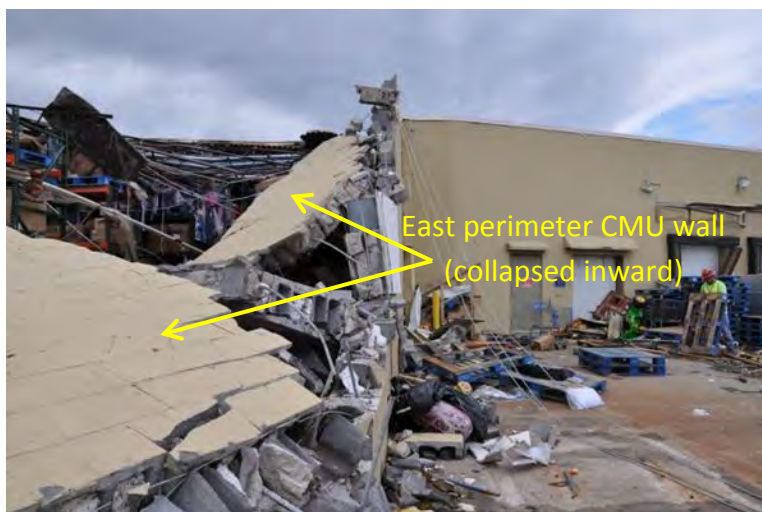
Figure 3–40. Collapsed east wall due to loss of roof lateral bracing and inward wind pressure.

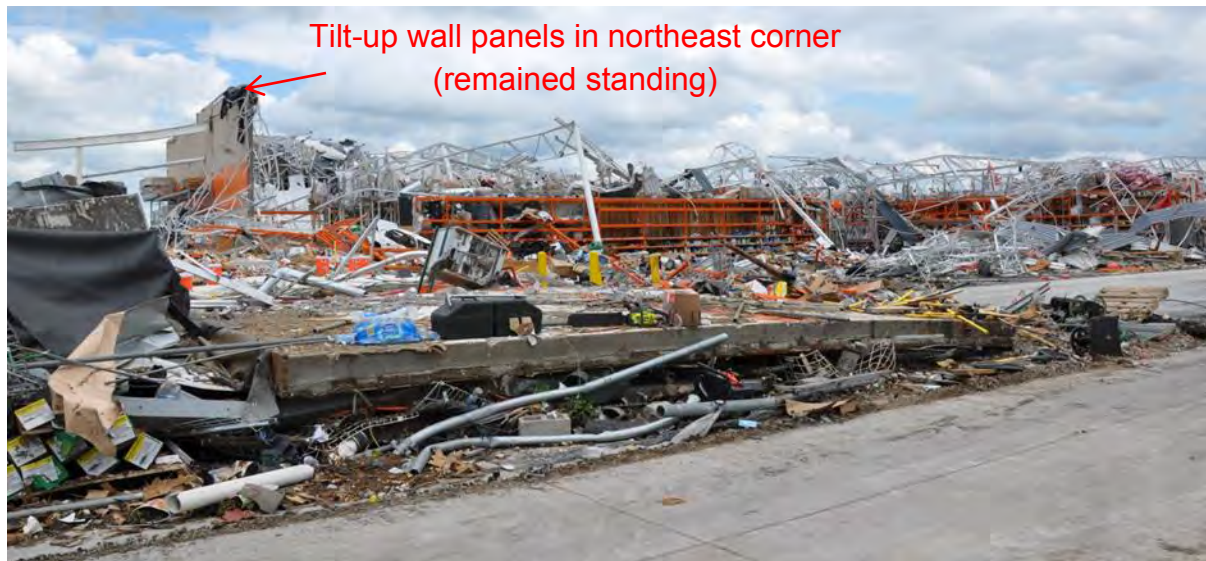
- The loss of the entire roof system and collapse of the wall panels represented a failure of the building envelope. It is not known if the doors on the north, east, or west walls were breached prior to the collapse of the entire building. However, the metal roll-up doors at the loading dock on the north wall (uncollapsed wall panels) appeared to have remained closed during and after the tornado.

Figure 3–49. Collapsed Home Depot building (view from the northwest). Note the loss of all roof decks and upward displacement of joists and joist-girders

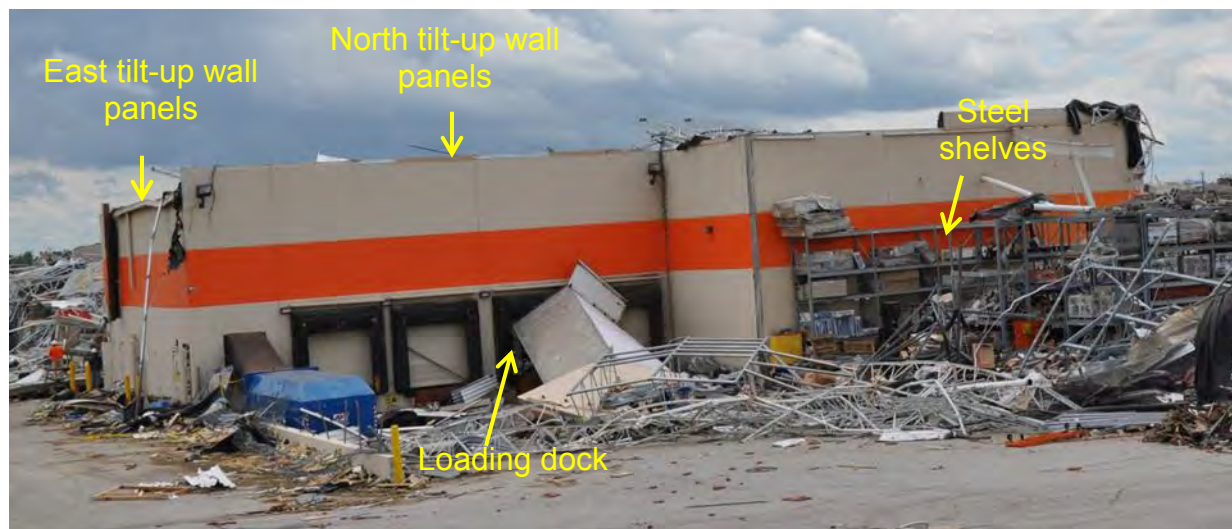
Figure 3–50. Ten tilt-up panels in the northeast corner remained standing. Seven of these 10 panels had positive connections to the footing and thus some degree of restraint against rotation. The other three uncollapsed panels had friction-only connections to the footing but appeared to have been supported against falling outward by steel shelving on the exterior side (Garden Center).

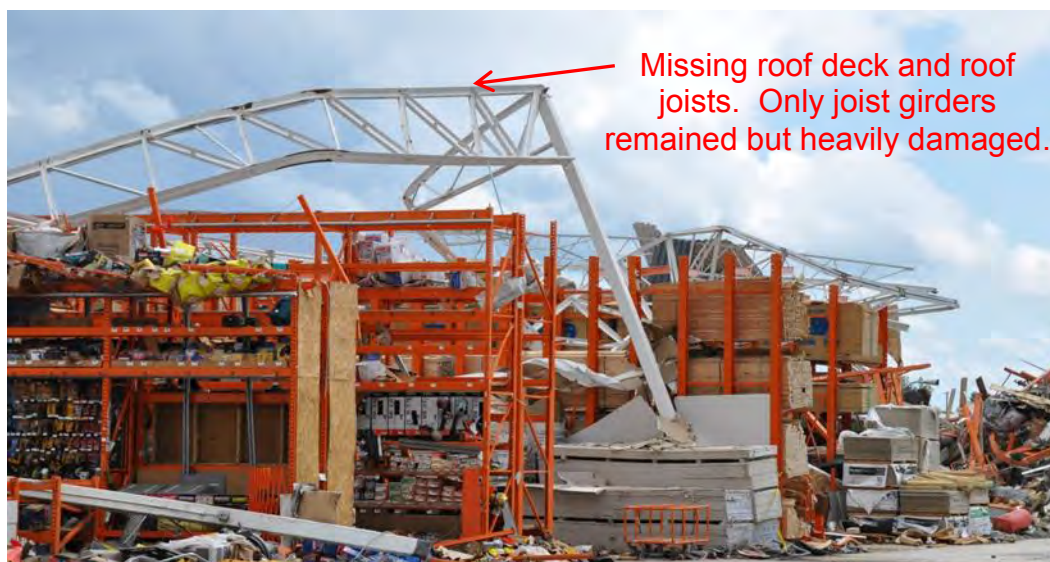
Figure 3–51. Damaged joist girders and interior columns. Note the complete loss of the roof system that was connected to the girders.

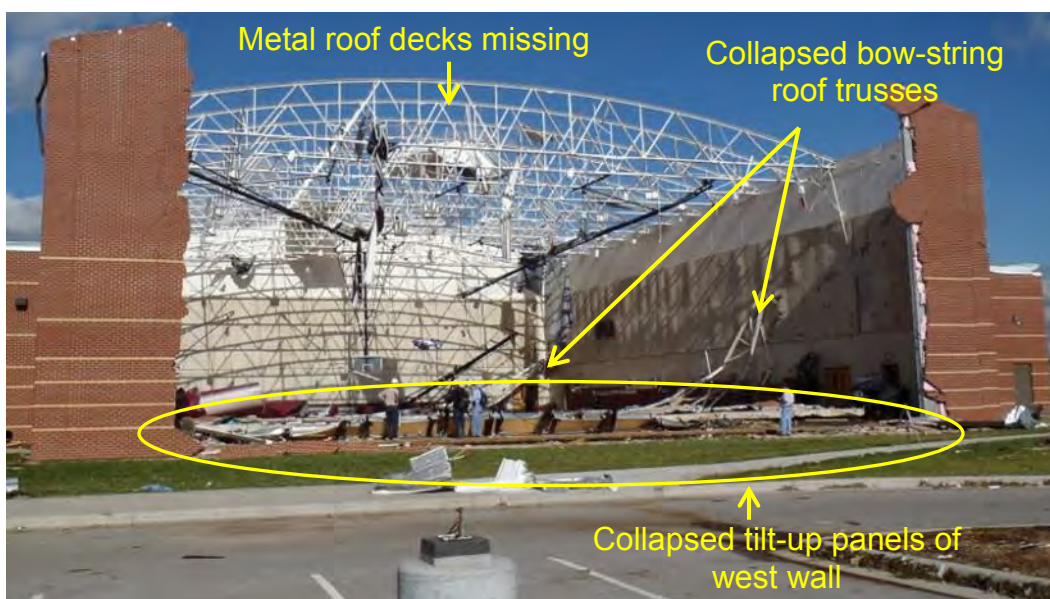
1. The loss of all roof covering materials and most of the metal roof decks (see Fig. 3–56 and 3–57). The disconnection of the roof decks from the supporting bow-string roof trusses appeared to be due to failure of the puddle welds (whole panels, each three-span or 30 ft

Figure 3-56. Joplin East Middle School Gymnasium building, viewed from the west, showing complete loss of steel roof deck, disconnection and collapse of the first two bow-string steel trusses, and collapse of 9 out of 11 tilt-up panels of the west wall.

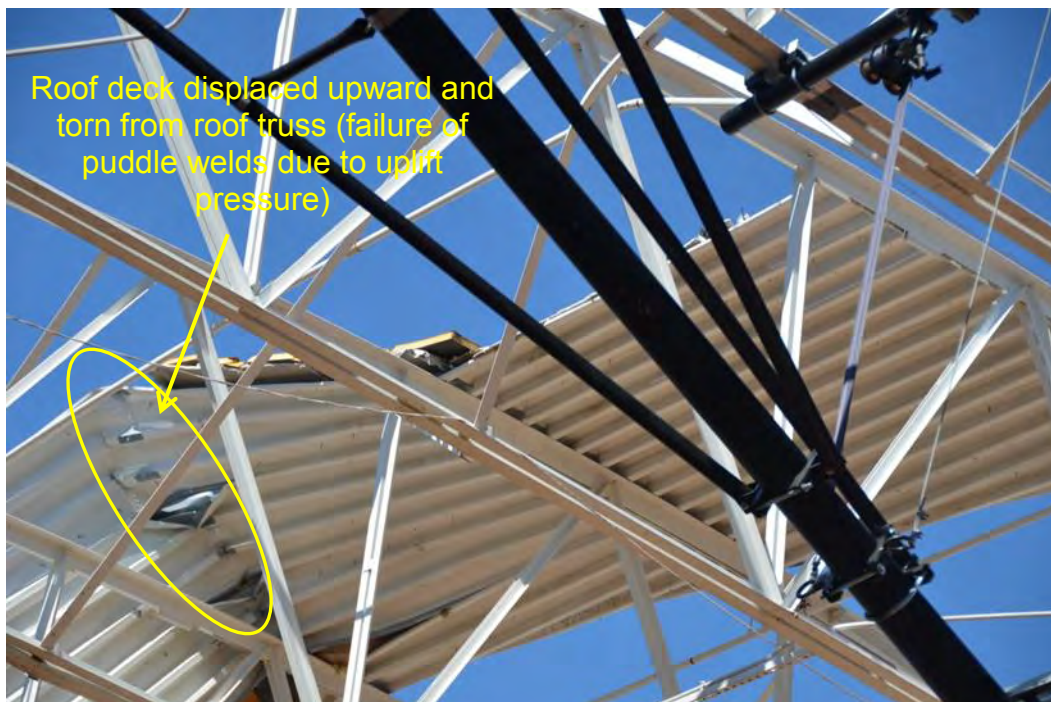
Figure 3–57. Disconnection of steel roof deck of Gymnasium due to failure of puddle welds due to uplift pressure.

Calculations using the design information obtained for this building indicated that the roof deck-to-joist connection (by 5/8 in. diameter puddle welds) was the weakest link in the overall uplift resistance of the building (weaker than the joist-to-wall connection). However, the uplift capacity of the roof deck-to-joist connection was well above the required maximum design uplift pressure of 17.3 lb/ft² based on the 90 mph basic design wind speed (thus, this building would not have failed the way it did under a code-level wind event; see Appendix J). The fact that the roof deck-to-joist connection was the weakest link for uplift resistance suggested that the steel roof decks were the first elements to fail, and this failure occurred due to tension failure of the puddle welds. This is consistent with the observed roof deck failure shown in Fig. 3-56 and 3-57. This is also corroborated by videos of the interior of the building recorded by security cameras during the storm, which showed roofing materials, including some roof deck panels, falling into the interior of the building prior to the collapse of the west wall panels.⁸⁵

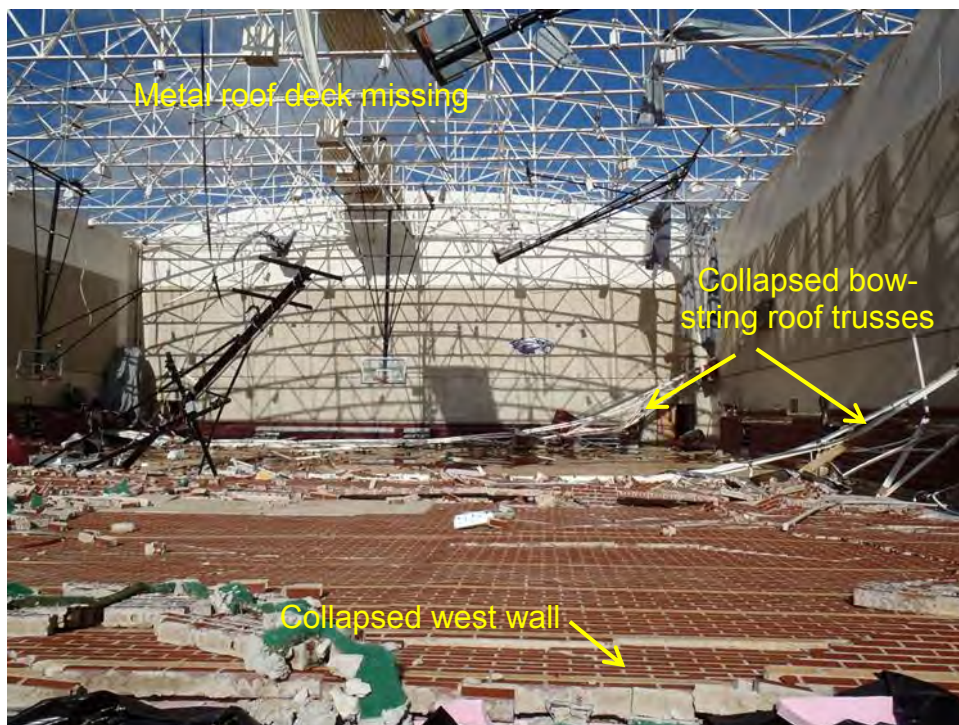
2. The disconnection and collapse of the first two bow-string roof trusses (nearest to the west wall). Both of the collapsed trusses sustained lateral, out-of-plane bending, and their disconnections from the top of the tilt-up wall panels appeared to have resulted from shear failure at the embedded seat angles at the ends of each truss (either shear fracture of the welds between the vertical headed studs that were embedded in the concrete or of the welds connecting the joist to the seat angle; see Fig. 3–58 and 3–59).

3. The collapse of 9 out of 11 tilt-up wall panels of the west wall toward the building's interior (along the tornado's translational direction). These collapsed panels became truly unbraced laterally after the disconnection and loss of the roof decks. The two panels of this wall that did not collapse were end panels that were also laterally supported along their height by bearing against the end panels of the north and south walls. Thus, these two panels did have some lateral support aside from the lateral bracing provided by the roof system, unlike the nine intermediate panels that collapsed.

Figure 3–58. Collapsed bow–string roof trusses and collapsed west wall tilt–up panels in the interior of the Gymnasium.

The failure of the roof deck-to-joist connection and subsequent loss of all the roof decks resulted in nine tilt-up panels of the west wall becoming laterally unsupported and simply overturning at the base in the direction of lateral wind load (west to east). As these panels fell toward the interior of the building, they impacted the first two bow-string roof trusses that were nearest to them (and within their collapse radius), resulting in out-of-plane bending of the trusses, subsequent shear failure of the truss-to-wall connections, and ultimately the collapse of these two roof trusses (see Fig. 3-58, 3-59, and 3-60).

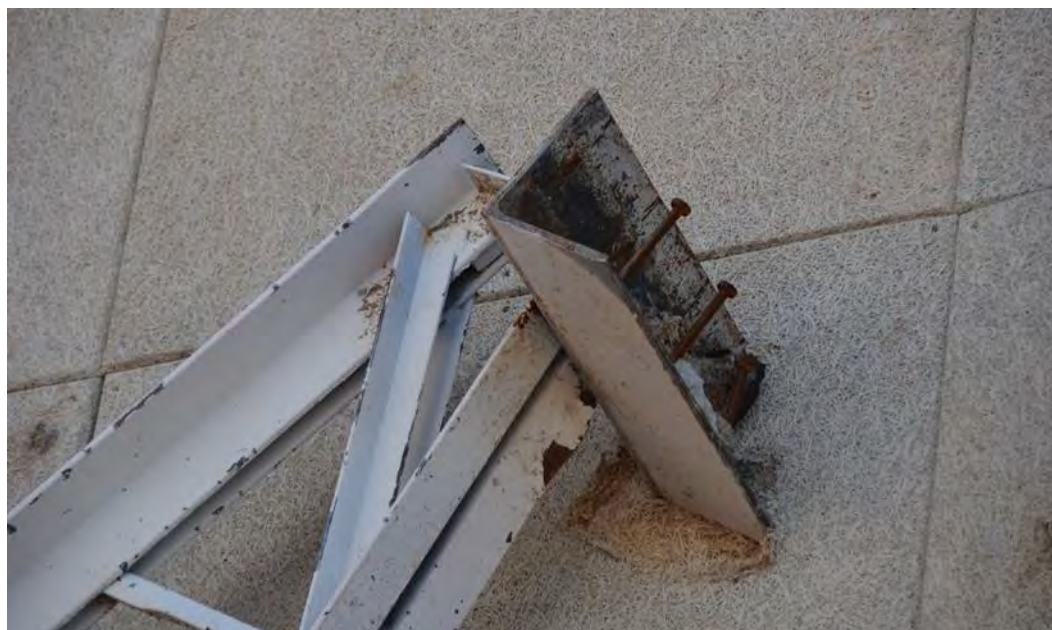
Figure 3–59. Seat angle welded to end of bow–string roof truss and embedded into top of tilt–up panel got disconnected. Note missing vertical headed studs (4, each 10 in. long), which appeared to have been sheared off from the angle. The three horizontal studs remained connected to the seat angle but pulled out from the concrete.

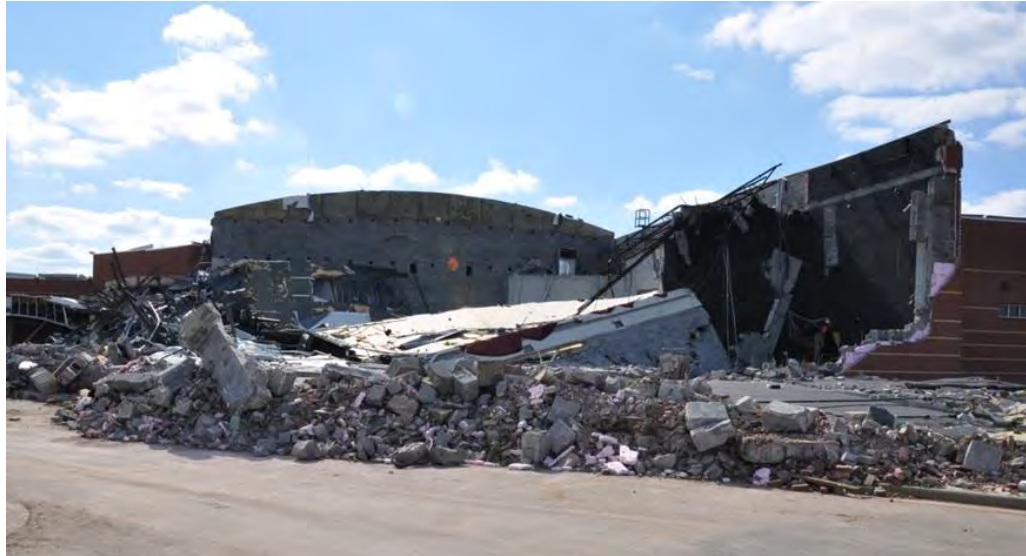
1. The disconnection and loss of roof decks in part of the roof, and the collapse of the entire roof system (trusses, steel deck, and roof covering) into the building interior (see Fig. 3–61 and 3–62).
2. Collapses of the east and south perimeter CMU walls, with the south wall collapsed into the building (toward the north) and the east wall collapsed outward, away from the building (toward the east). Similar to the collapsed CMU walls of other BTS buildings in the May 22, 2011, Joplin tornado, the east and south walls failed due to overturning of the entire wall at the wall-to-foundation connections, rather than due to inadequate strength within the CMU walls (see Fig. 3–63).

Figure 3–62. In wreckage of Auditorium, missing roof deck from top of joist—only puddle-weld marks remained.

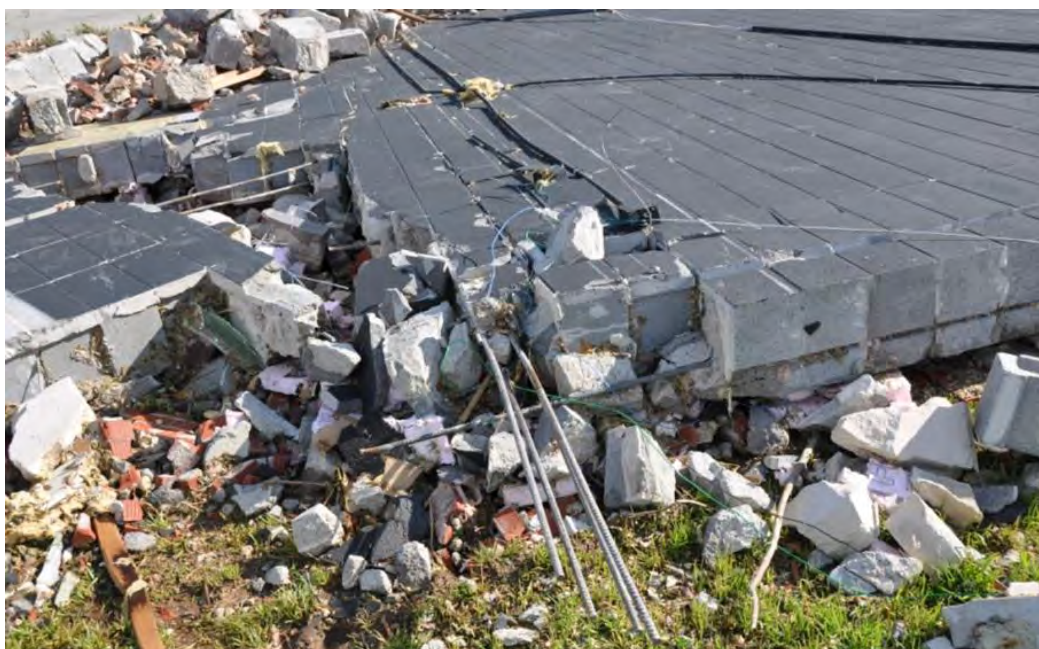
2. The failure of the roof system caused the perimeter CMU walls to lose lateral support on the interior side of the building. While the north and west walls remained braced laterally through connections with the roof systems of adjacent sections, the south and east walls lost their sole lateral support and subsequently collapsed due to overturning.

Figure 3–63. Collapse due to overturning (outward) of east perimeter Joplin East Middle School Auditorium wall after loss of roof diaphragm.

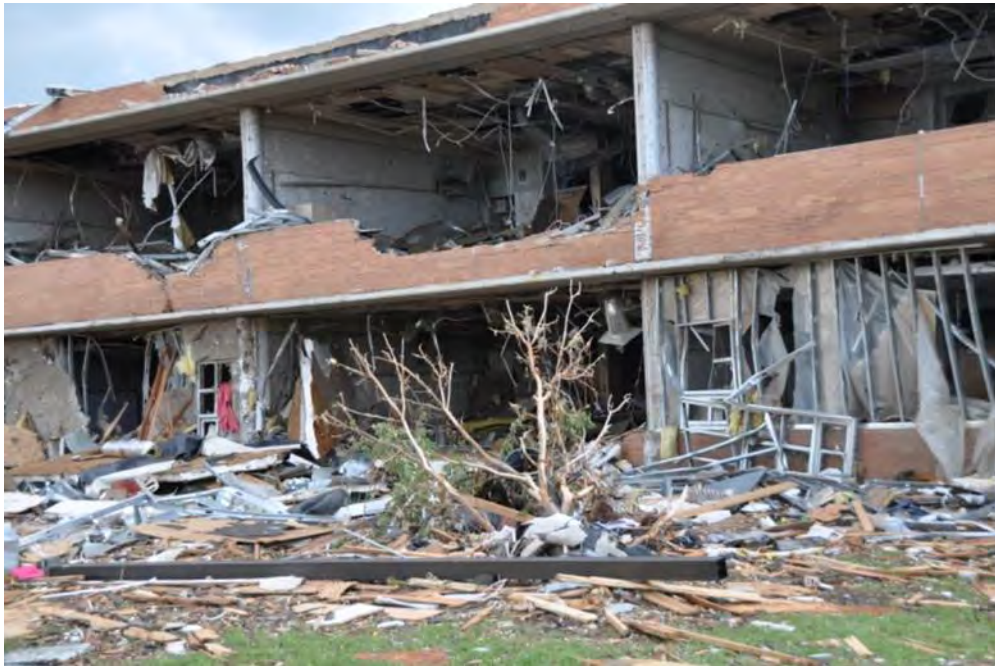
- The two RC frame buildings and other building sections making up the north end of the school complex sustained damage primarily to their vertical building envelopes. These buildings were similar in design, each a three–story structure with one story below ground. Each building’s structural system consisted of an RC frame made of circular columns and rectangular beams, supporting RC floors and composite, concrete–steel roof decks. Between the column lines there were interior, non–load–bearing unreinforced masonry (URM) partition walls. The exterior, vertical envelope consisted of a combination of brick and aluminum stud walls supporting cement–based boards and glass windows. While these buildings sustained no damage to their structural systems, the damage to their envelopes, which included the breakage and collapse of portions of the brick curtain walls and most of the aluminum stud curtain walls, resulted in a complete loss of function in both buildings due to subsequent damage to their interiors (electrical, HVAC systems, etc.). The roof envelopes, made of composite concrete–steel decking, appeared undamaged. Fig. 3–66, 3–67, and 3–68 show views from the exterior of the two RC frame buildings and from the interior of the school building section that linked these buildings; these photographs were taken 3 days after the tornado on May 25, 2011.

Figure 3–66. View from the exterior showing damage to the envelope of one of the RC frame buildings (east building) of Joplin High School.

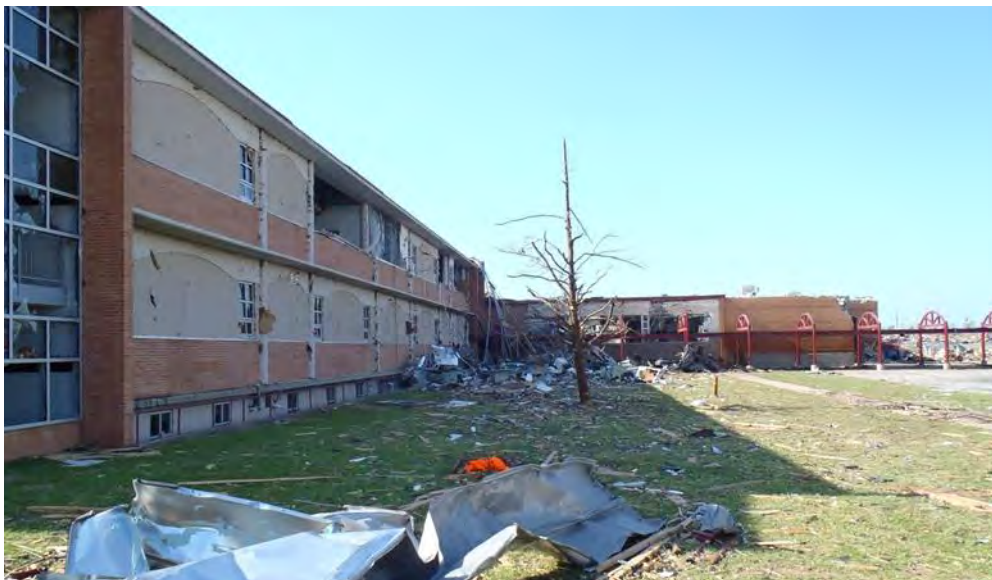
Figure 3–67. View from the exterior showing damage to the envelope of one of the RC frame buildings (west building) of Joplin High School.

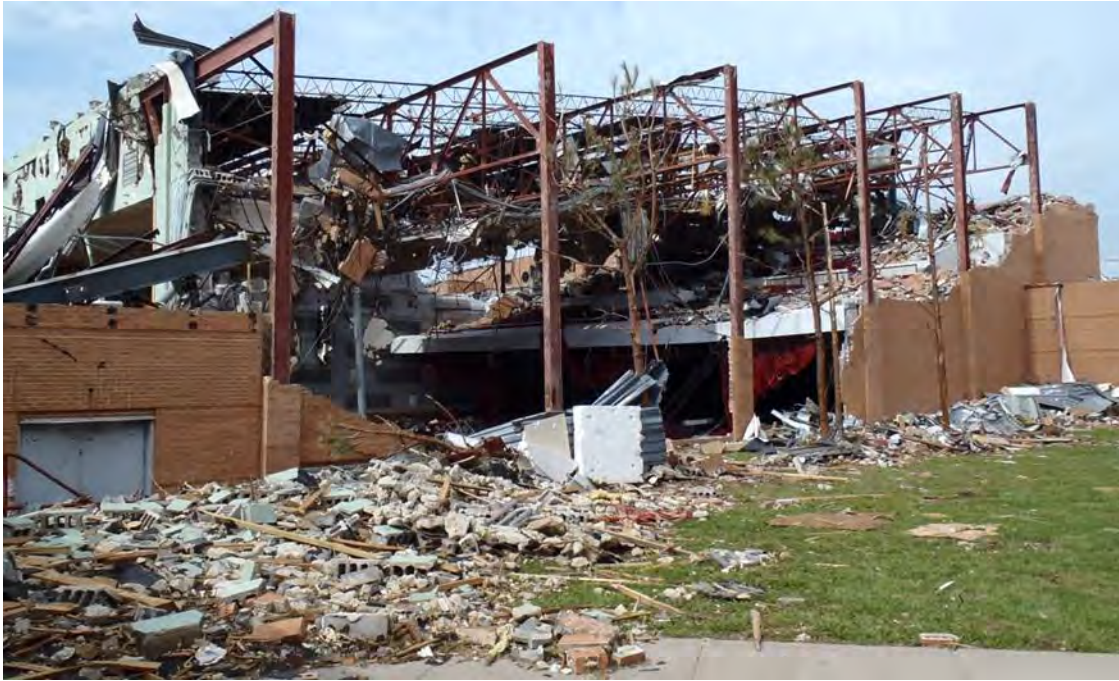
The structural steel frames of the Auditorium building appeared to have sustained only minor damage, with all six frames remaining intact despite the failure of a few lateral braces between them. However, the damage to the roof (lateral bracing) system was significant, with (a) disconnection and complete loss of most of the steel roof deck panels; (b) loss of a large number of the open-web steel roof joists in several spans; and (c) the collapse of most of the exterior URM/brick walls. Fig. 3–70 shows the north side of the Auditorium building.

Figure 3–70. View from north of the Joplin High School Auditorium building.

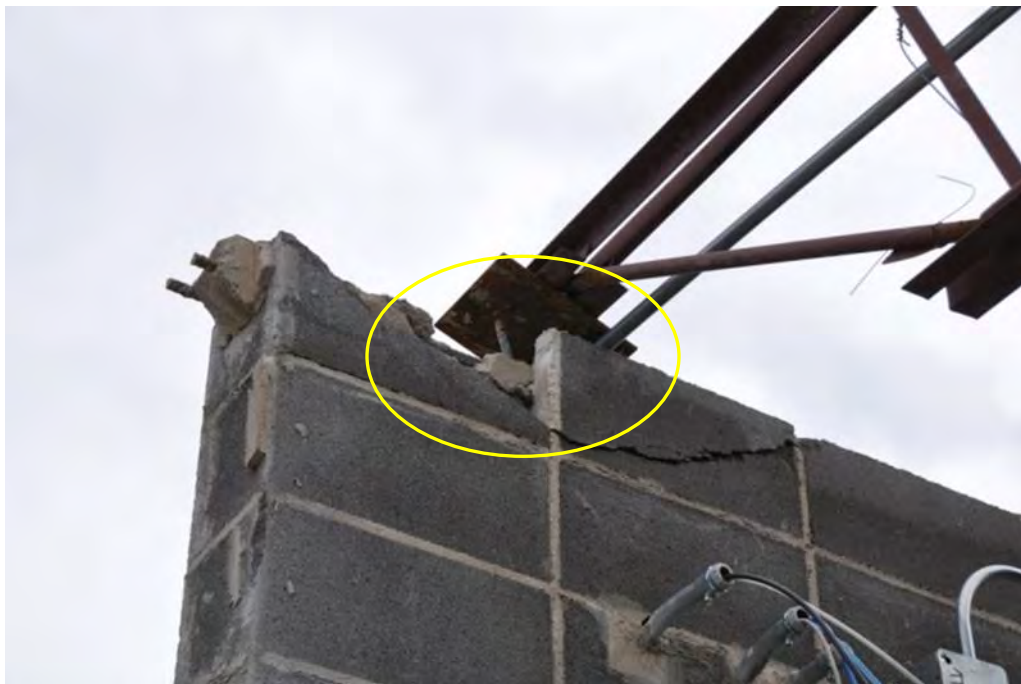
These single-story BTS buildings typically had CMU walls made of three layers (a partially grouted and reinforced concrete masonry inner layer, a foam insulation middle layer, and an outer brick layer). The top course of the CMU at the top of the wall was grouted to form a continuous cap beam for anchorage of the steel roof joists. The bottom of the CMU wall was anchored (only about 6 in. deep) into the concrete footing with steel reinforcing bars. The typical damage to these buildings included disconnection and loss of panels of the steel roof deck and failure of the connection between the steel roof joists and the CMU

walls, and ultimately, the collapse of a large portion of the exterior CMU walls due to loss of lateral roof bracing (see Fig. 3–71, 3–72, and 3–73)

Figure 3–71. Failure of joist-to-CMU wall connection due to uplift.

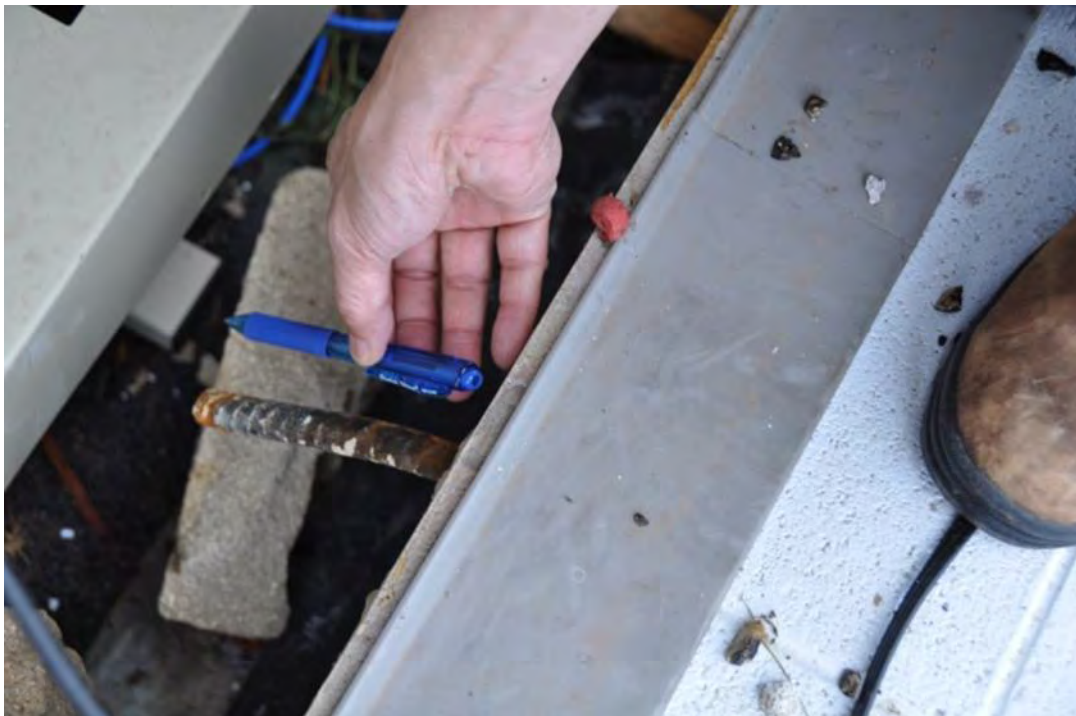
Figure 3–73. Short anchorage between CMU wall and concrete footing.

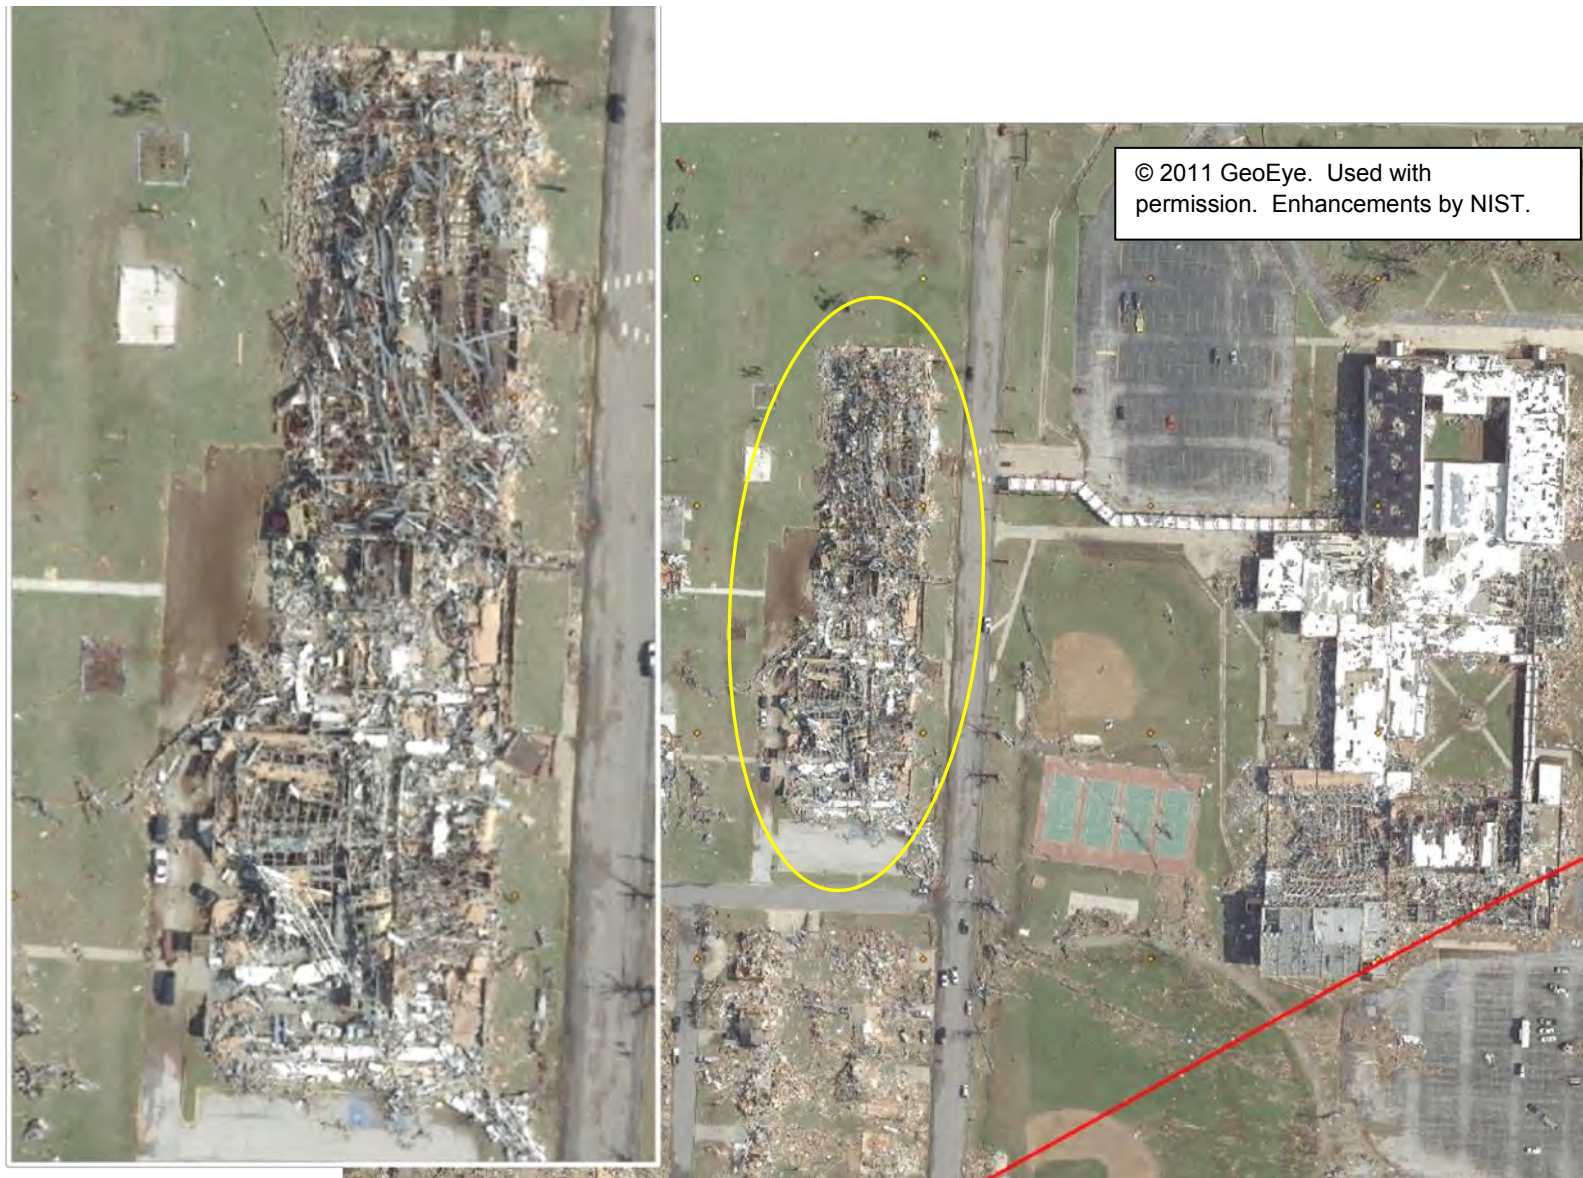
Figure 3–74. Overview of damage at Franklin Technology Center, with center line of tornado damage path (in red).

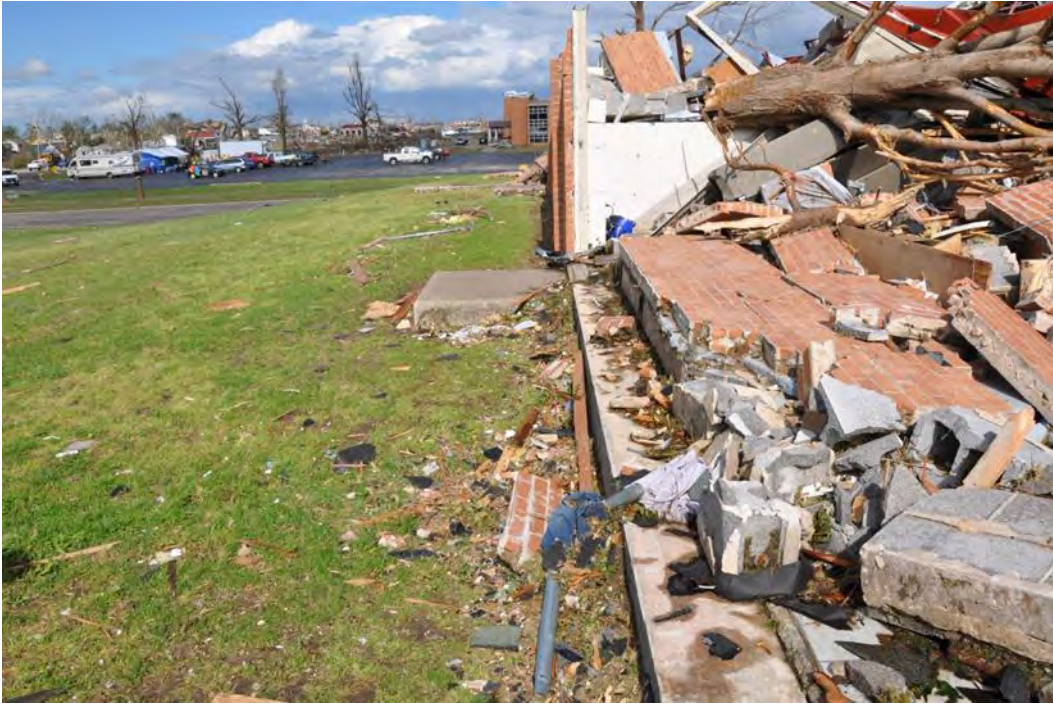
Figure 3-78. Perimeter CMU wall that collapsed after loss of roof lateral bracing (note lack of reinforcing dowels connecting wall to concrete footing).

- Almost all of the perimeter CMU walls collapsed. It should be noted that while the walls were partially grouted and reinforced, as specified in the available design information for the 1978 south-half addition, close inspection on May 25, 2011, found that there were wall sections (especially in the original 1960s north half) that had no or minimal structural connection between the wall and the RC foundation⁸⁶ (see Fig. 3–78 and 3–79).

⁸⁶ This is not inconsistent with standard practice. Friction-only connections between walls and footings are accepted for regions with low or no seismic risk. Rotational stability is to be provided for the wall by temporary bracing during the construction phase (prior to connection to the roof system) and by lateral bracing provided by the roof system after connection with the roof.
