Draft Final Report • National Institute of Standards and Technology (NIST)

of the May 22, 2011,
Tornado in
Joplin, Missouri

NIST NCSTAR 3 (Draft)

November 2013

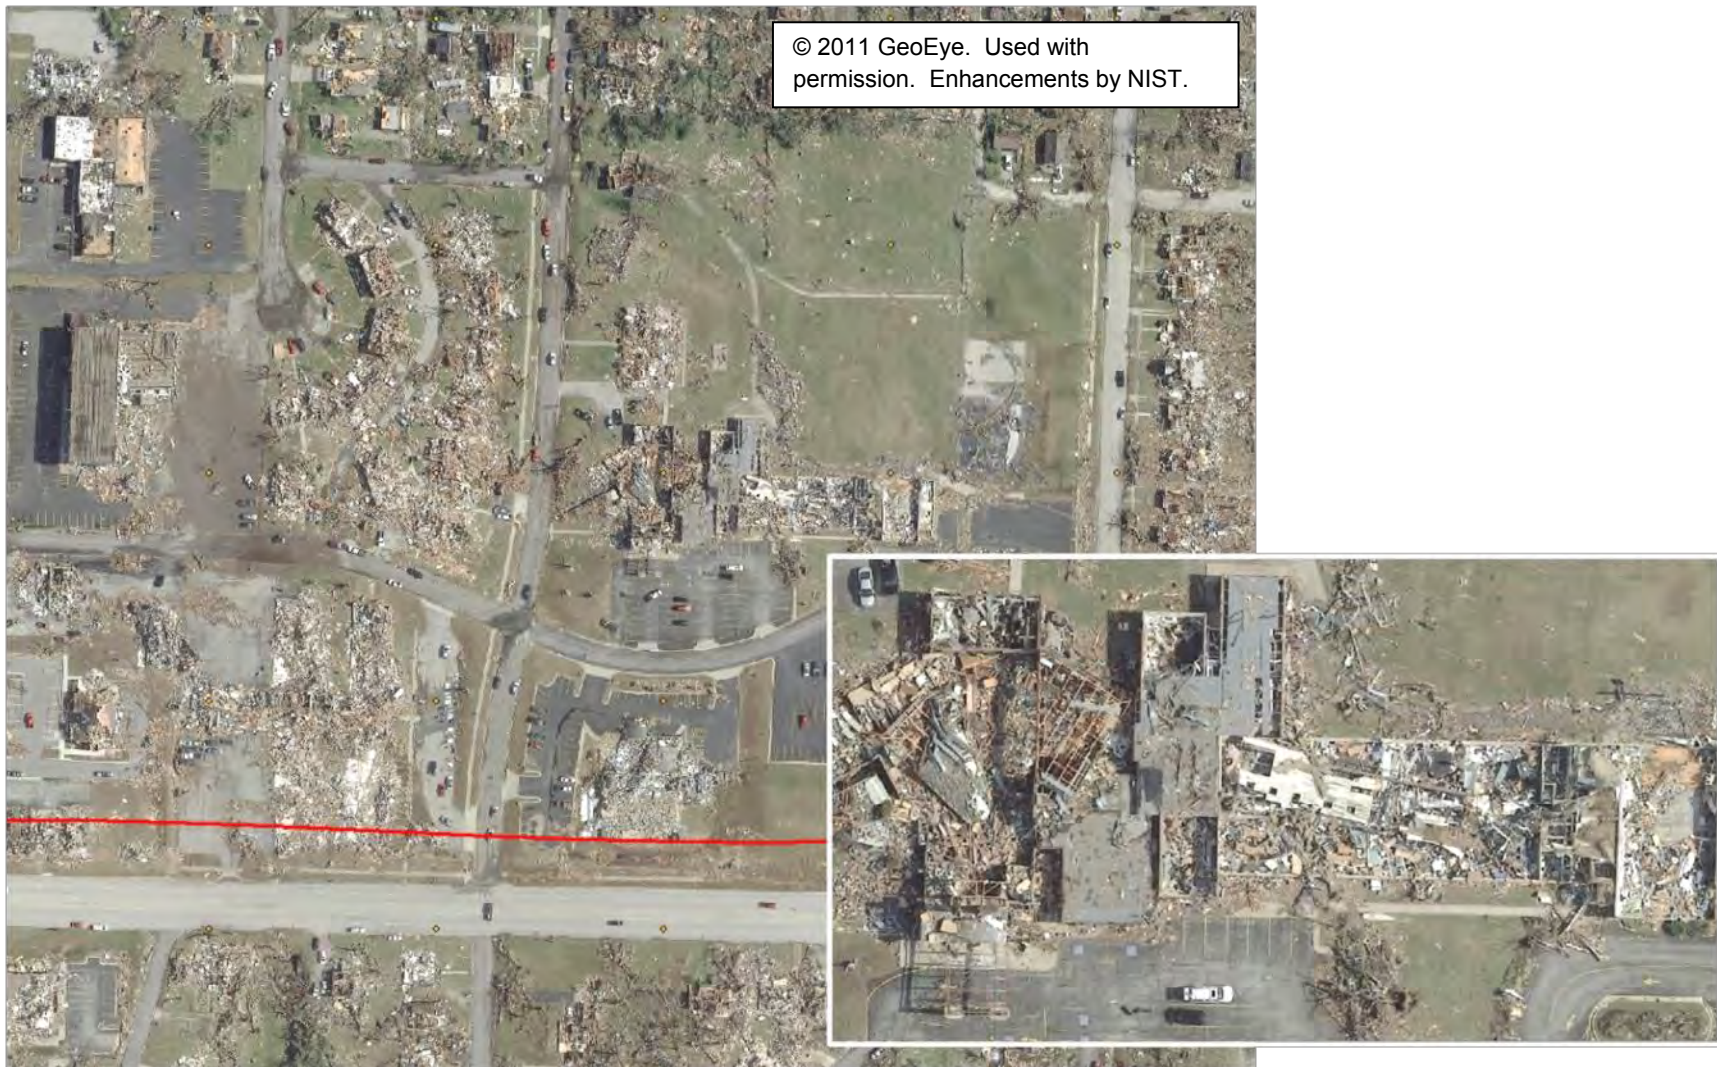
Figure 3–80. Overview of damage at St. Mary's Catholic Elementary School, with estimated center line of tornado damage path shown in red.

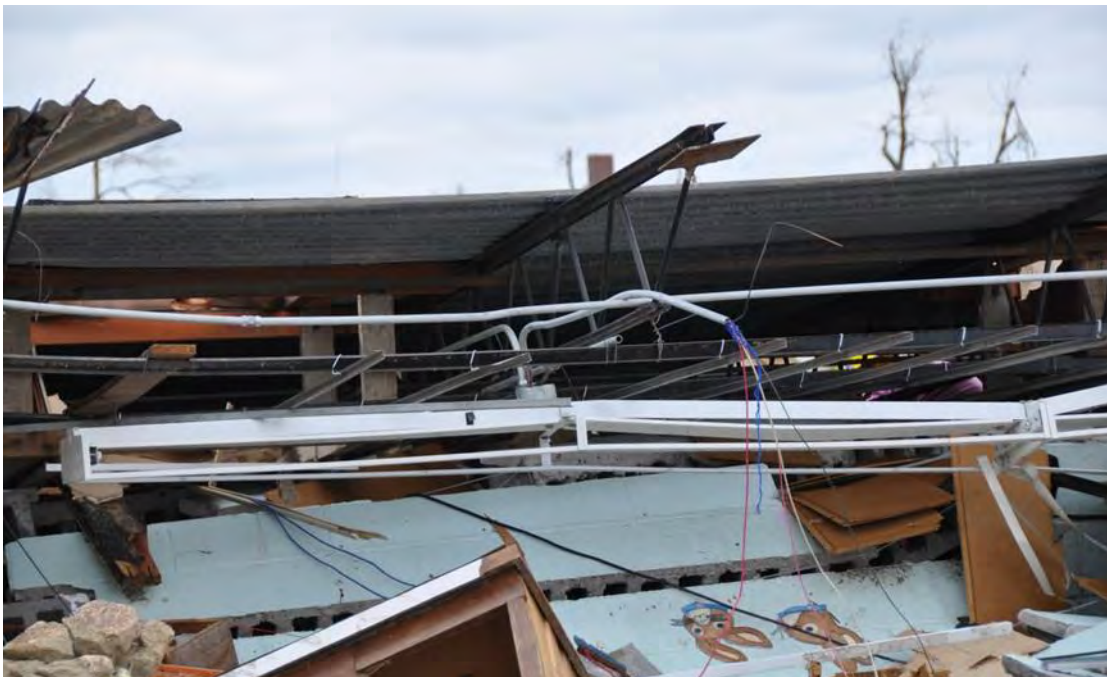
Figure 3–82. Section of building at St. Mary’s Catholic Elementary school with complete loss of the steel roof system.

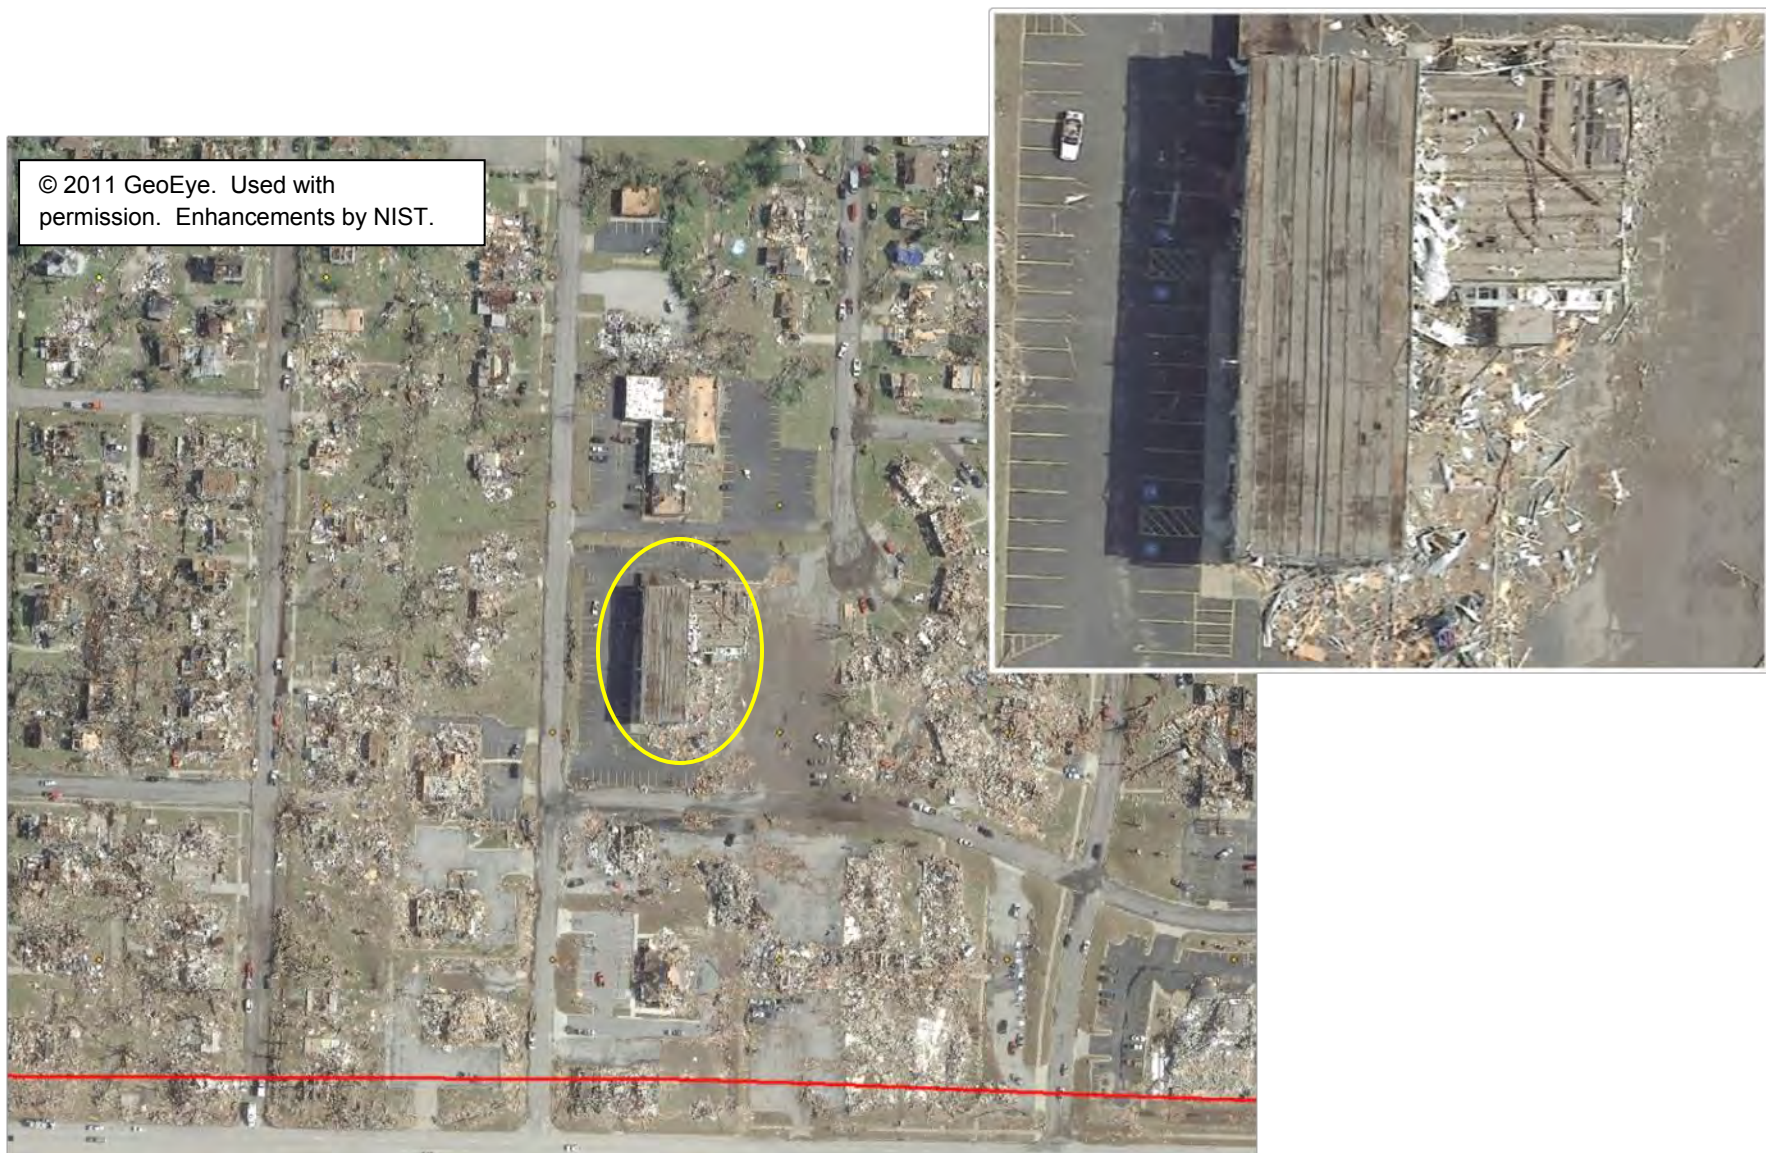
Figure 3–84. Overview of damage to the Ozark Center for Autism and surrounding buildings, with estimated center line of tornado damage path shown in red.

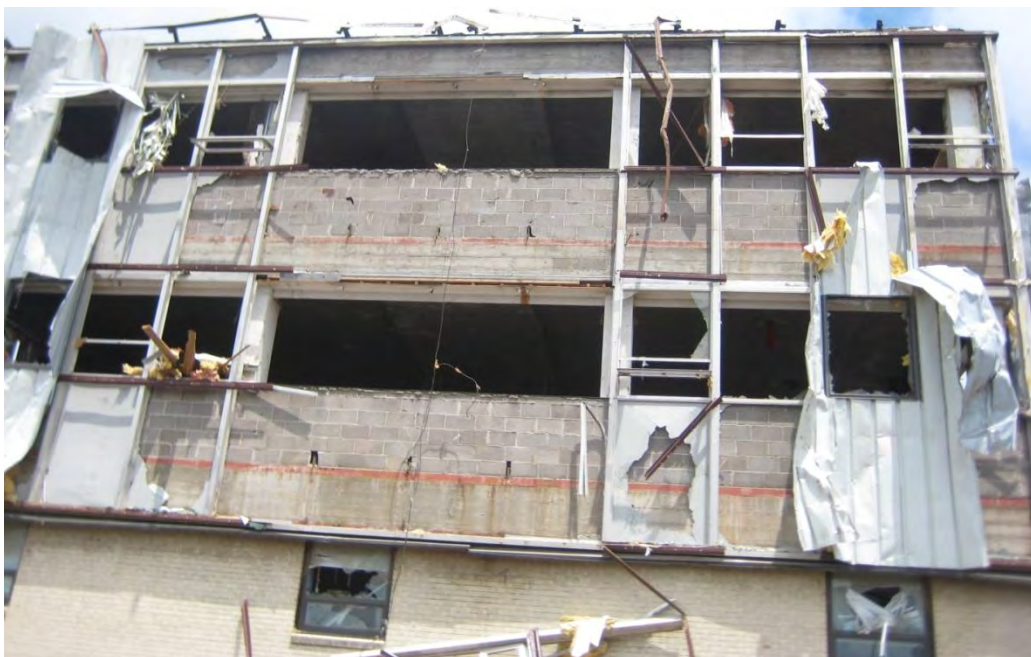
Figure 3–89. Typical damage to the Ozark Center building envelope (broken window glazing, missing window frames, and torn exterior steel panels).

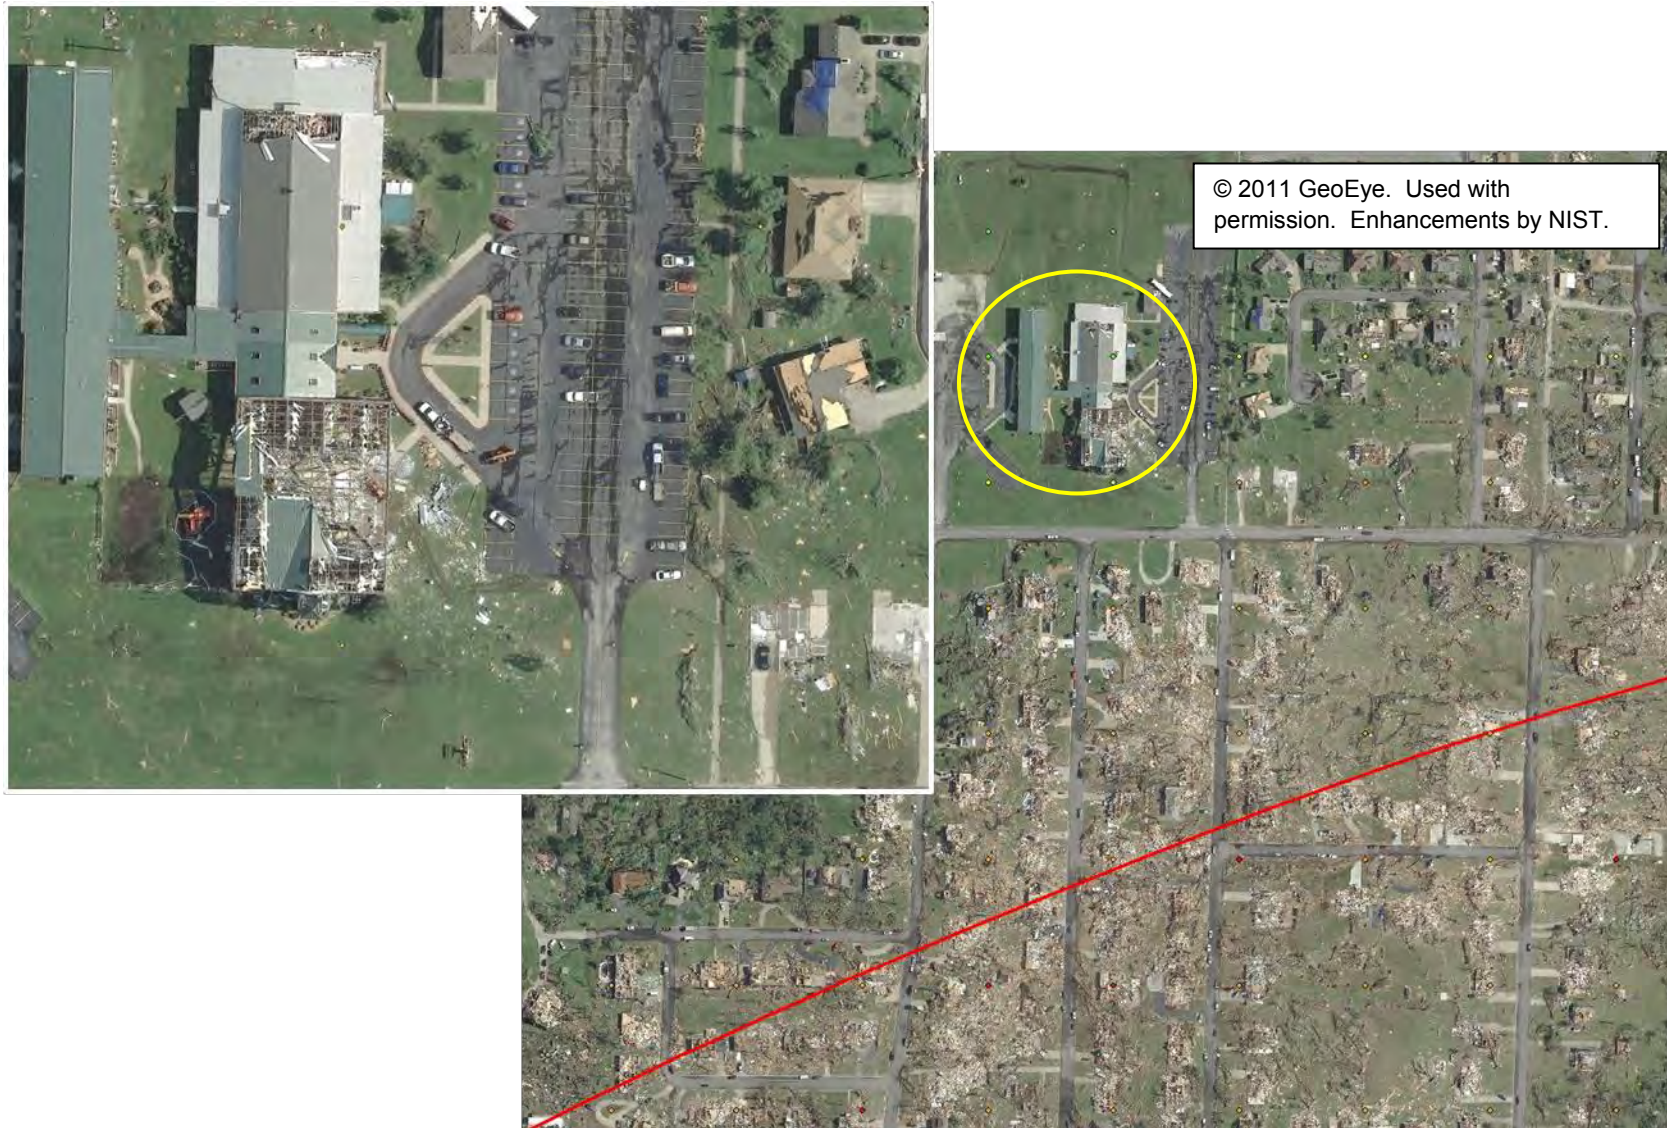
Figure 3–90. Overview of damage at St. Paul’s United Methodist Church and surrounding areas, with the estimated center line of the tornado damage path shown in red.

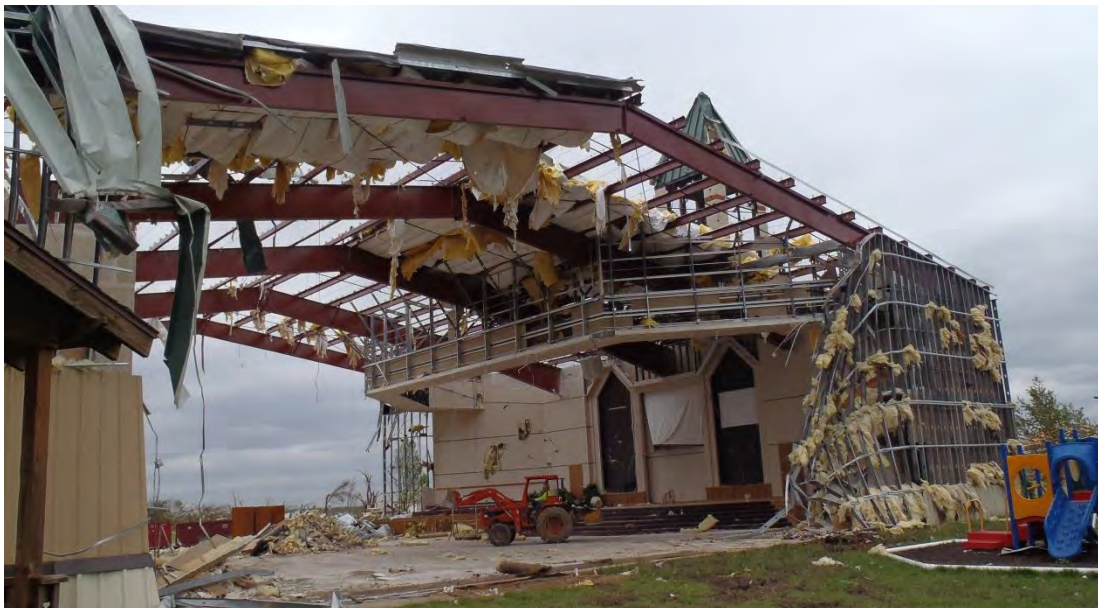
The building sustained significant damage to the envelope (disconnection and loss of all sheet steel roof decks and all vertical sheet steel wall panels, as well as the collapse of part of the steel-stud exterior frames), but only limited damage to the MWFRS (braced primary rigid frames). As a result, the building did not collapse, but sustained complete loss of functionality due to the loss of the envelope and subsequent damage to the building interior. NIST does not have information regarding the church's occupancy at the time of the May 22, 2011, Joplin tornado. There were no reported fatalities or injuries at this facility, however.

Figure 3–94. Damage to envelope of St. Paul's United Methodist Church.

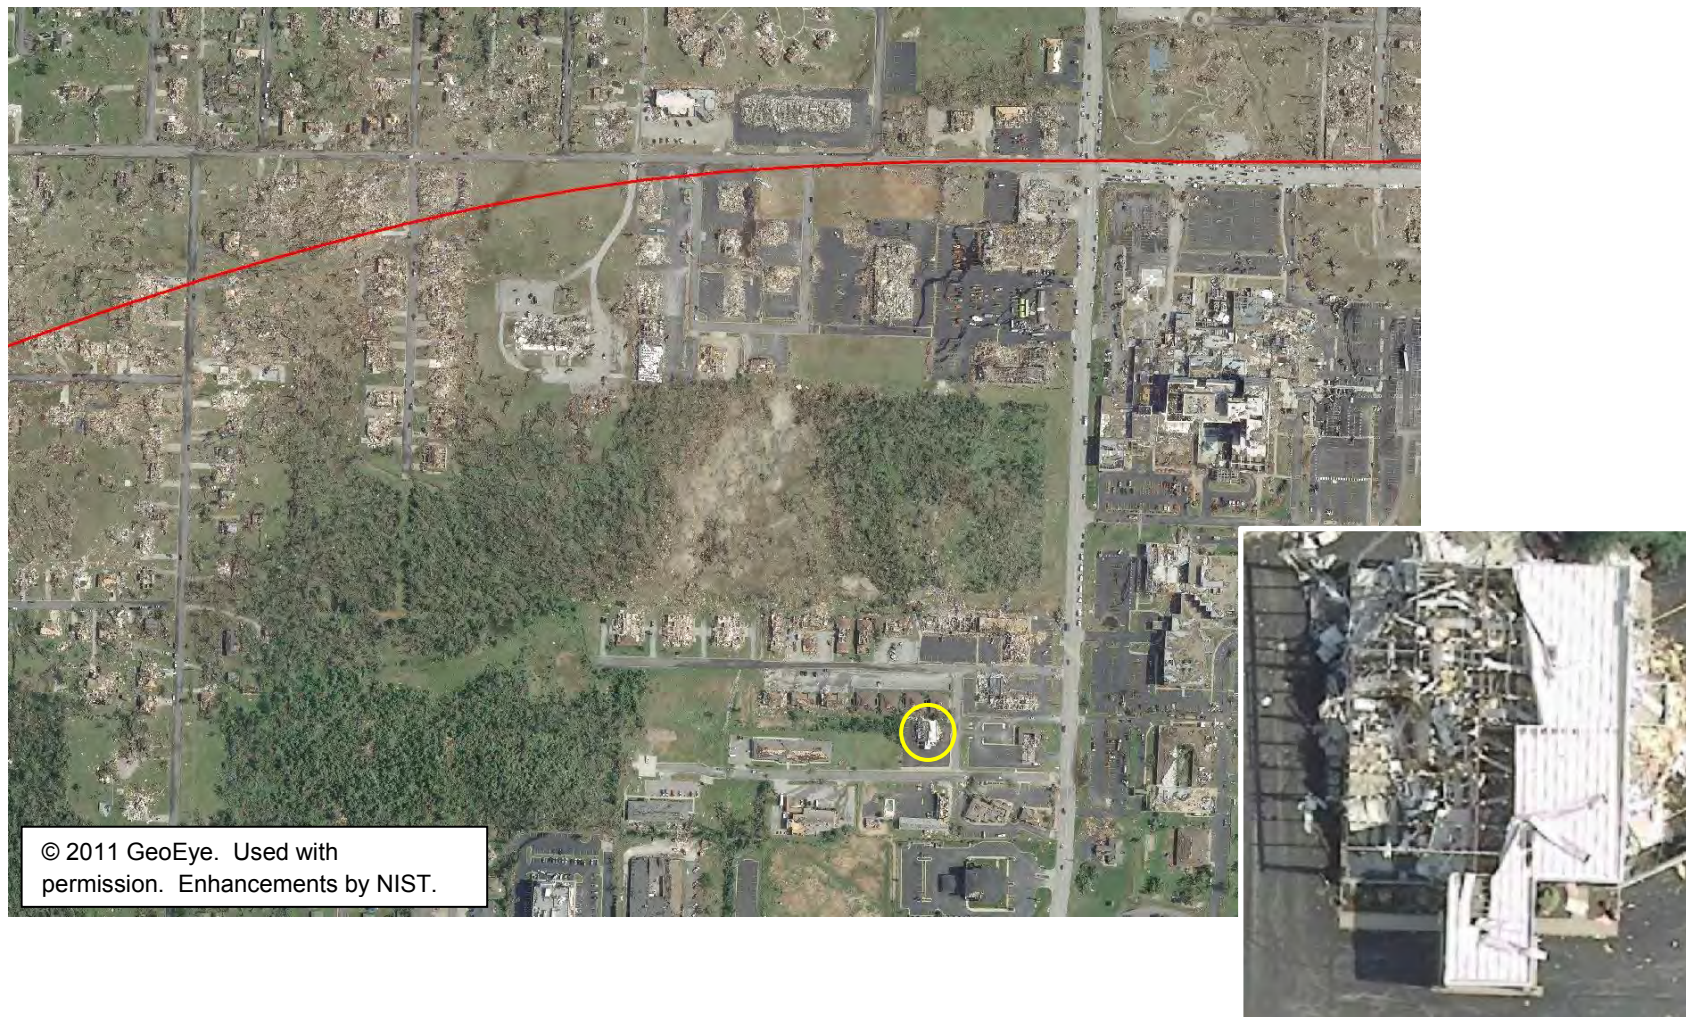
Figure 3–95. Overview of damage at the Ramesh Shah Ophthalmology Center, with the estimated center line of the tornado damage path shown in red.

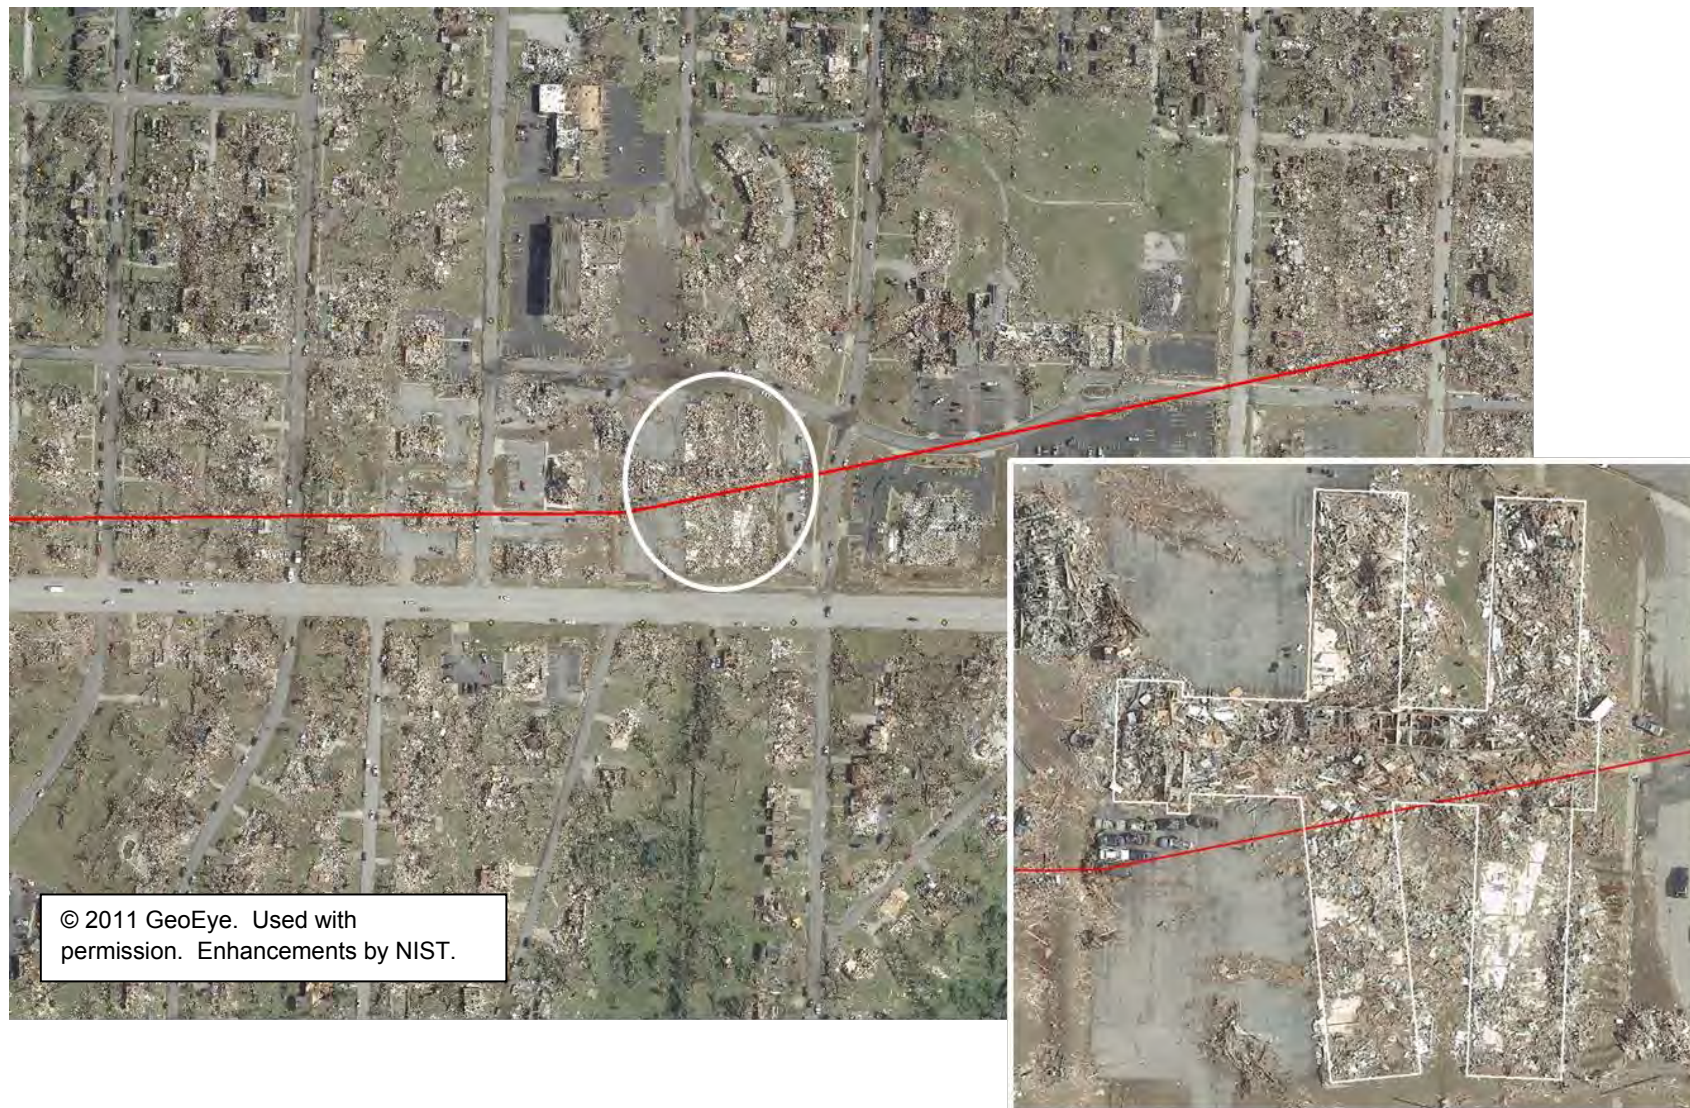
The Greenbriar Nursing Home, located at 2502 South Moffet Avenue (in the same vicinity as the Ozark Center and St. Mary's school) (Greenbriar), was at the center of the estimated tornado damage path (see Fig. 3-102). The facility was constructed in the mid-1960s, likely based on either BOCA BBC/1960 or 1965, and comprised a rectangular core section, oriented in the east-west direction, that was connected to four rectangular wing sections, oriented in the north-south direction. The maximum wind speed affecting this facility, estimated based on wind field model results for a point just to the west of the building, was about $165 \text{ mph} \pm 20 \text{ mph}$ (EF-3 range, see Fig. 3-103). The Greenbriar was directly east (downstream) of several residential neighborhoods that were totally demolished (see Fig. 3-1 and 3-102). Due to this juxtaposition, the Greenbriar Nursing Home was likely affected by significant amounts of wind-borne debris in addition to the strong tornado wind speed. The entire facility (core and four wing sections) collapsed completely in the storm.

Figure 3–102. Overview of the Greenbriar Nursing Home, shown in relation to the estimated center line of the tornado damage path (red line).

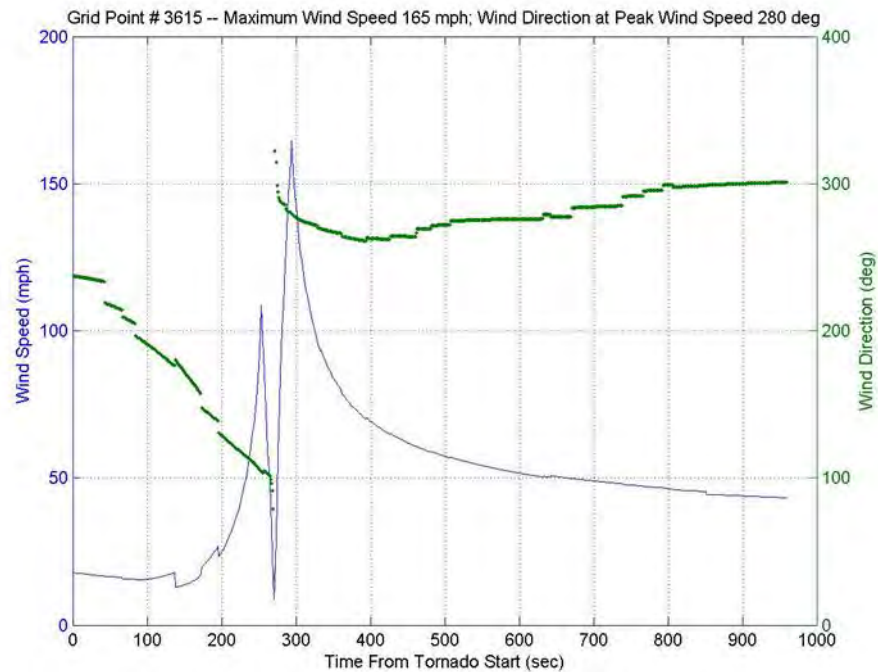
Figure 3–103. Estimated time–history of wind speed affecting the Greenbriar Nursing Home.

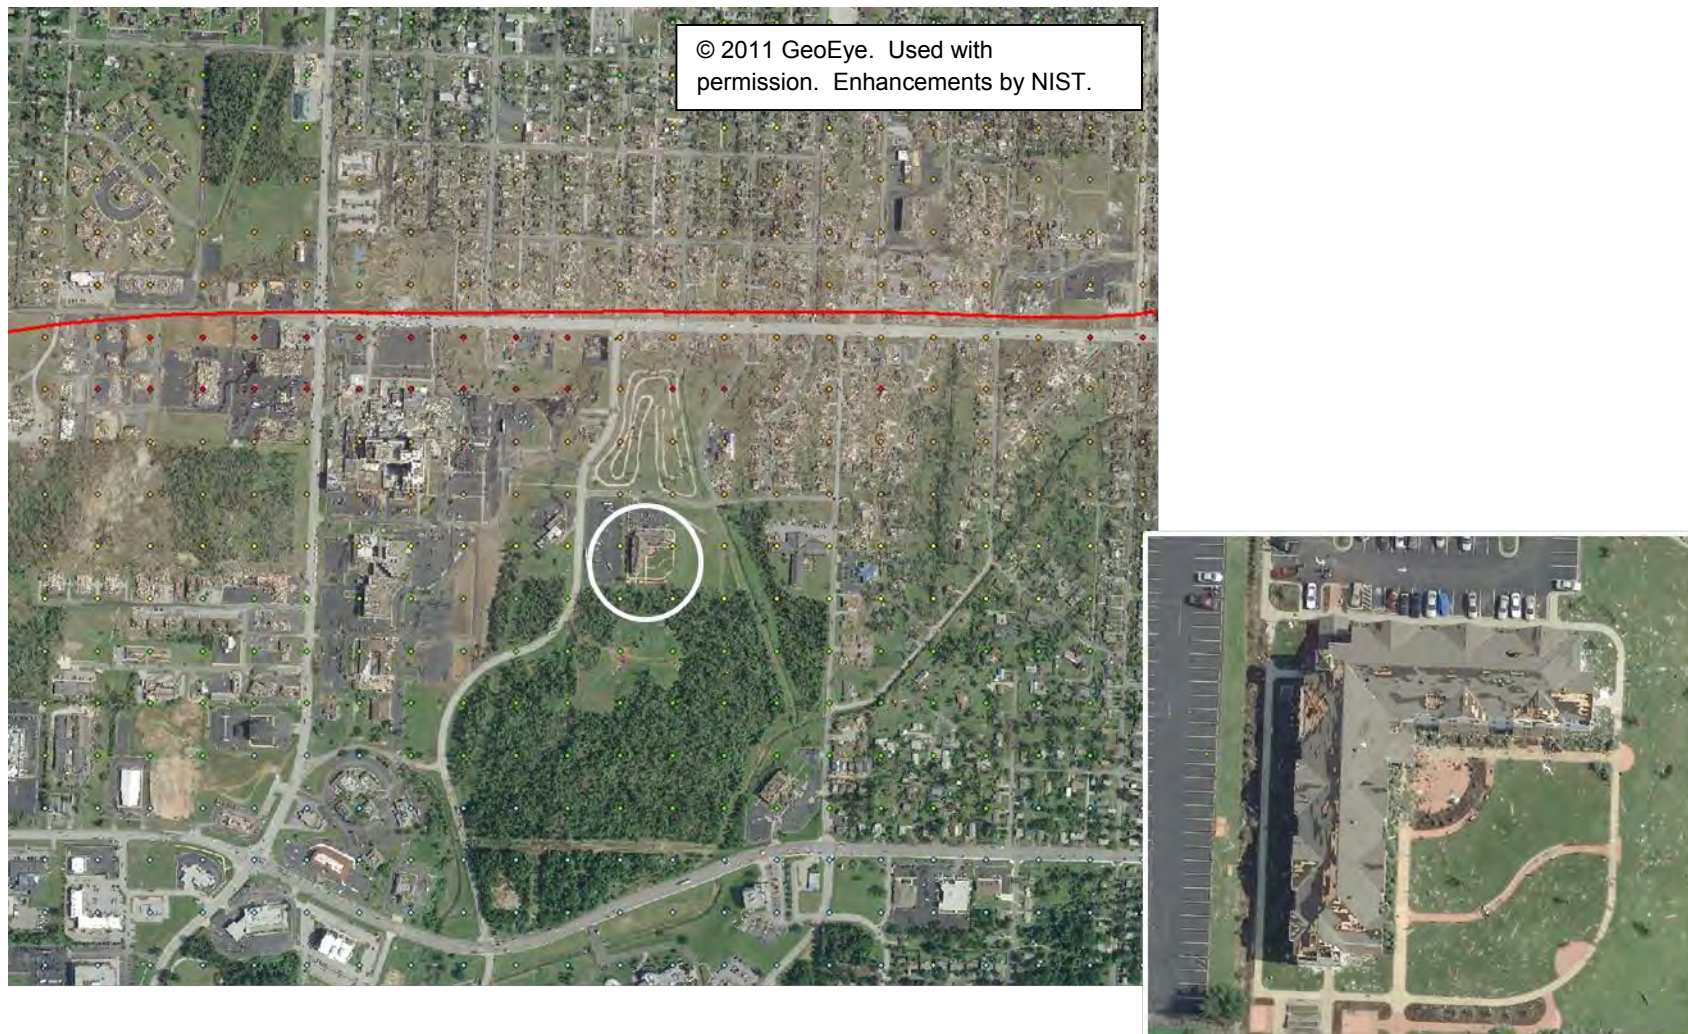
Figure 3–107. Overview of the Mercy Village Apartments, shown in relation to the estimated center line of the tornado damage path (red line). SJRMC is located to the west (left) of the apartments.

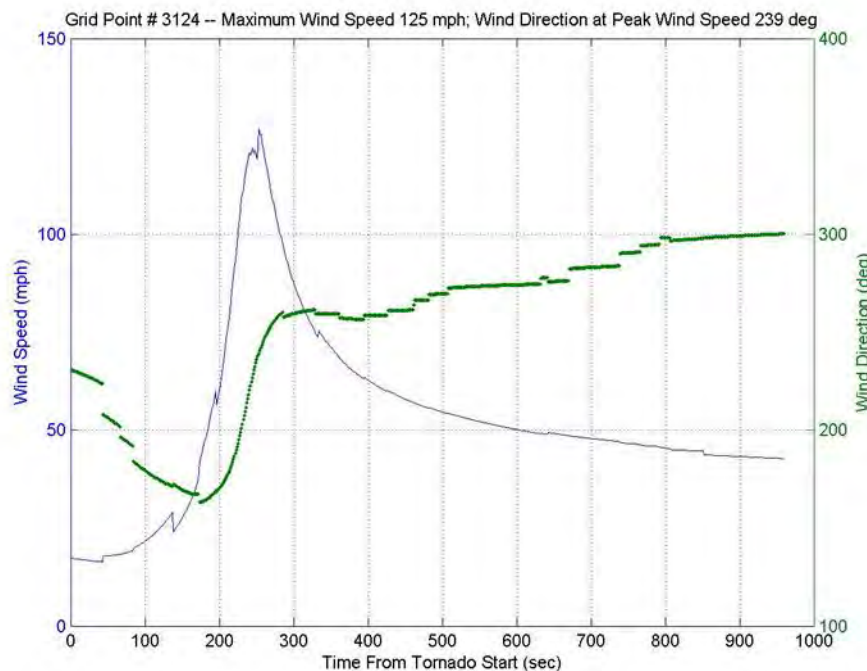
Figure 3-108. Estimated time-history of wind speed affecting the Mercy Village Apartments.

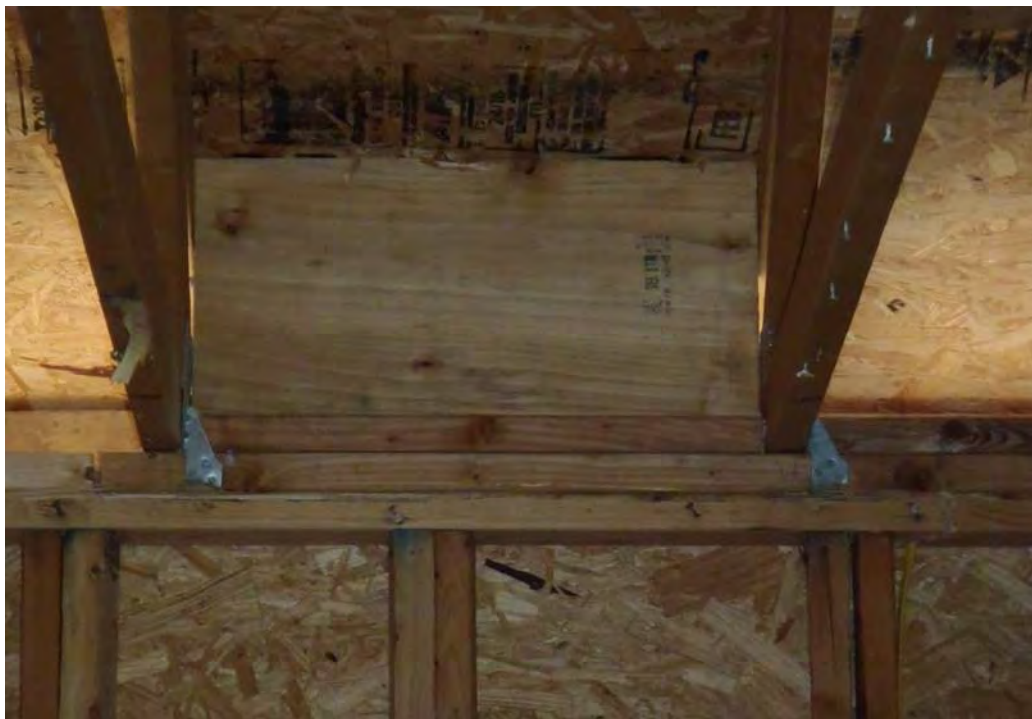
- Structural System:
 - Roof System: 2×4 wood roof trusses sheathed with plywood panels. The ends of each roof truss were connected to the top board of the double top plate of the third-floor exterior bearing walls with hurricane tie-downs (generally referred to as “hurricane clips,” see Fig. 3-109). Note that the hurricane tie-downs are installed on the inside of the wall while the sheathing that provides the transfer of loads to the wall studs is located on the outside of the wall. Hurricane tie-down manufacturer data suggests that this configuration reduces the effectiveness of the hurricane tie-downs by 50 percent unless straps are added to the inside of the wall framing to tie the double top plate to the wall studs.

Figure 3–109. Hurricane tie–downs connecting wood roof trusses to load–bearing wood–frame wall.

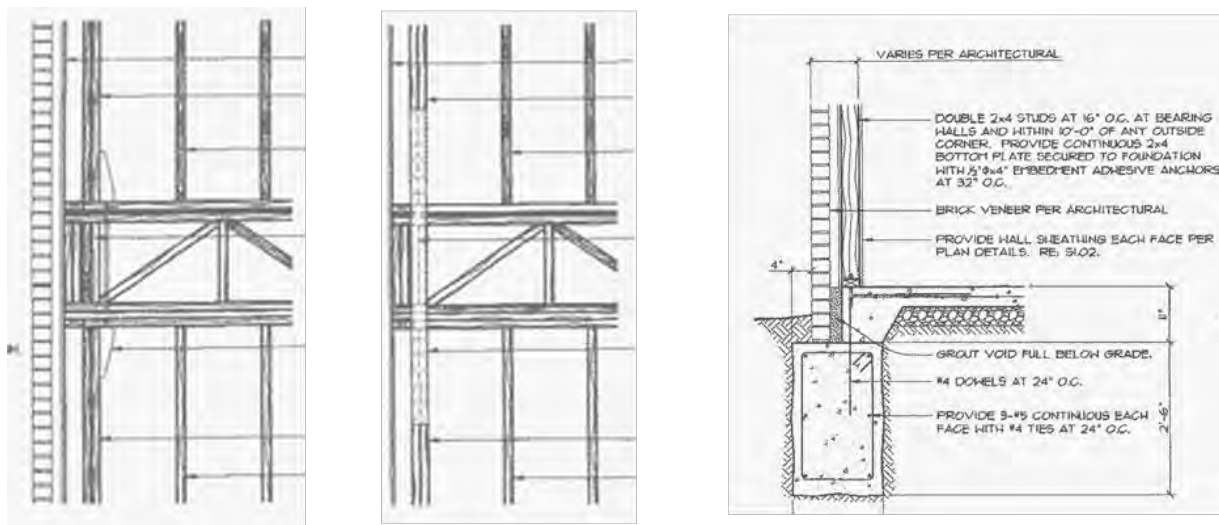
below and above the second and third floors were tied to the floor trusses between them using pre–loaded hold–downs (Simpson PHD2–SDS3 hold–downs) and steel straps. And the first–story walls were secured to the concrete foundation with $\frac{1}{2}$ in. diameter \times 4 in. embedment adhesive anchors at 32 in. on center. The hurricane roof tie–downs, pre–loaded wall hold–downs, and embedment foundation anchors provided a structural wood–frame system with a continuous vertical load path (see Fig. 3–110).

Figure 3-110. L to R, pre-deflected wall hold-down, steel strap, and wall anchor.

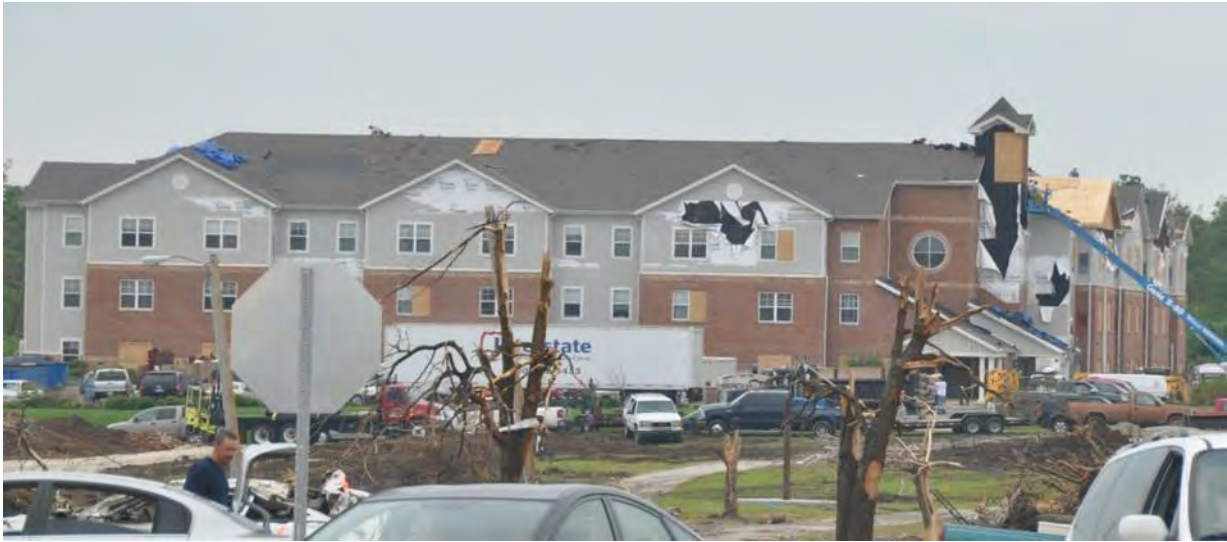
While the tornado hazards (wind speed and wind-borne debris) that affected the Mercy Village Apartments building on May 22, 2011, were estimated to be less severe than those that affected the Greenbriar Nursing Home (125 mph \pm 20 mph versus 165 mph \pm 20 mph, and a less significant wind-borne debris field given the surrounding areas and relative proximity to the tornado damage path; see Fig. 3-107), these hazards still exceeded the conditions that the building was designed to resist (90 mph basic wind speed, corresponding to roughly 115 mph ultimate wind speed, with no provisions for wind-borne debris impact). Despite these hazards, the damage at Mercy Village Apartments was limited mostly to the building envelope, with almost no damage to the structural system or its load-carrying ability (at wind speeds in this range, strong wood-frame structures have been observed to have their roof system either damaged or disconnected due to wind uplift). This good structural performance can probably be attributed in part to the use of more robust connections, typically required only for residential wood-frame buildings in hurricane-prone regions, between the primary structural systems of the building (roof-to-wall, wall-to-wall between floors, and wall-to-foundation, thus ensuring continuity of load path from roof to foundation). The damage to the building envelope, shown in Fig. 3-111 and 3-112, included:

- Damage to window glazing on all sides of the building (both insulating glass and tempered glass), likely due to wind-borne debris impacts (there were windows near the broken windows that were not damaged, suggesting that wind pressure was likely not the cause of the broken windows).
- Damage to the exterior brick veneer, cement-board sidings (missing, broken boards), and roof covering (lost roof shingles).

Figure 3–111. Mercy Village Apartments, viewed from the north, with envelope damage (siding, window glazing, roof covering).

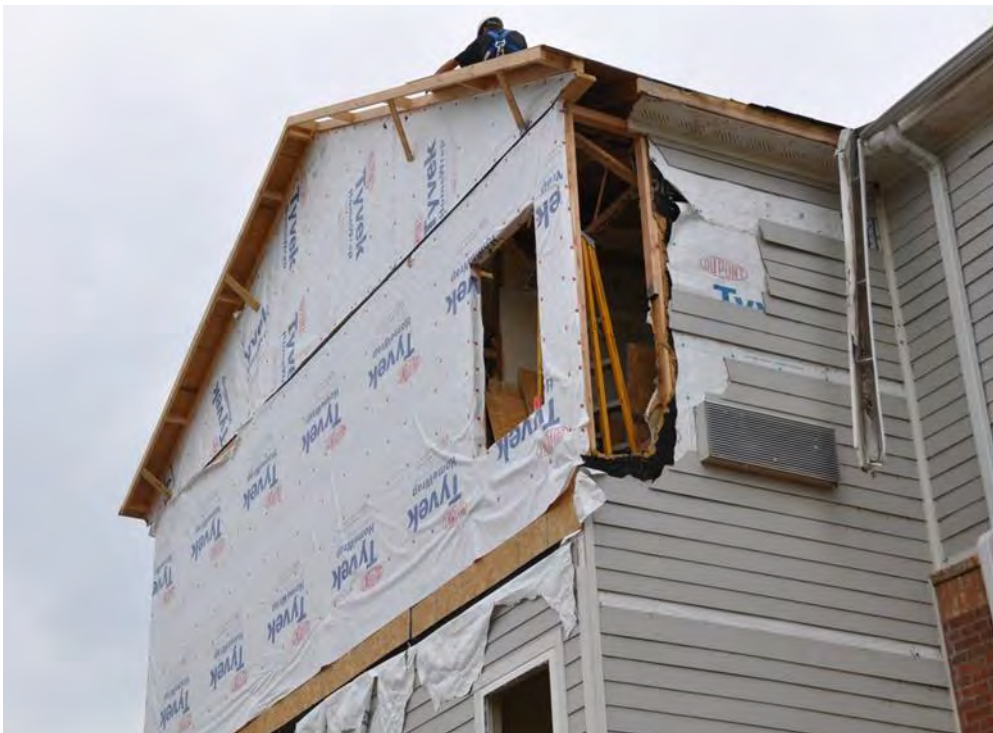
Figure 3–112. Damage to the building envelope of the Mercy Village Apartments.

- Loss of small sections of wall and roof plywood sheathing between the third floor and roof (see Fig. 3–112).
- Reported damage to the interior due to water infiltration where there were damaged windows.

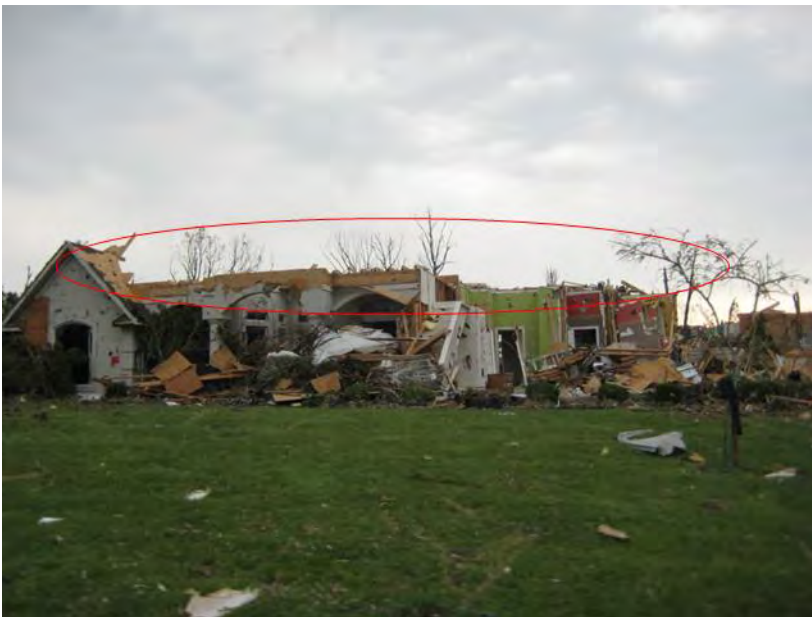
The structural failures observed among residential buildings predominantly involved disconnection of component structural systems (roof-to-wall and wall-to-foundation connections), with roof disconnections causing most of the damage (see Fig. 3–113 to 3–118). This indicated that structural failure tended to be due to a lack of robustness in the connections between residential structural components (i.e., the inability to maintain a continuous vertical load path from roof to foundation), rather than to the structural capacity within the components. More robust uplift-resistant connections between primary structural components can help keep the roof system connected to the supporting walls (and thus continuing to provide lateral bracing for the walls, keeping them from collapsing due to lateral wind loads) and thereby reduce the severity of damage to individual residential buildings. Keeping more affected buildings intact can reduce wind-borne debris, the potential for injuries and fatalities, and overall damage, which can enhance a community's resilience to tornadoes.

Figure 3-116. Typical roof-to-wall connection damage.

To achieve this improved performance, *overall system integrity* (i.e., primary structural components of residential systems remain connected, albeit damaged) up to a certain wind speed range (for example, a maximum wind speed in the EF-3 range), should be stipulated as a required design objective.

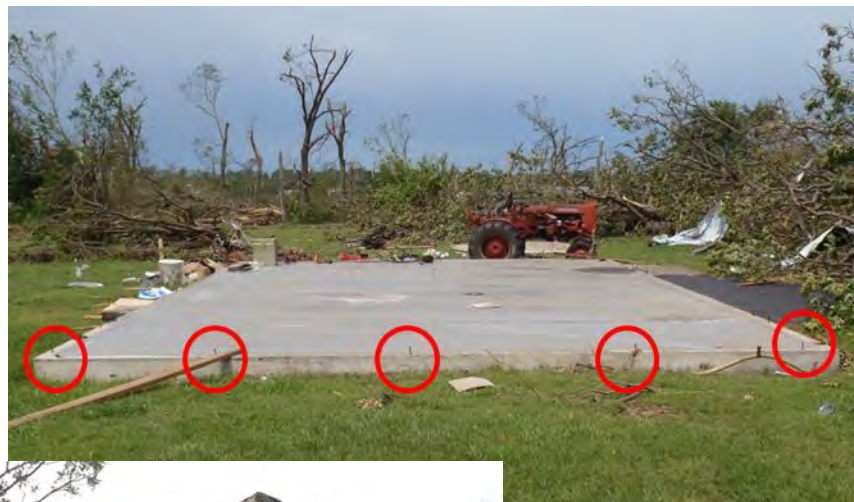
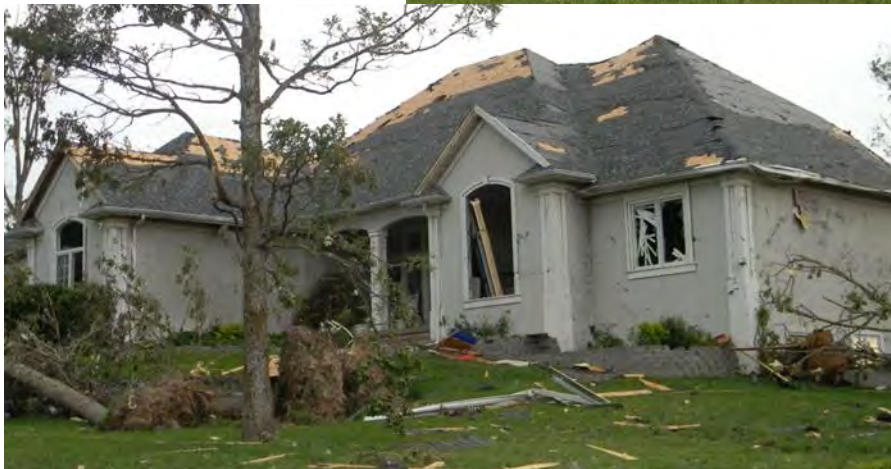
Figure 3-118. Typical damage to residential dwelling envelope.

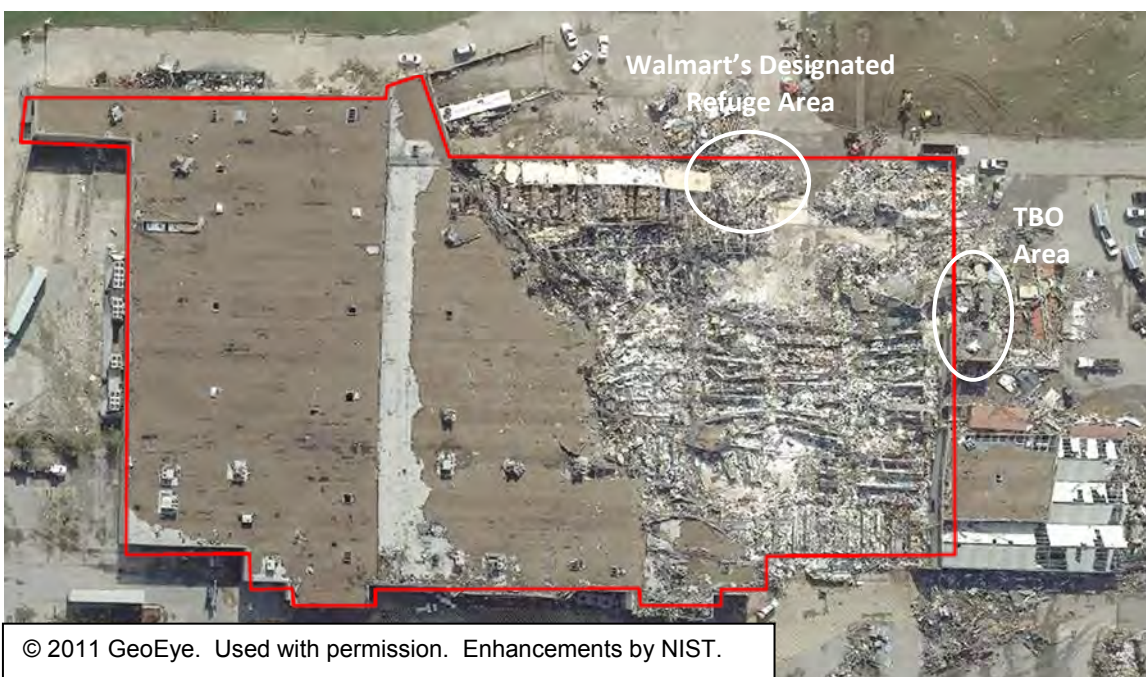
Figure 3–119. Aerial photo showing the locations of the designated refuge area and TBO area in the Walmart store a drawing containing the refuge area. .

As a result of the May 22, 2011, Joplin tornado, the roof system of the south half of the Walmart failed, with many steel roof trusses collapsing into the interior of the building, including into the designated refuge area. The east exterior CMU wall also collapsed inward onto the designated refuge area (see Sec. 3.2.1.2). There were three fatalities and an unknown number of injuries at the store. It is not clear exactly where the three fatalities occurred; however, some of the injuries were confirmed through survivor interviews to have occurred in the designated refuge area. Accounts from survivors also indicated that the wood shelving units and counter in the refuge area might have acted as a dead stop that kept some of the roof trusses from collapsing completely to the floor, thus creating air space between the trusses and the floor and keeping some occupants of the refuge area from being more seriously injured. This fortuitous development, rather than protection designed into the refuge area, might have helped to reduce the number of casualties at the store. Overall, however, the designated safe area in Walmart Store #59 did not provide safe refuge for occupants in this particular tornado event.

NIST's review of structural drawings and its field damage survey also suggested that the TBO area, based solely on structural considerations, might have provided a better refuge than the designated area (see Fig. 3-119). The TBO area, located behind the automobile service bay, was surrounded by hard CMU walls on all sides (the south perimeter CMU wall, which was laterally braced on both sides of the wall, and interior CMU partition walls on other sides). This area sustained envelope damage but did not sustain structural collapse. This observation highlights the need for structural evaluation in selecting best available refuge areas by a qualified architect or engineer.
