Draft Final Report • National Institute of Standards and Technology (NIST)

of the May 22, 2011,
Tornado in
Joplin, Missouri

NIST NCSTAR 3 (Draft)

November 2013

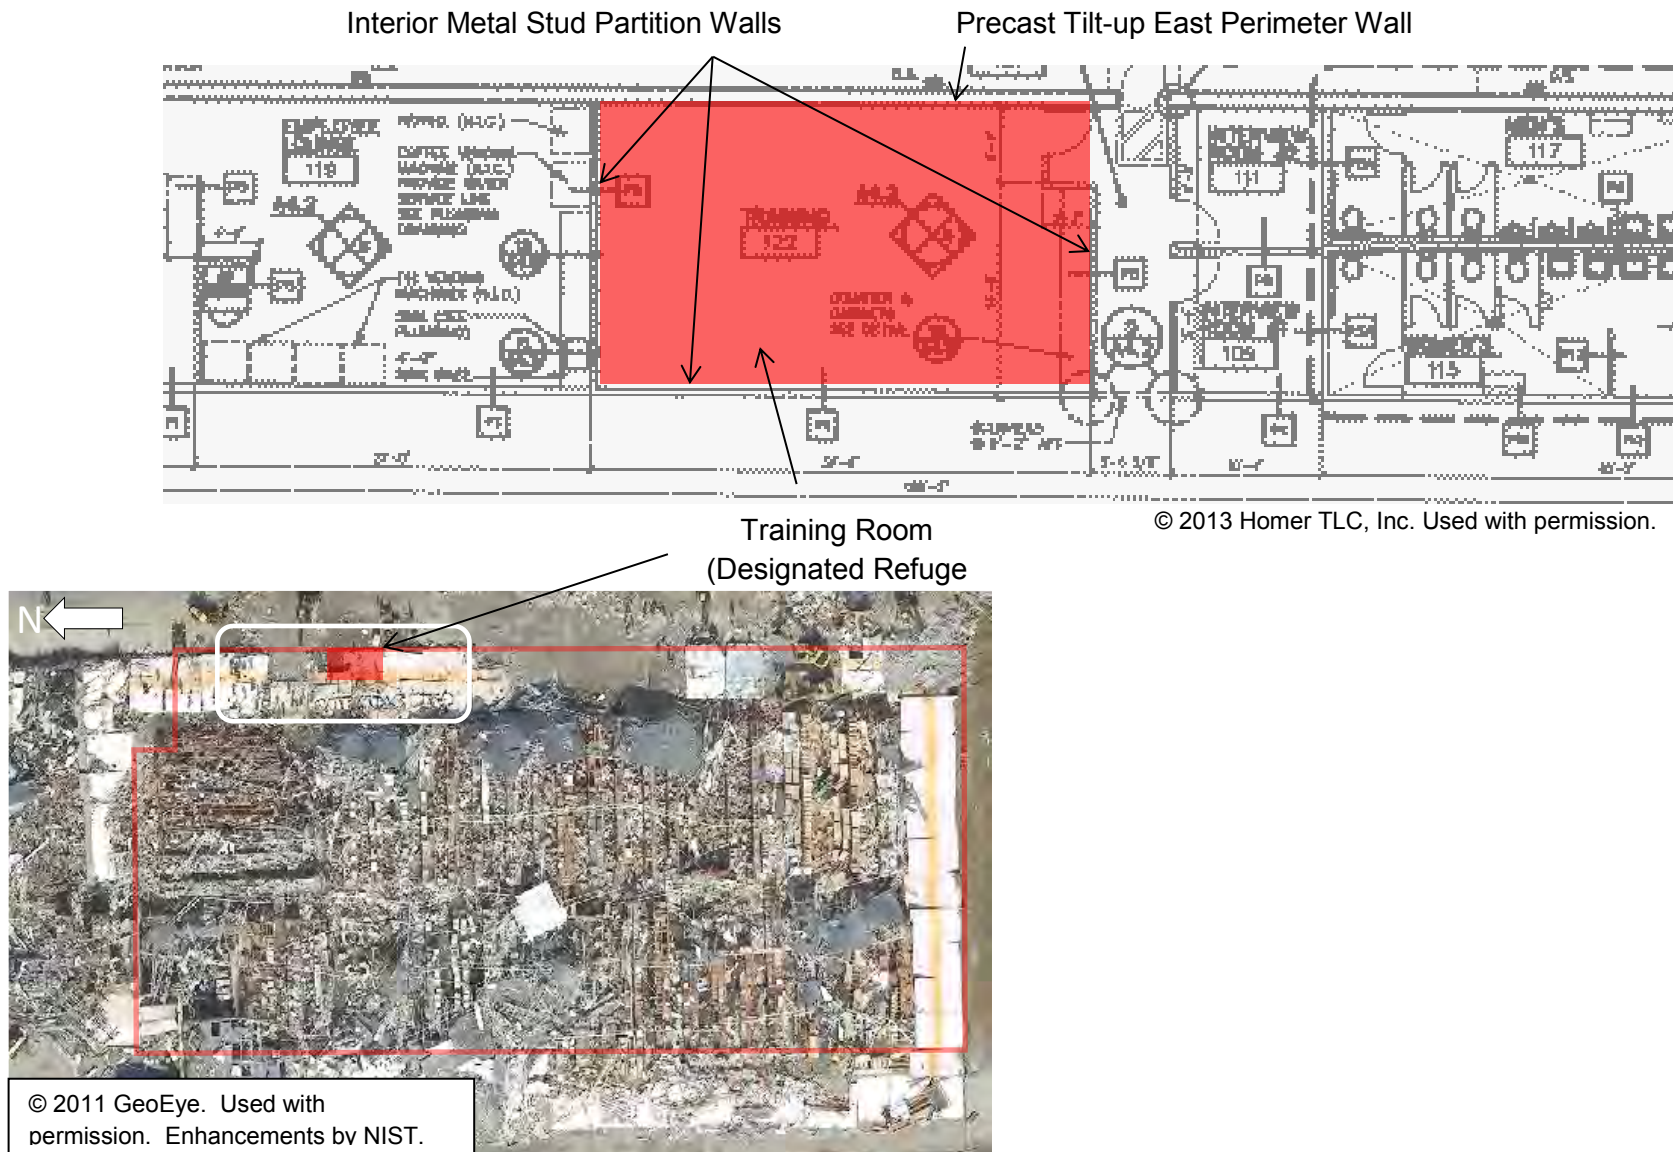
Design drawings indicated that the Training Room/designated refuge area was 34 ft × 20 ft in plan, and bounded by the hard tilt-up east perimeter wall on the east side and three interior partition walls on the north, south, and west sides. The interior partition walls were made of steel stud frames (6 in. wide, 20-gauge, 16 in. on center), covered with 5/8 in. gypsum boards on one side and 1/2 in. plywood panels on the other. The hard wall that bounded the east side of this room comprised tilt-up wall panels that did not have positive connections to the concrete strip footing. North of this room was a group of wall panels (around the loading dock) that had some rotational capacity due to their positive wall-to-footing connection (designed for accidental truck collisions with the dock, see Fig. 3-46 in Sec. 3.2.1.3). The roof system was structurally similar throughout the store's interior. Thus, structurally speaking, the area along the same (east perimeter) wall and about two wall panels north of the Training Room (adjacent to the locker room near the loading dock, see Fig. 3-121) might have been a better selection for the best available refuge area in this store.

Figure 3-120. Location of the Training Room/designated refuge area at the Home Depot. Perimeter tilt-up wall panels here collapsed inward and onto the safe area.

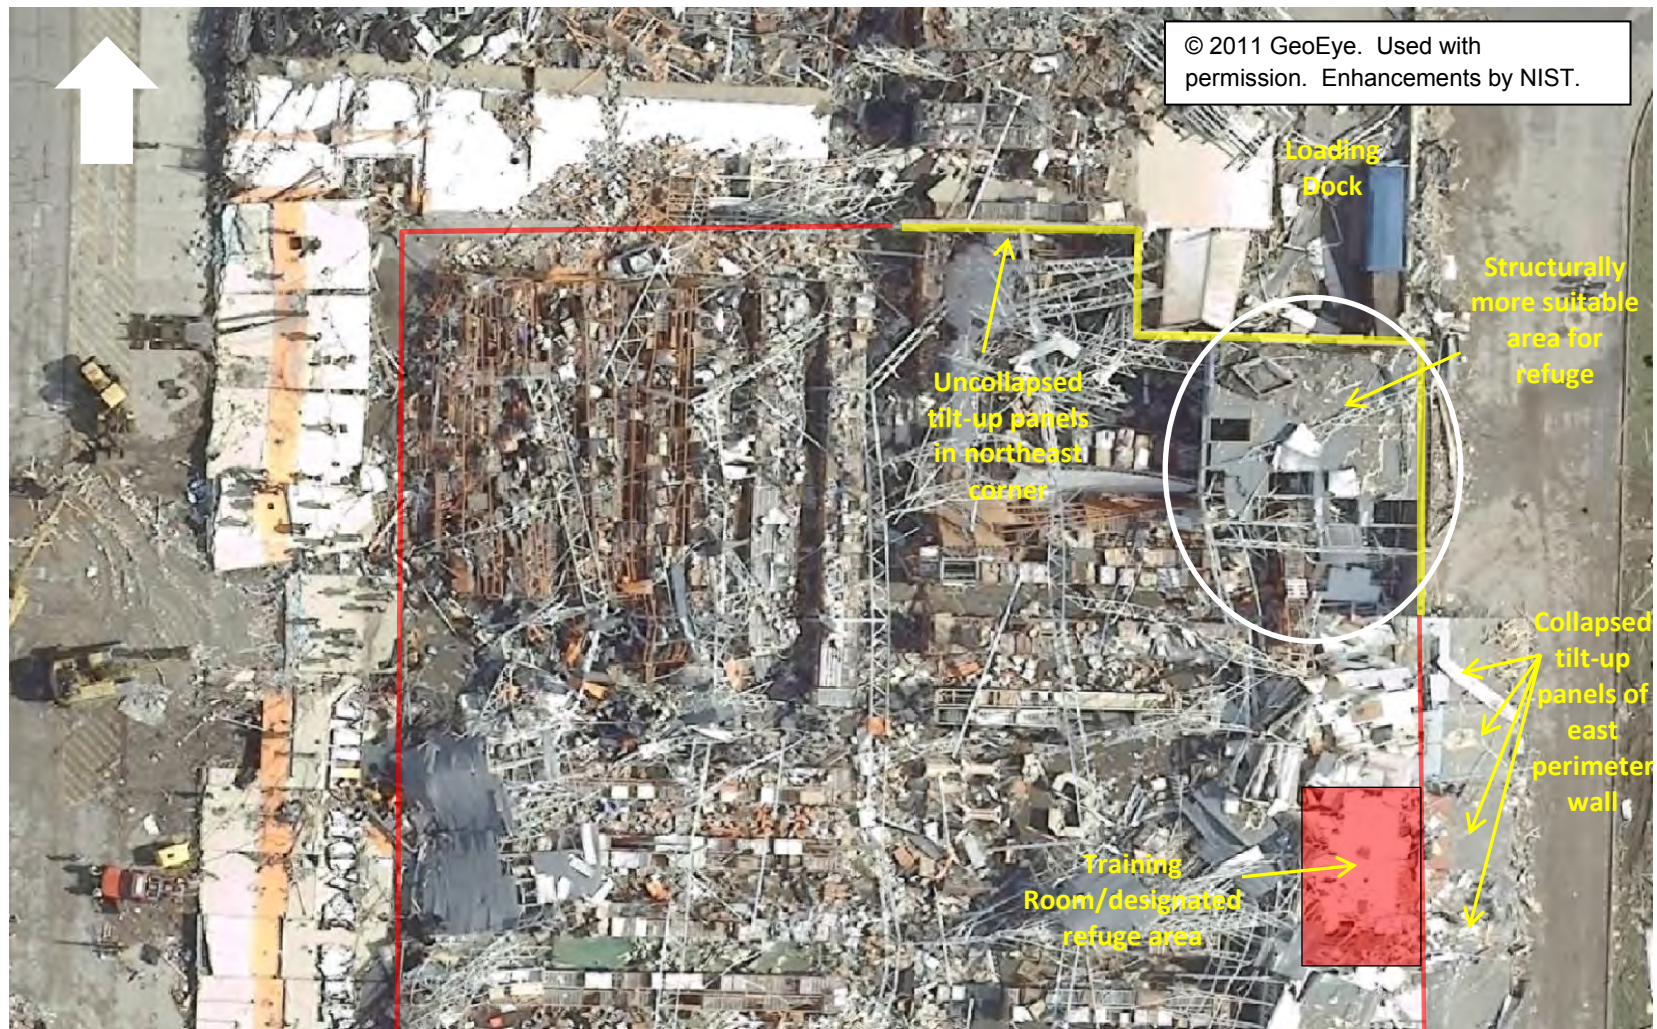
Figure 3–121. North section of the Home Depot. Red line indicates perimeter tilt-up wall panels that collapsed. Yellow line traces perimeter tilt-up wall panels (northeast corner, around loading dock) that did not collapse. Red rectangle designates the Training Room/designated refuge area.

As discussed in Sec. 3.2.1.3, the Home Depot sustained total collapse in the Joplin tornado, with 63 of its 73 tilt-up perimeter hard wall panels collapsing either inward toward the interior of the building or outward away from the interior of the building. The perimeter hard wall panels that bounded the designated refuge area were among the 63 that collapsed. However, they fortuitously collapsed outward away from the building and the refuge area in the Training Room (see Fig. 3–121 and 3–122), and thus averting the potential for further injuries or fatalities among the building occupants who might have sought shelter in this area.

In summary, the designated refuge area in the Home Depot did not provide better protection than other areas in the store during the May 22, 2011, Joplin tornado. An area near the loading dock may have been structurally more suitable to serve as a refuge, since the hard walls of this area had additional rotational capacity due to the design of the wall-to-footing connections. NIST does not have information on how the designated refuge area at this Home Depot was selected, including whether an experienced and qualified architect or engineer was consulted. Currently, such consultations are not mandatory and the selection can be done at the discretion of the facility owner. There were eight fatalities and an unknown number of injuries at the Home Depot. While media accounts indicated that there were injuries that occurred to occupants of the designated safe area, NIST was not able to obtain direct confirmation of the locations of the injuries and fatalities at this facility (see Chapter 4) including the designated refuge area.

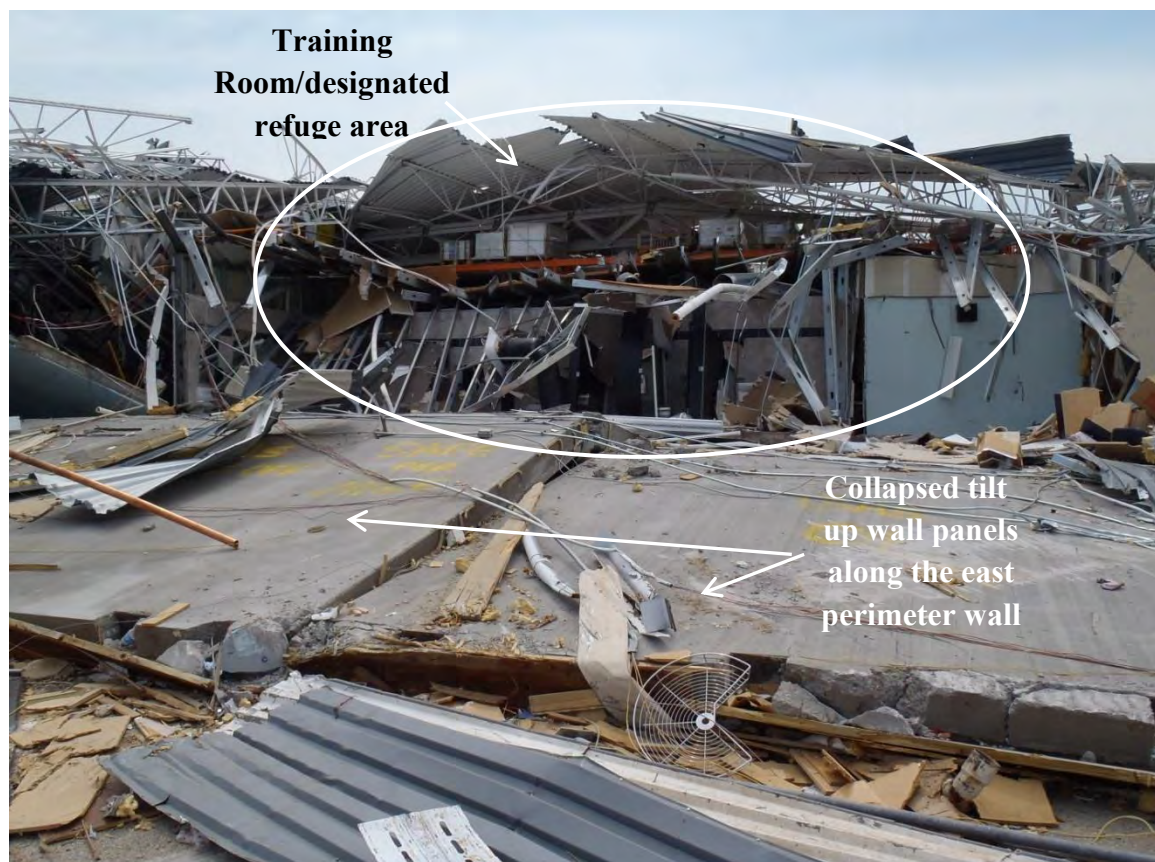
Figure 3–122. View, from outside toward the west, of the Training Room/designated refuge area of the Home Depot.

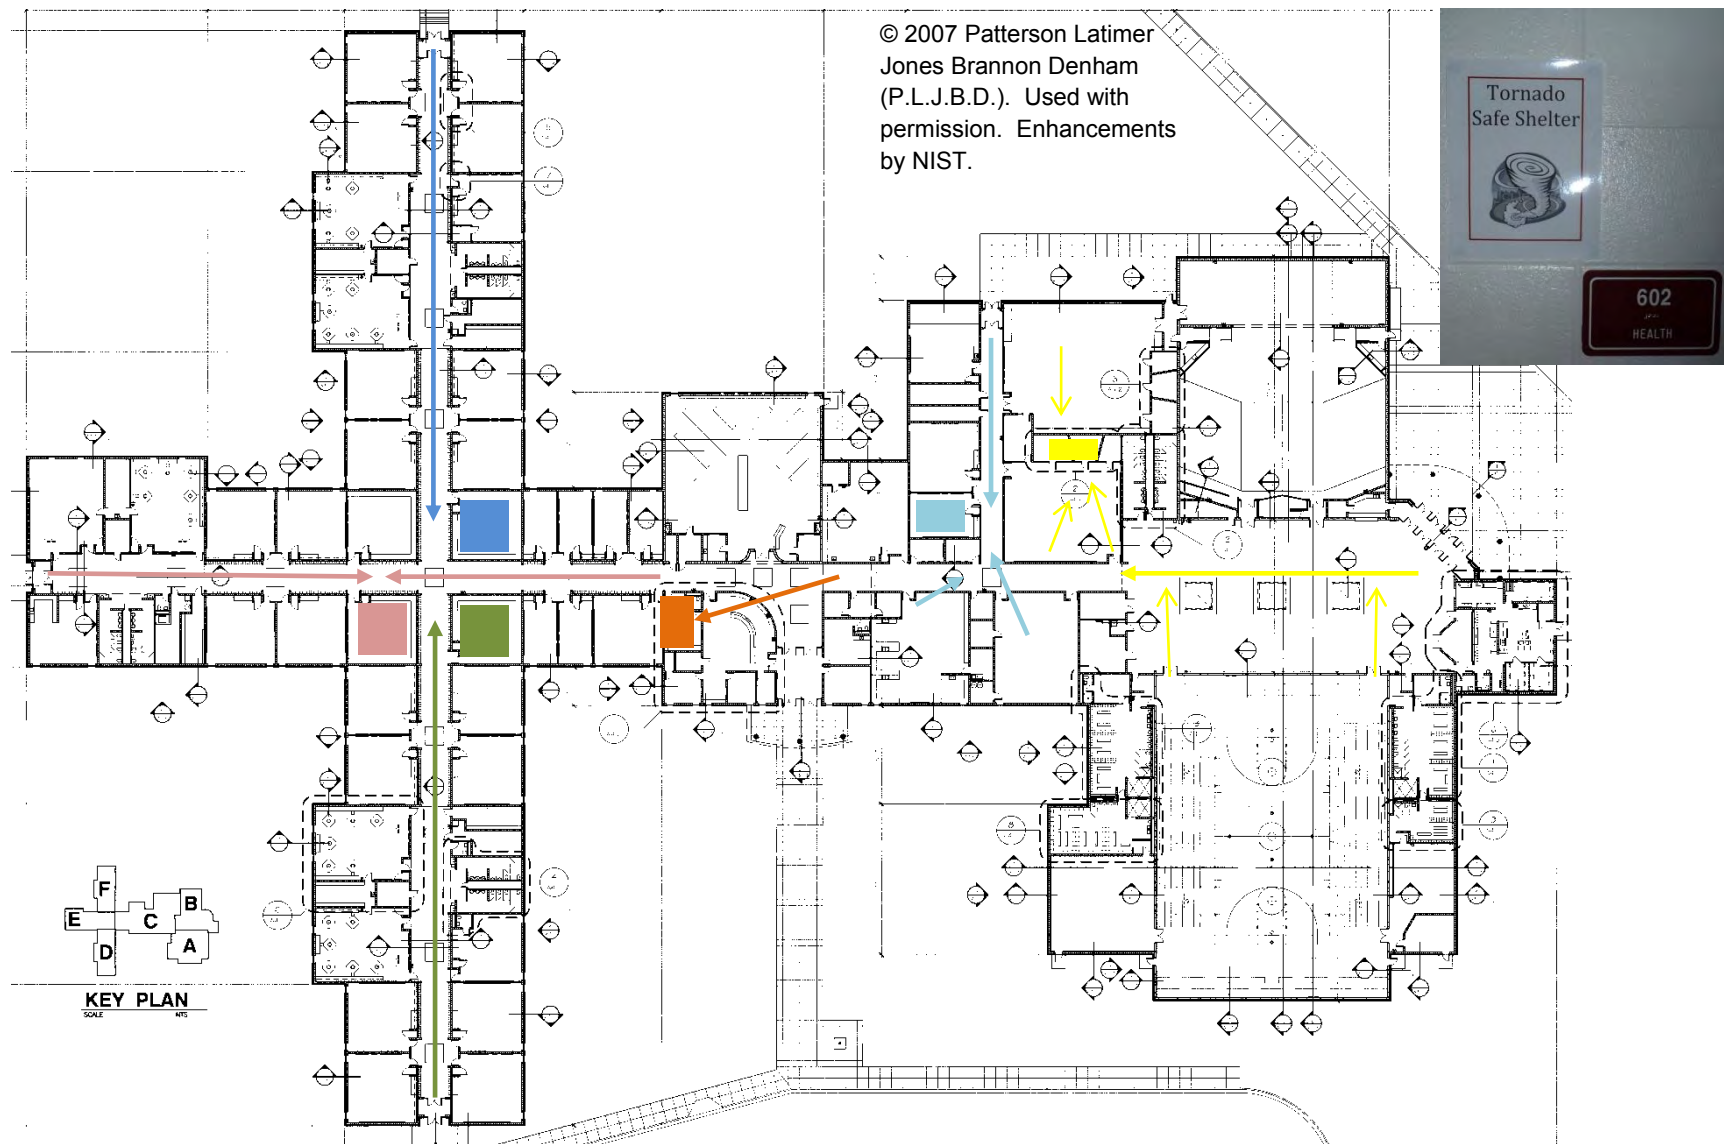
Figure 3–123. Locations of Tornado Safe Shelters (color blocks) in Joplin East Middle School and their associated, pre-planned tornado evacuation routes (arrows of corresponding color).

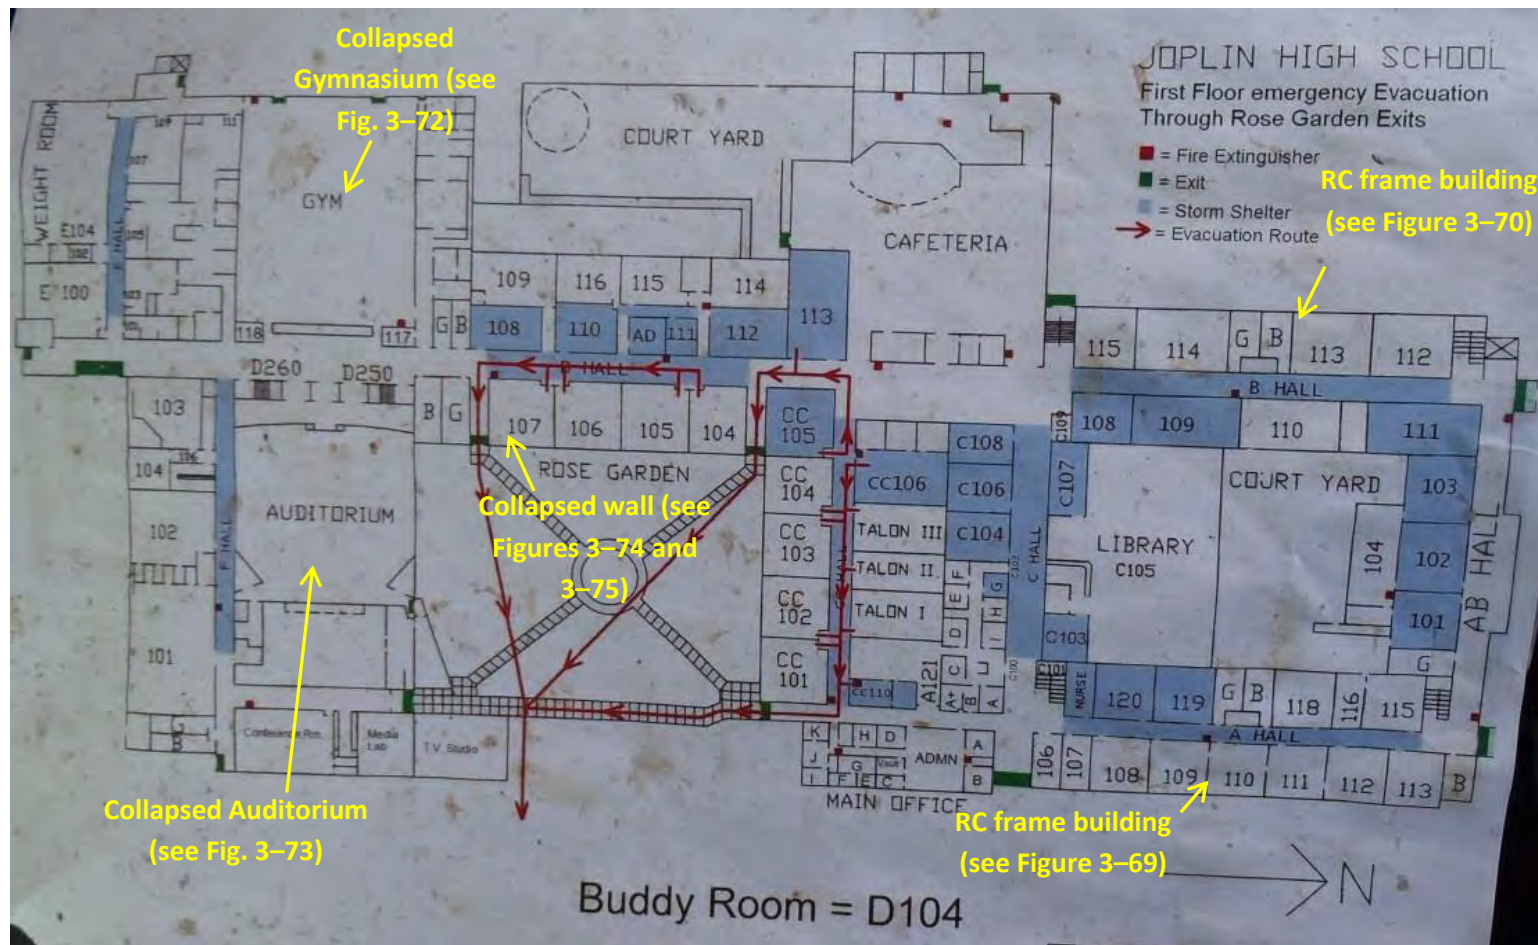
Locations of “storm shelters” (blue shaded areas) and pre-planned evacuation routes (red arrows) on the first floor of Joplin High School are shown on Fig. 3–124. Although NIST was able to obtain only a partial set of drawings for this facility, information from the available drawings and field damage surveys indicated that these designated areas were the best available refuge areas, though not hardened areas or shelters designed in accordance with the tornado design criteria identified earlier in this chapter. The

Figure 3-124. Locations of “storm shelters” at Joplin High School and pre-planned emergency evacuation routes.

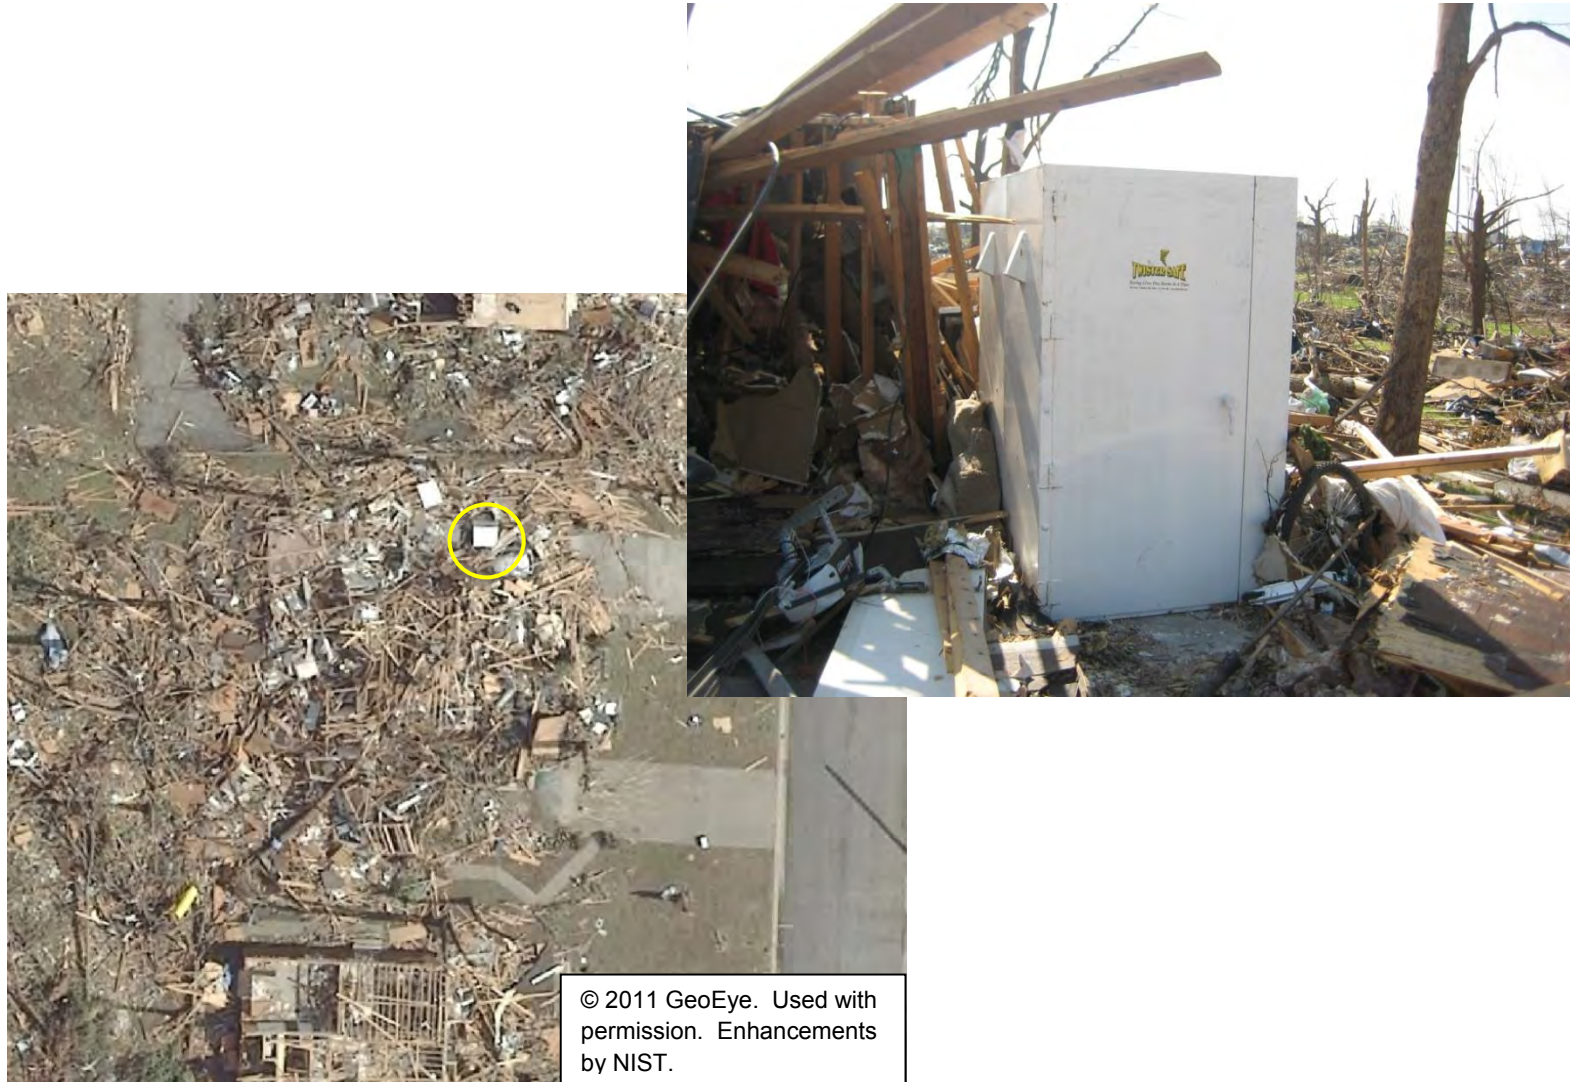
Figure 3–128. Wood-frame home completely destroyed except for the steel shelter bolted to the concrete floor in the garage.

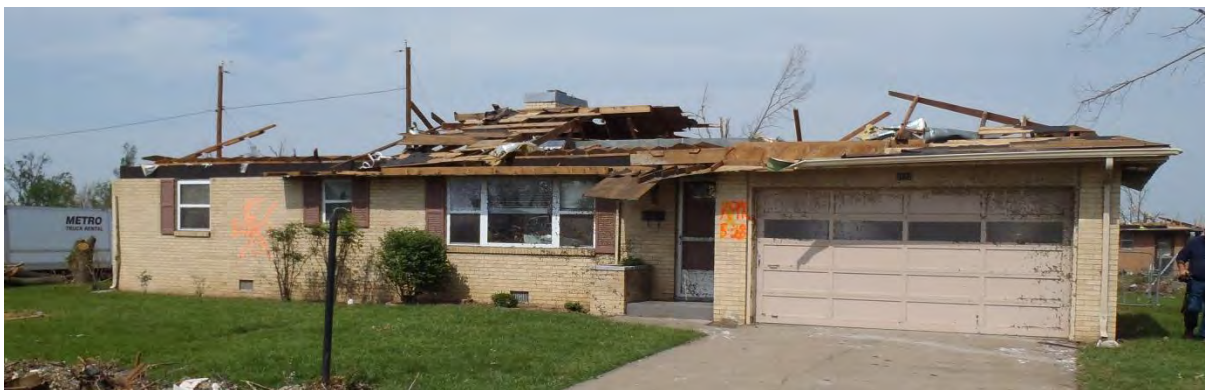
Figure 3–130. Extent of damage (roof system disconnected) at residence with in-home, above-ground Kevlar storm shelter.

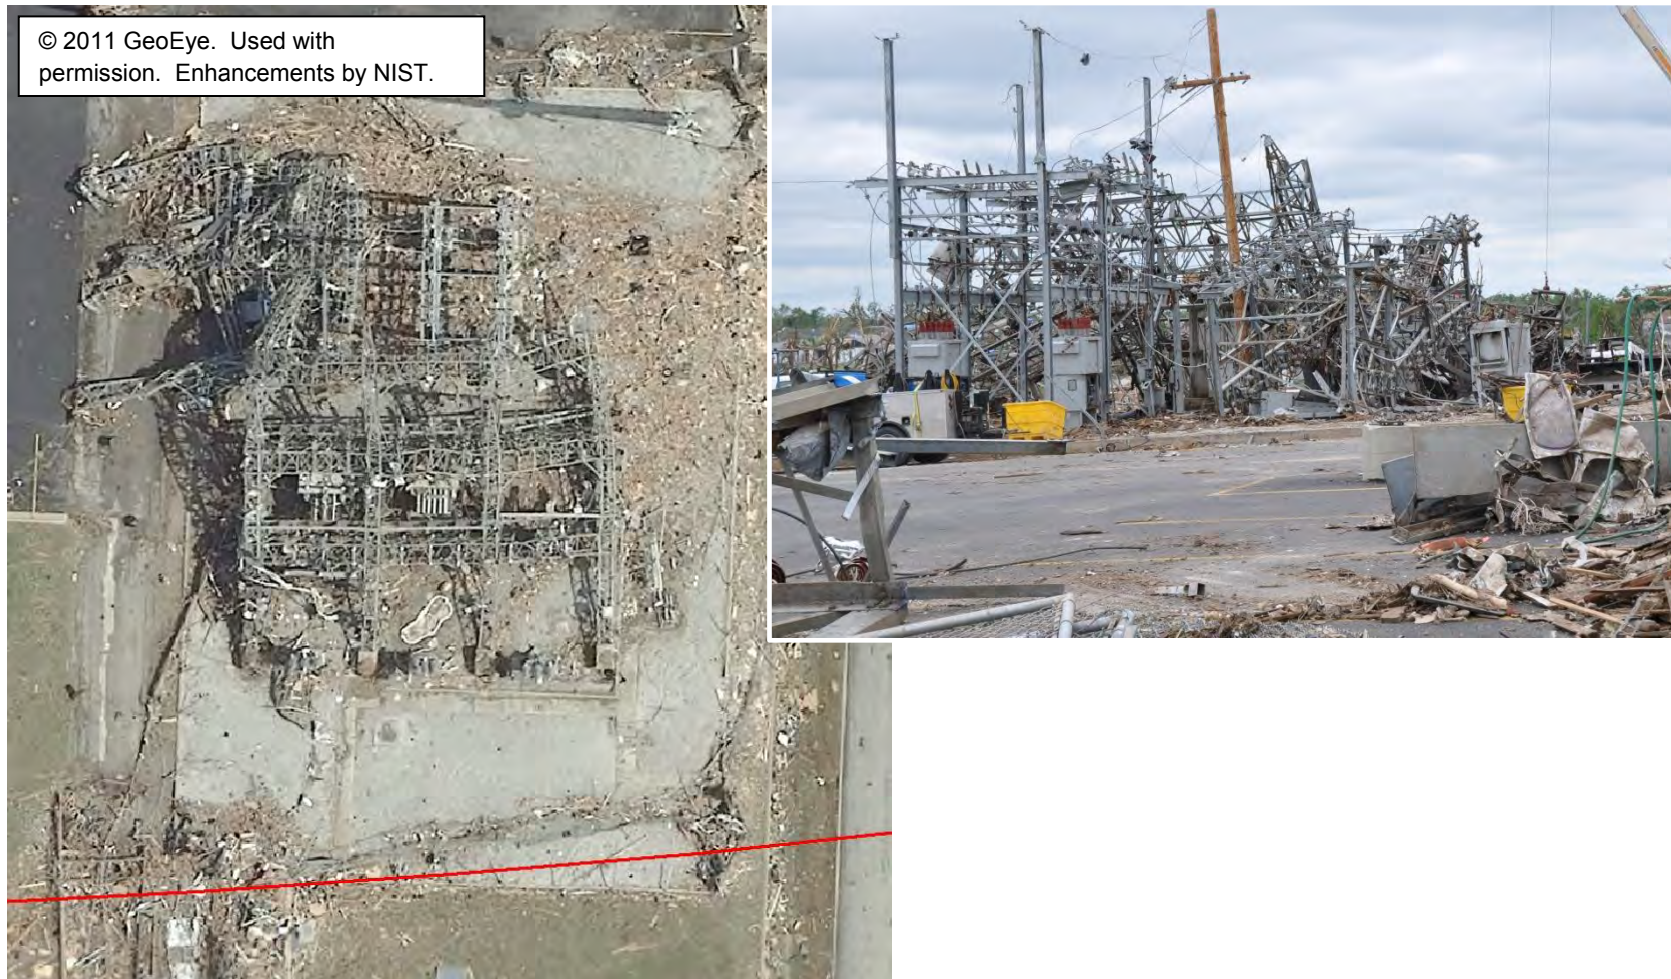
Figure 3–131. Destroyed EDE Power Substation 59.

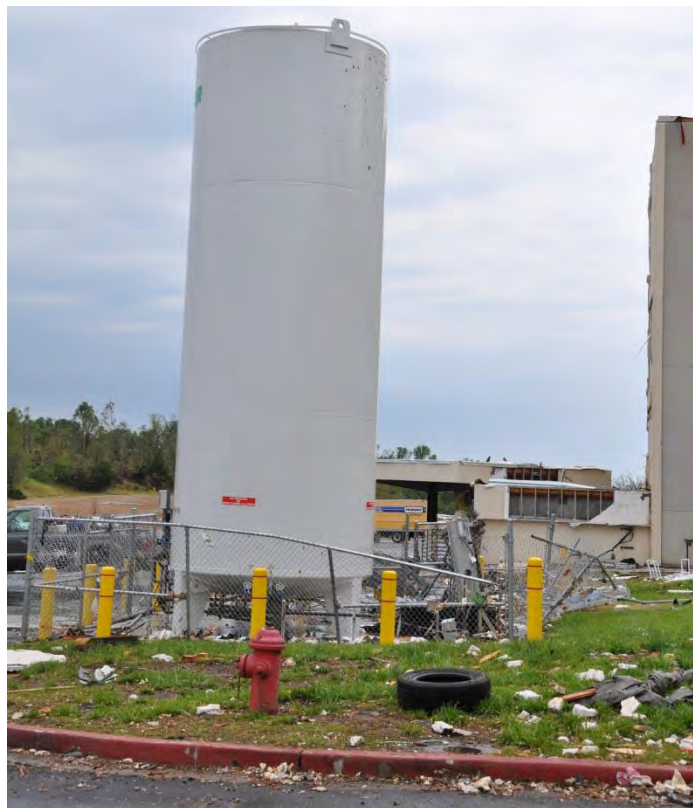
Figure 3-133. Liquid oxygen tank at SJRMC that leaked.

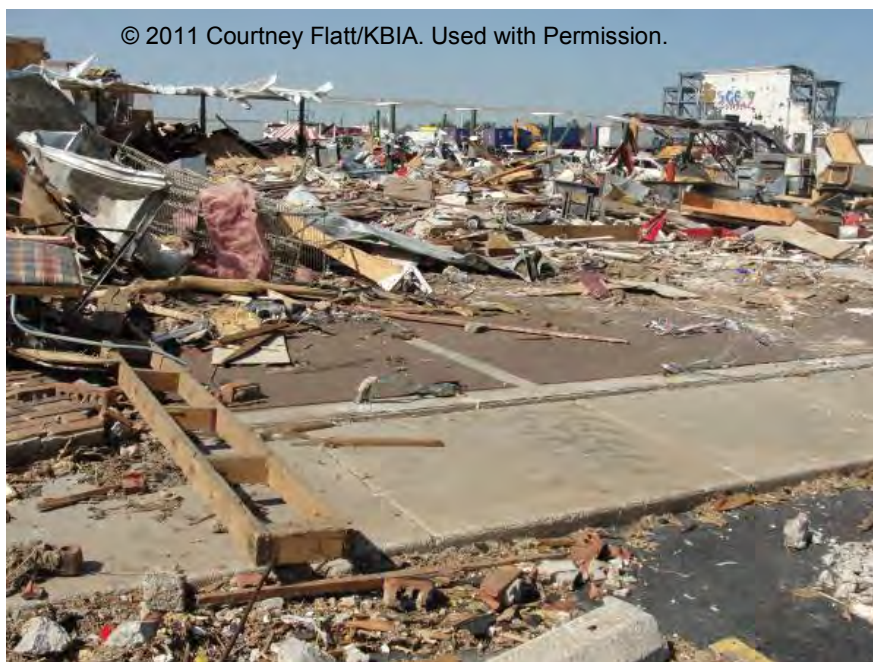
Figure 4–5. Joplin Elks Lodge #501 destroyed by the May 22, 2011, Joplin tornado.

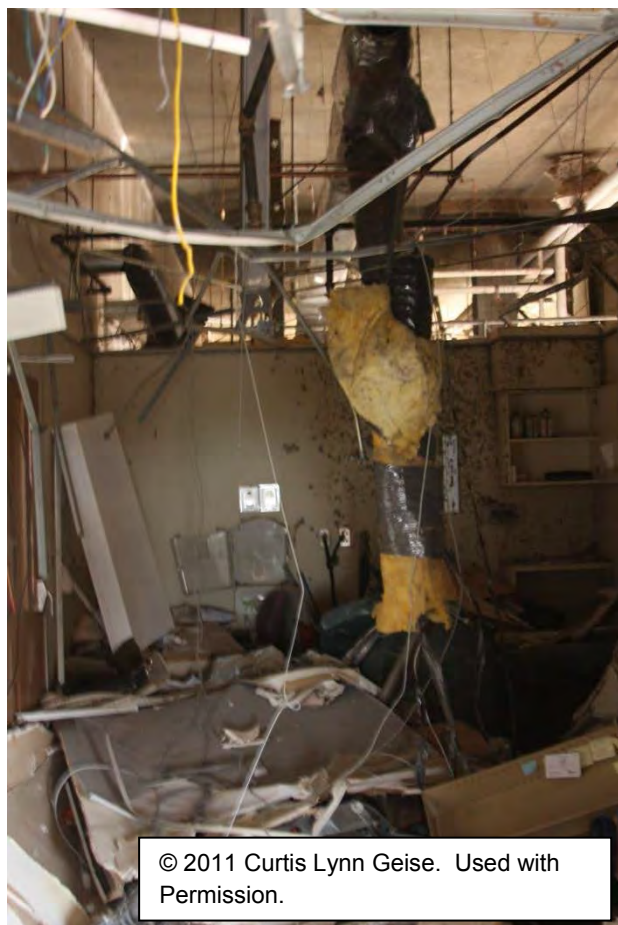
Walls in, doors in, door frames in, debris everywhere. You can't imagine the shattering that goes on when you have materials exposed to that kind of wind. Plus just the wires that were down from the ceiling, all the equipment that's inside a room, debris a foot, two feet deep some places that you had to move before you could get somebody out . . . but instantly without any thought you knew you were leaving this place because it was just absolutely wrecked. (NIST Interview 6)

When the couple in the first-floor Emergency Room made it out of their examination room, they noticed the rain just pouring in from where the ceiling used to be. With water at their ankles, and live wires sparking around them, they were concerned about being electrocuted if they remained in the building for much longer (NIST Interview 2). See Fig. 4–6 for an example of damage done to the interior of the SJRMC.

Figure 4–6. Damage to the interior of SJRMC.

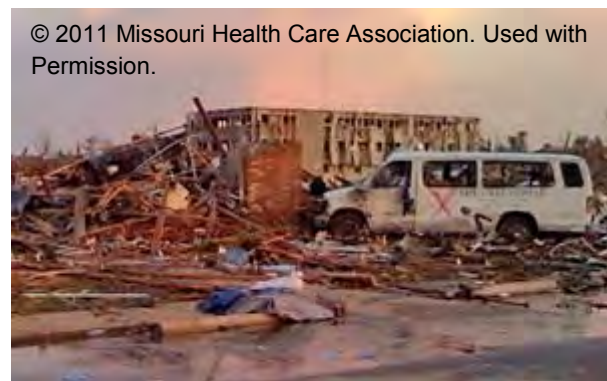
A total of 19 fatalities from the May 22, 2011, Joplin tornado are attributed to the Greenbriar Nursing Home, which was completely demolished by the tornado (see Fig. 4–7). All deaths were due to impact-related causes, except for one individual whose cause of death was pneumonia (and whose death occurred one month after the tornado hit), according to the death certificates. Five of the 19 fatalities were individuals who were injured at Greenbriar Nursing Home and later transported to hospitals where they died from their tornado injuries, according to the death certificates. No information was found on the exact cause of death for these five fatalities; only the cause of the injury that contributed to their death which was recorded on the death certificate. There was a media report that the cause of at least one of these five deaths was mucormycosis, a fungal infection that attacks the body after injury (Younker 2011a); however, NIST was not able to independently confirm that report.

Figure 4–7. The small brick wall in the foreground (to the left of the van) is one of the few portions of the Greenbriar Nursing Home left standing following the May 22, 2011, Joplin tornado. (The building standing in the background was not part of the Greenbriar.)

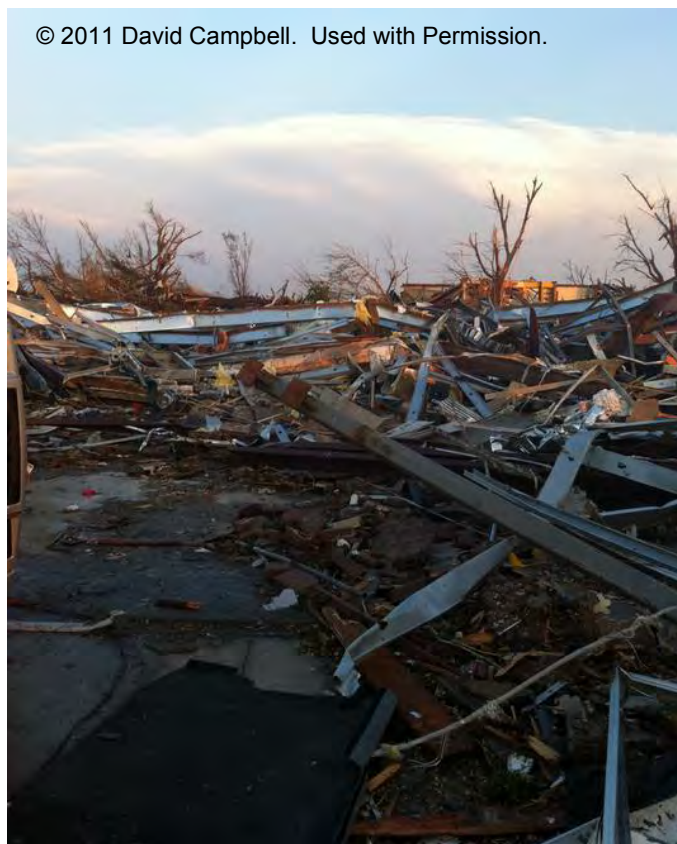
Figure 4-9. The AT&T store following the May 22, 2011, Joplin tornado.

The store was exposed to an estimated maximum wind speed of approximately 160 mph \pm 20 mph during the storm. One employee remembered the bathroom door coming off the hinges, slamming him in the back, and sending him flying into a brick wall (CWA 2011). Another employee recalled feeling for a moment like he was flying and then the sensation of being crushed, before he was knocked unconscious. When the storm was over, building materials and other debris had pinned some of the employees, so much so that they were unable to move. Those who could free themselves went for help, and those who remained realized that there was one death among them (i.e., an employee). One employee stated that the deceased was pinned down by a metal door (Skinner 2011). The severity of injuries to survivors at the AT&T store is unknown.

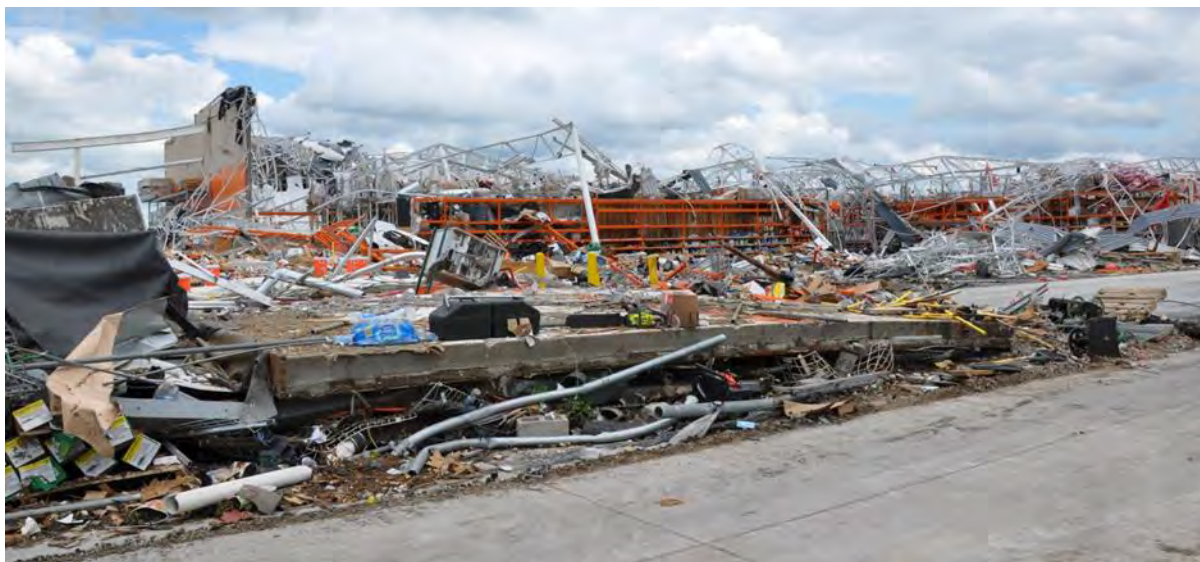
Figure 4–10. A view of the Home Depot building that collapsed in the May 22, 2011, Joplin tornado.

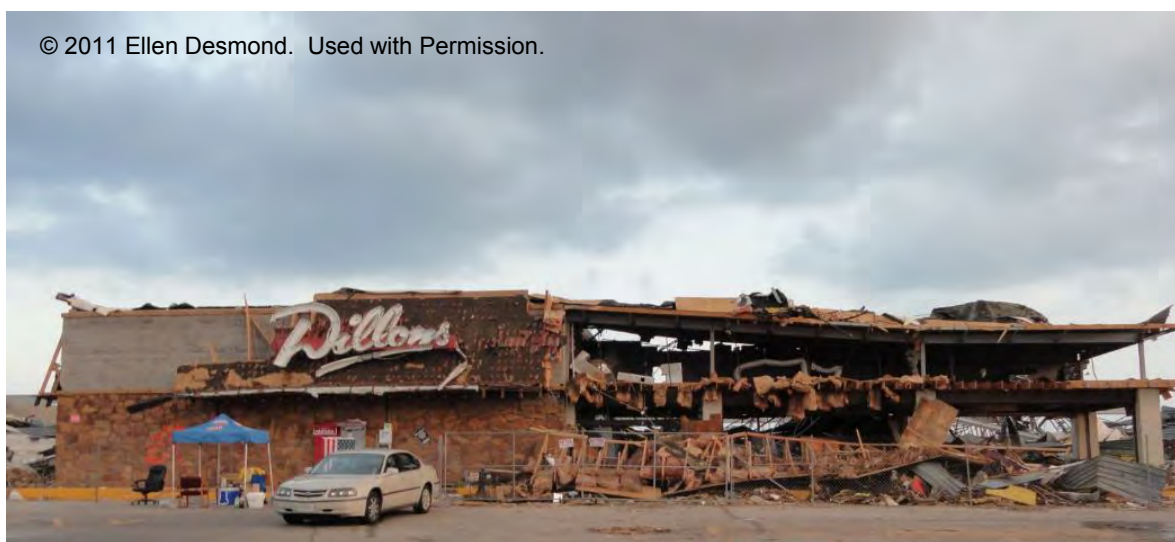
The Dillon’s store was a box-type construction made of CMU perimeter walls and open-joist steel roof trusses. The store was exposed to an estimated maximum wind speed of approximately $170 \text{ mph} \pm 20 \text{ mph}$. See Fig. 4–11 for damage to the Dillon’s grocery inflicted by the May 22, 2011, Joplin tornado. The tornado caused injuries among building occupants, including cuts, bruises, and scratches; however, none of these injuries was life-threatening.

Figure 4–11. Damage to Dillon’s grocery inflicted by the May 22, 2011, Joplin tornado.

The cooler was located in a corner of the store, against the exterior wall on the western side of the building. After the tornado blew through the building, the cooler remained nominally intact. The cooler doors had popped off and a steel beam had fallen on top of the cooler, which crushed into the back part of it. However, when the tornado was over, the cooler remained standing.

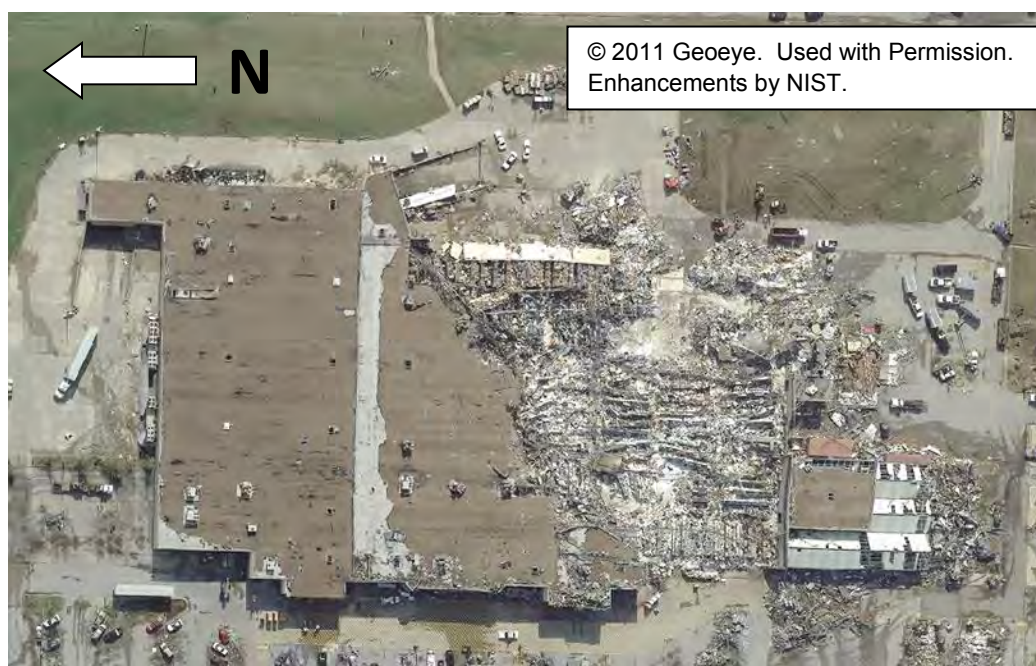
As discussed in Chapter 3, the uncollapsed north half of the building experienced a lower estimated maximum wind speed of $120 \text{ mph} \pm 20 \text{ mph}$ (EF-2 speeds, from a northerly direction) and the collapsed south half experienced a higher estimated maximum wind speed of $165 \text{ mph} \pm 20 \text{ mph}$ (EF-3 to EF-4 speeds, from a west-northerly wind direction) (see Fig. 4-12). A total of three people lost their lives that day in the Walmart. It is uncertain exactly where, inside the store, the fatally injured were located. However, information from the Walmart EOC notes that the fatalities were reportedly the persons closest to the center of the store. All three decedents died due to blunt-force trauma to the body, according to the death certificates. No information could be found on how many did not take shelter in the Site-to-Store refuge area or on the number of people injured at the store.

Figure 4-12. Aerial photo of the tornado-damaged Walmart Store #59, showing the collapsed south half and uncollapsed north half of the building.

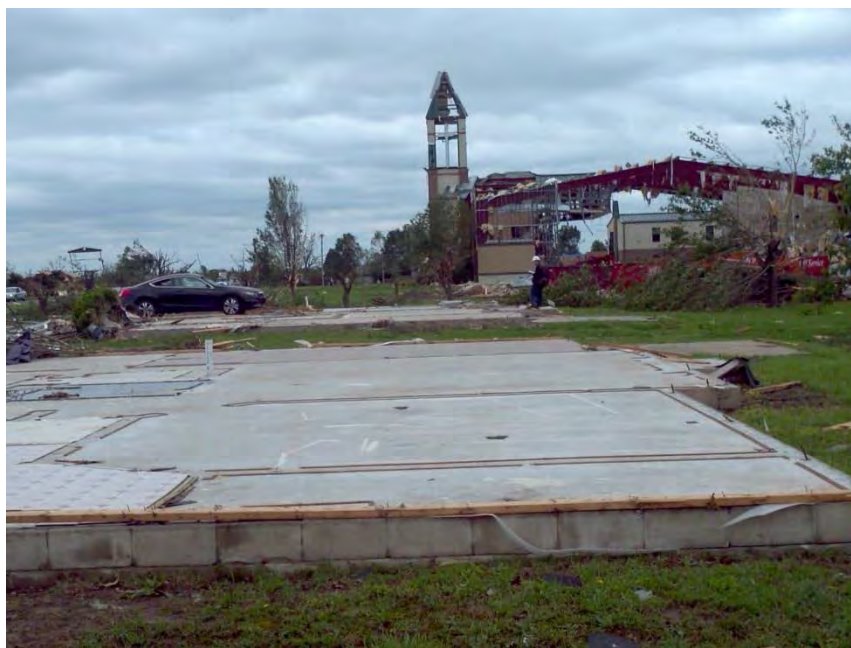
Interviewees suffered anywhere from no damage to their house to the entire house being scraped off of the foundation, with nothing left. Fig. 4-14 shows a foundation and ground floor, all that was left of a house located within the damage path, along with the occupant's vehicle, which before the storm was in the garage. The winds even ripped some of the tiles and carpeting from the floor of this house. The occupant was sent flying into the storm as his house was ripped apart; however he did not suffer any life-threatening injuries.

Figure 4-14. Demolished home located within the tornado damage path in Joplin.

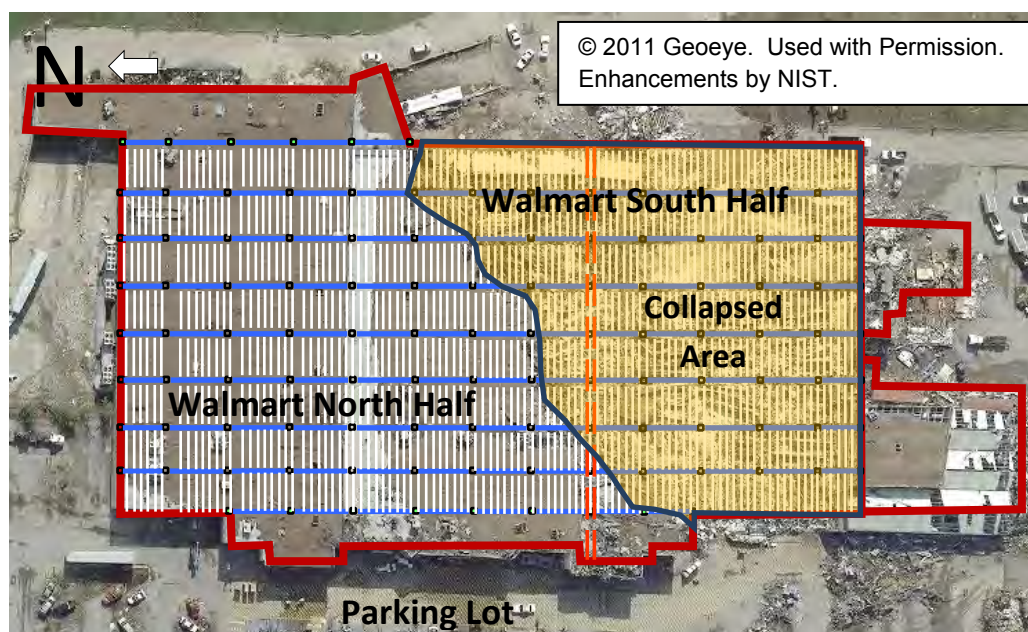
Figure 4–25. Overhead view of tornado damage to Walmart Store #59.

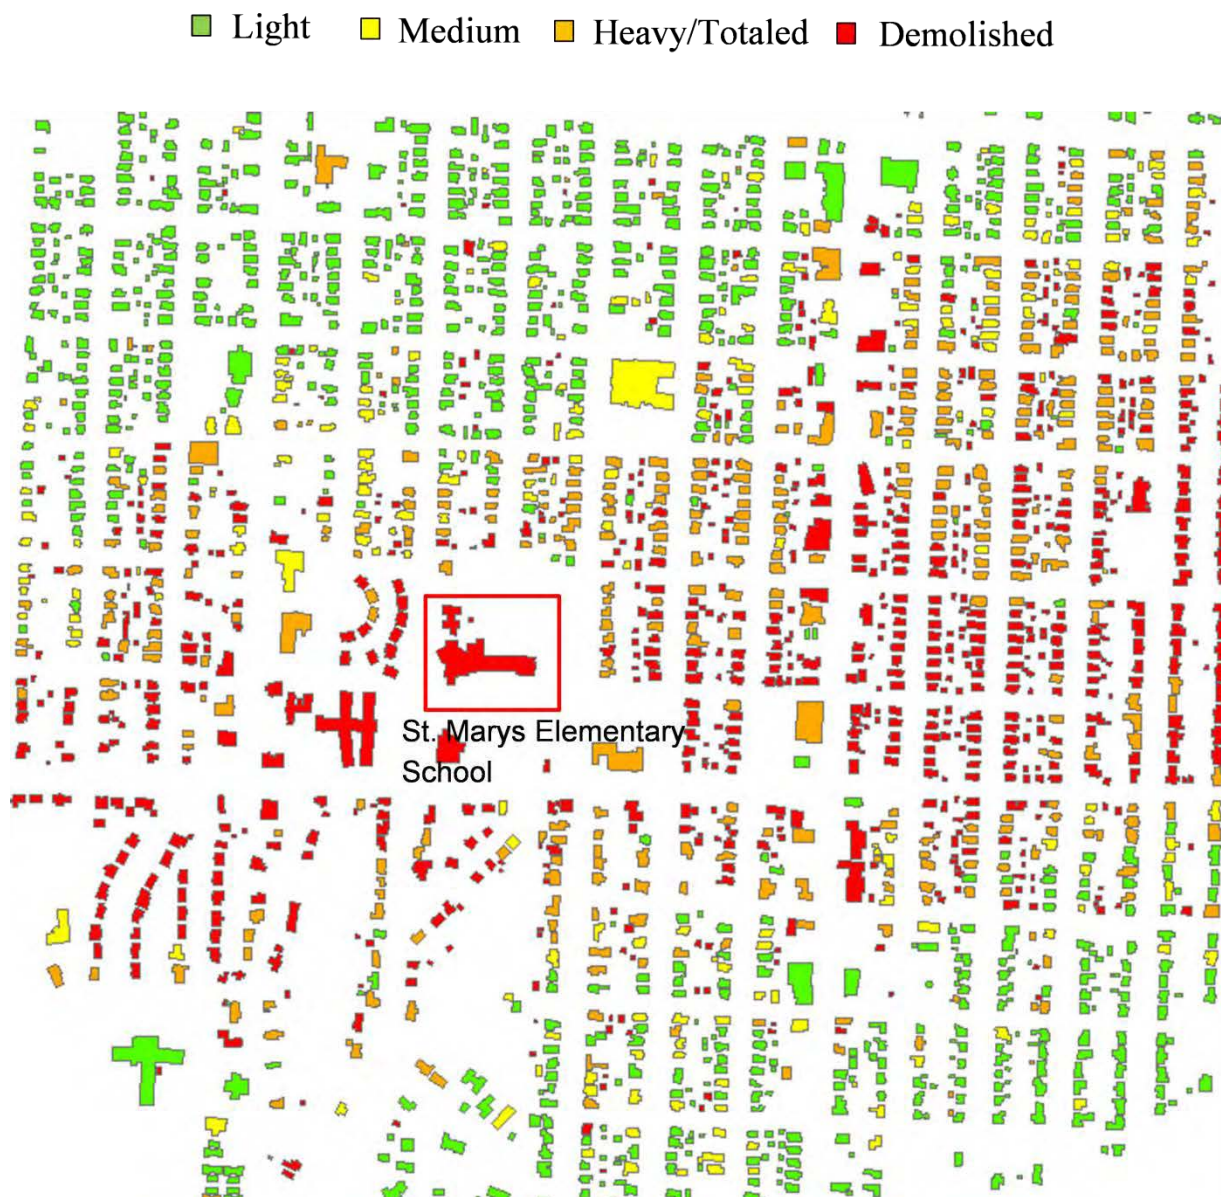
Figure 4–26: A sample of the Pictometry® database damage levels distinguished by color.

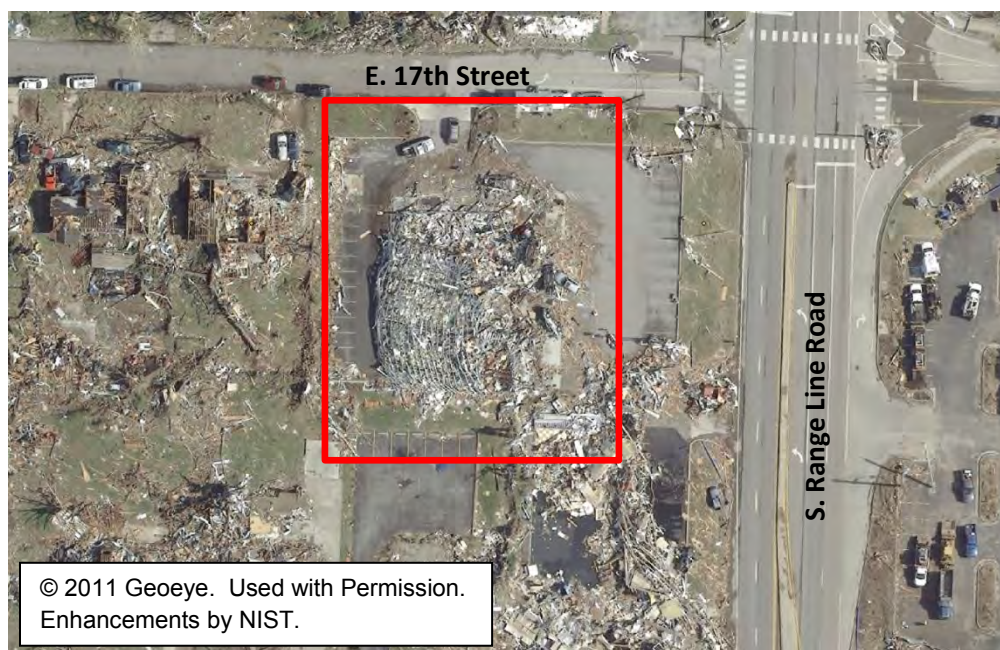
Figure 4–27. Aerial photo showing the AT&T store demolished by the storm (outlined in red).

The first of the buildings in Table 4–6, the AT&T store, sustained complete structural failure with loss of the metal roof decks; disconnection, displacement, and collapse of the entire roof truss system; and complete collapse of all exterior unreinforced CMU walls. In addition, most building components collapsed in place (into all areas of the building interior).
