Draft Final Report • National Institute of Standards and Technology (NIST)

of the May 22, 2011,
Tornado in
Joplin, Missouri

NIST NCSTAR 3 (Draft)

November 2013

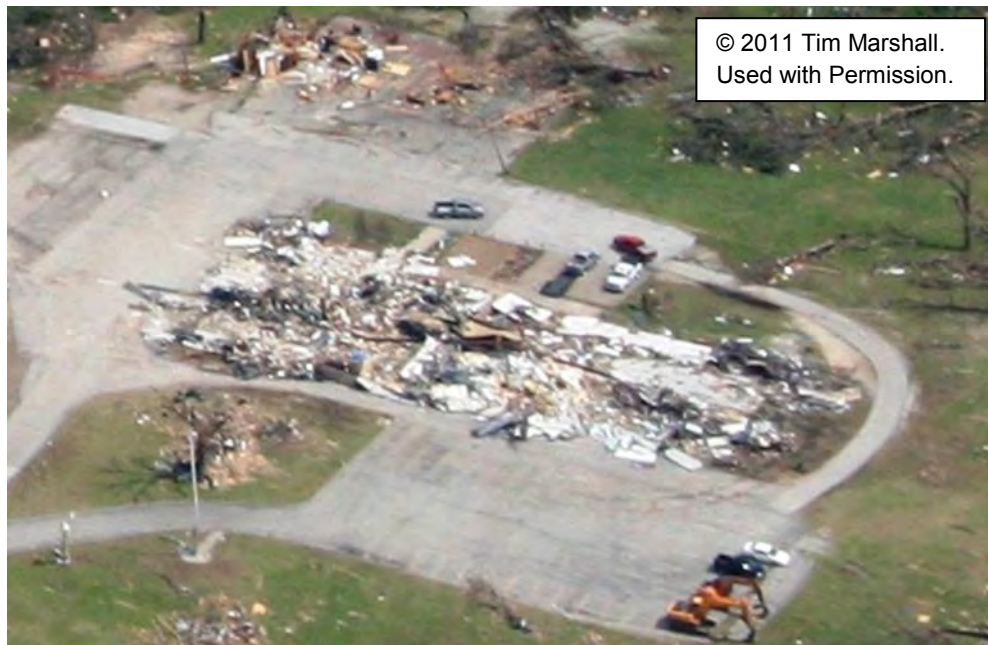
As shown in Fig. 4–28, the Joplin Elks Lodge sustained complete demolition, with disconnection and loss of the entire roof system and complete collapse of the structural wood frame. Similar to the AT&T store, most building components collapsed into the building’s interior due to the storm.

Figure 4–28. Tornado damage to the Joplin Elks Lodge.

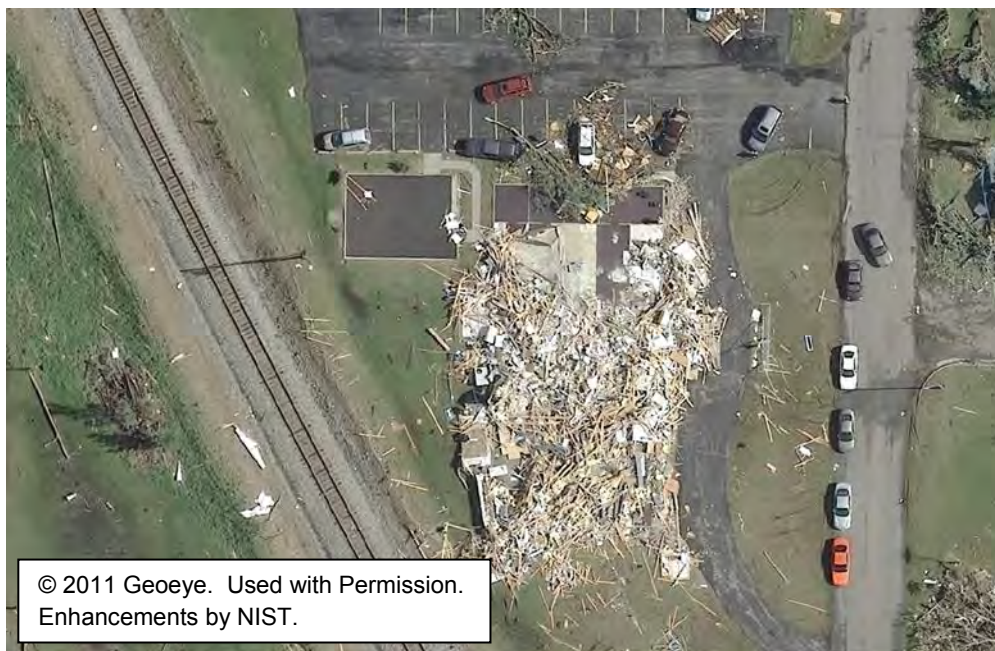
Figure 4–29. Aerial photo showing damage to the Full Gospel Church building.

The Full Gospel Church (Fig. 4–29) was completely demolished, with the entire wood roof system disconnected from the supporting wood-frame walls and disintegrated; and all supporting walls disconnected from the concrete slab foundation and collapsed. Additionally, a significant amount of debris, mostly building materials, ended up in all areas of the building’s interior.

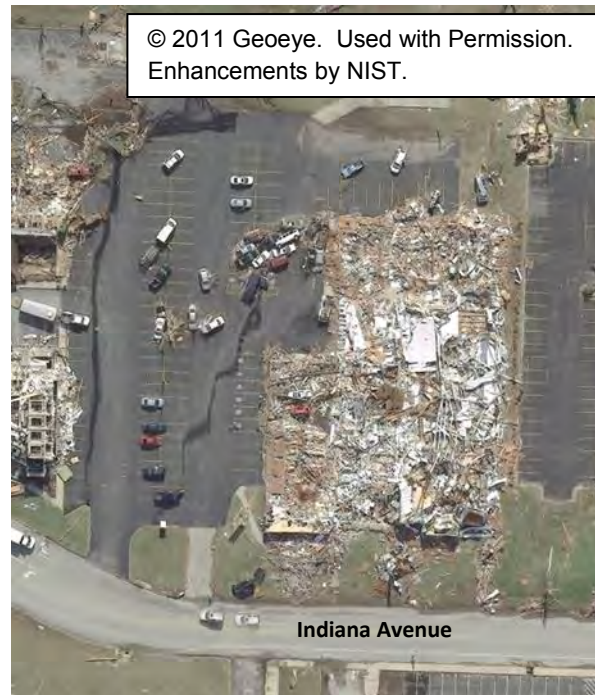
Figure 4–30. Aerial photo showing damage to Harmony Heights Baptist Church.

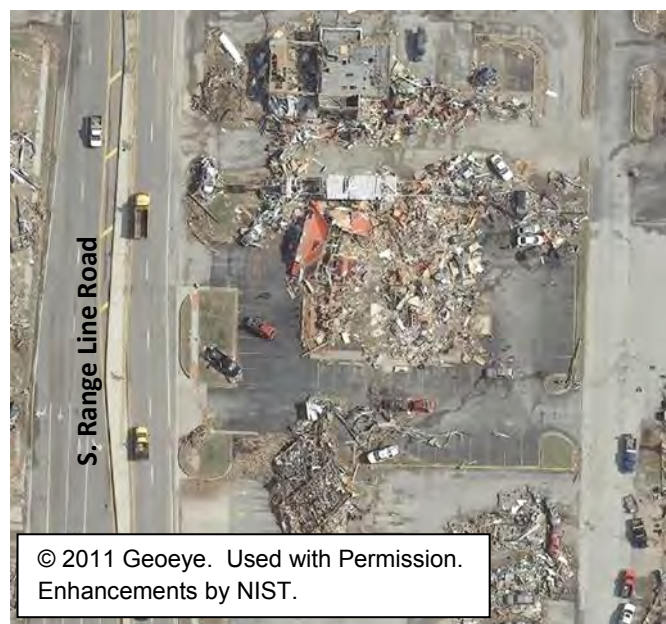
Figure 4–31. Aerial photo showing damage to the Joplin Pizza Hut.

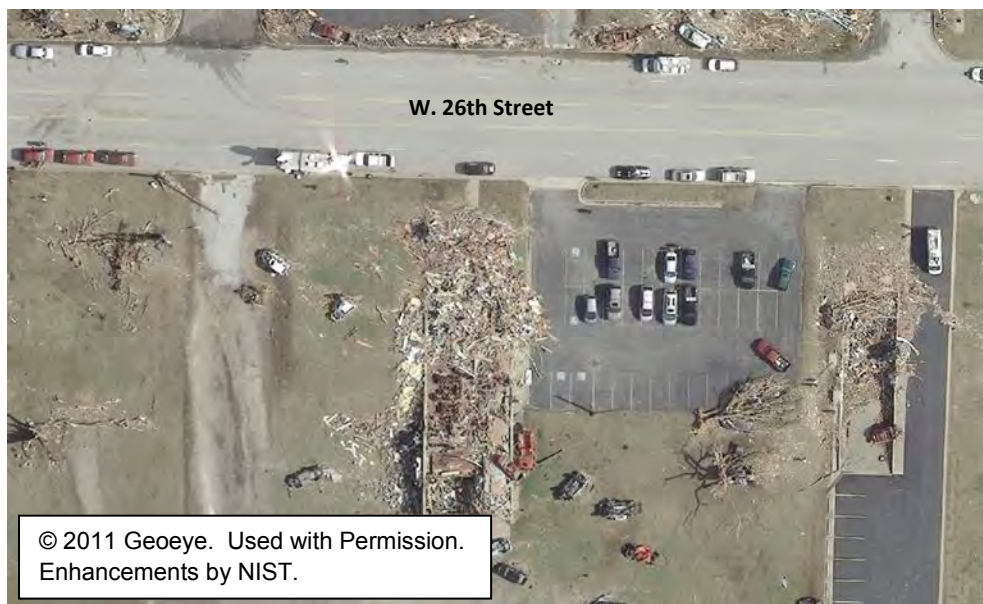
Figure 4–32. Aerial photo showing damage to the Stained Glass Theater.

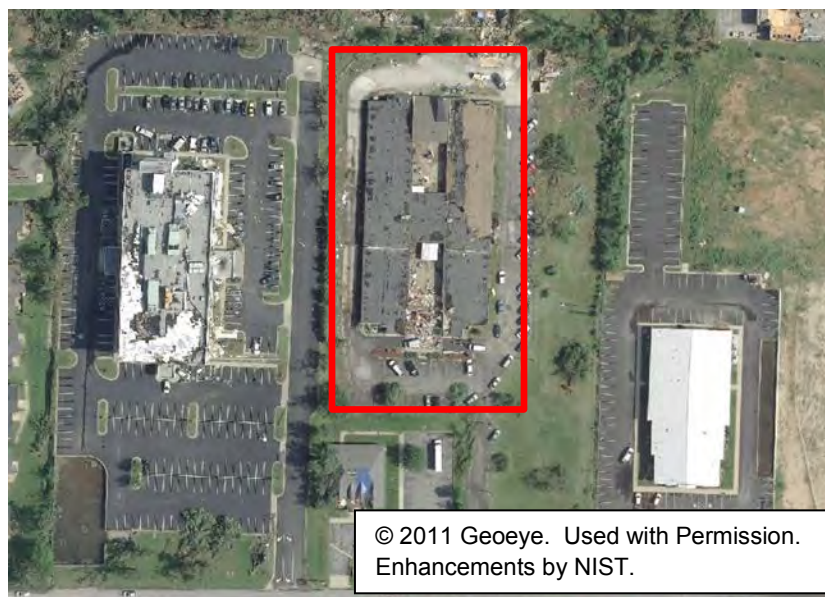
died the day after the tornado. One possibility is that the tornado, even at lower wind speeds, caused sufficient damage to the building to cause individuals who were already relatively frail to pass away.

Figure 4–33. Aerial photo showing damage to the Meadows Healthcare facility (outlined in red).

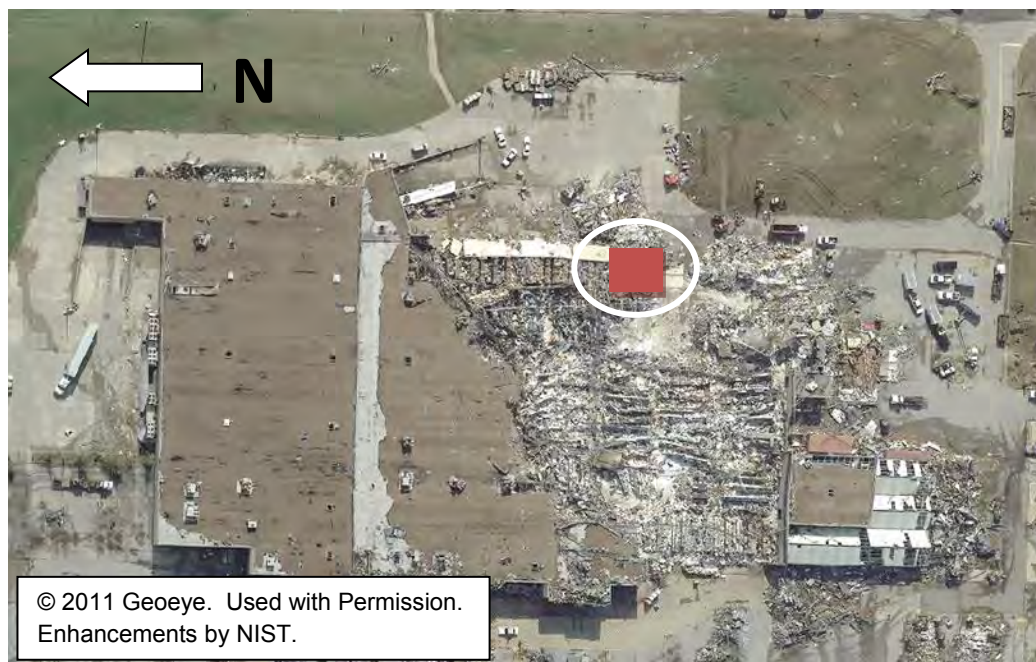
east wall. Figure 4–34 identifies this area with a red square circled in white. The refuge area was located in the southeastern part of the building, within the collapsed south half of the building that received the higher wind speeds (maximum of 165 mph). As noted in Chapter 3, the refuge area was not a hardened area, but simply an area of the store in which individuals could congregate during a tornado.

Figure 4–34. Aerial photo showing damage to Walmart Store #59, including the red box (circled in white) to indicate the store’s refuge area.

Within the collapsed area, where patrons are known to have congregated during the tornado, the building lost all of its roof decks and joists. Although the majority of the joist girders remained in place, and all columns remained in place, large sections of the leeward concrete masonry walls collapsed inward. The exterior wall of the refuge area was one of the walls that collapsed inward, and it fell into the area where 50 to 60 people had congregated. According to an interviewee, the collapsed wall closest to the refuge area rested on a set of cabinets nearby, creating a D-shaped pocket of safety.

The wind and debris hazard produced by this tornado, as estimated by the wind field model presented in Chapter 2, exceeded the conditions that this store was designed to withstand. In consequence, the Walmart building, specifically the southern half of the building in which many people were located, suffered complete collapse, which can be categorized as “demolished” (similar to most of the buildings discussed in the preceding section). Additional information on the possible failure sequence that led to the building’s collapse can be found in Chapter 3. The store did not have an underground location (or basement) or an indoor storm shelter where patrons could shelter from the storm. The structural collapse of a portion of the Walmart building on May 22, 2011, is thought to have caused three fatalities and an unknown number of injuries among the approximately 200 occupants located inside the building during the storm. However, no official information was found by NIST on the exact location inside the store of the three fatalities.

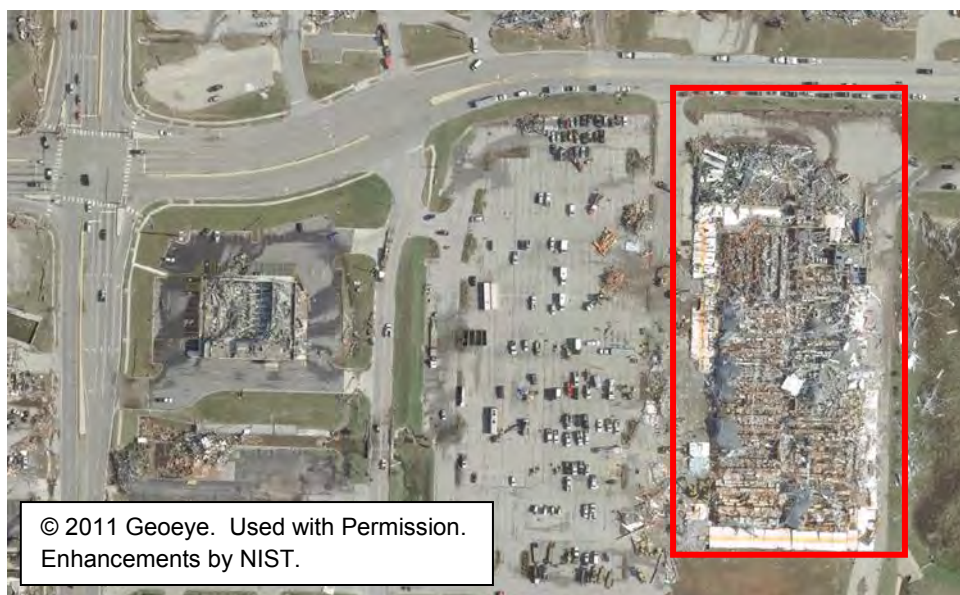
The Home Depot's perimeter tilt-up walls and roof system completely collapsed during the tornado. In total, 63 of the 73 wall panels collapsed either inward or outward, leaving 10 standing after the storm. Due to the wind and debris damage it sustained, this building was categorized as "demolished" in the GIS database. An aerial photo of the damage to the Home Depot is shown in Fig. 4-35.

Figure 4-35.
Aerial photo
showing
damage to the
Home Depot
(outlined in red).

The wind and debris hazard produced by this tornado, as estimated by the wind field model presented in Chapter 2, exceeded the conditions that this building was designed to withstand. In consequence, the Home Depot suffered a complete collapse. Additional information on the possible failure sequence that led to the building's collapse can be found in Chapter 3. Similar to Walmart, the Home Depot did not

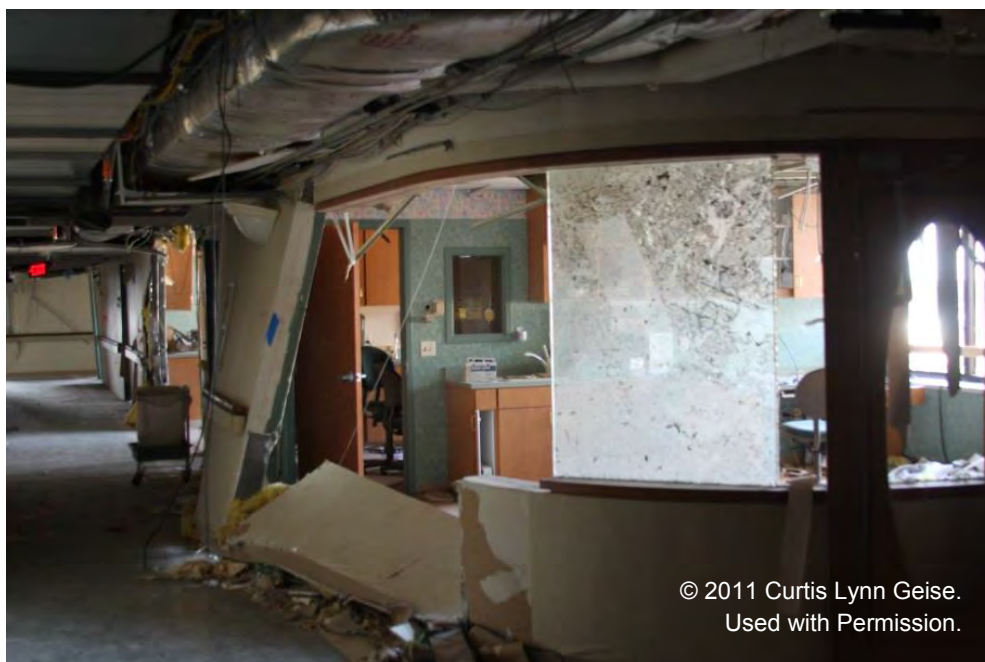
During the tornado, the towers were exposed to an estimated maximum wind speed of 170 mph \pm 20 mph (the EF-4 wind speed range). As mentioned in Chapter 3, the towers primarily sustained damage to their building envelopes and interiors, but did so without structural collapse. The damage to these buildings included the breakage of almost all vertical glass; damage to the roof systems, including the loss of aggregate roof ballast, which became wind-borne debris that further damaged the facility and the surrounding areas (see Chapter 3); damage to the interiors, including the breakage or collapse of interior partitions, suspended ceiling systems, furniture, fixtures, and equipment; damage to sections of gypsum-metal stud walls surrounding the elevator shaft and to the elevator equipment itself; and water and debris infiltration onto the floors. A view of the interior damage can be seen in Fig. 4-36.

Figure 4-36.
Damage to the
interior of
SJRM.

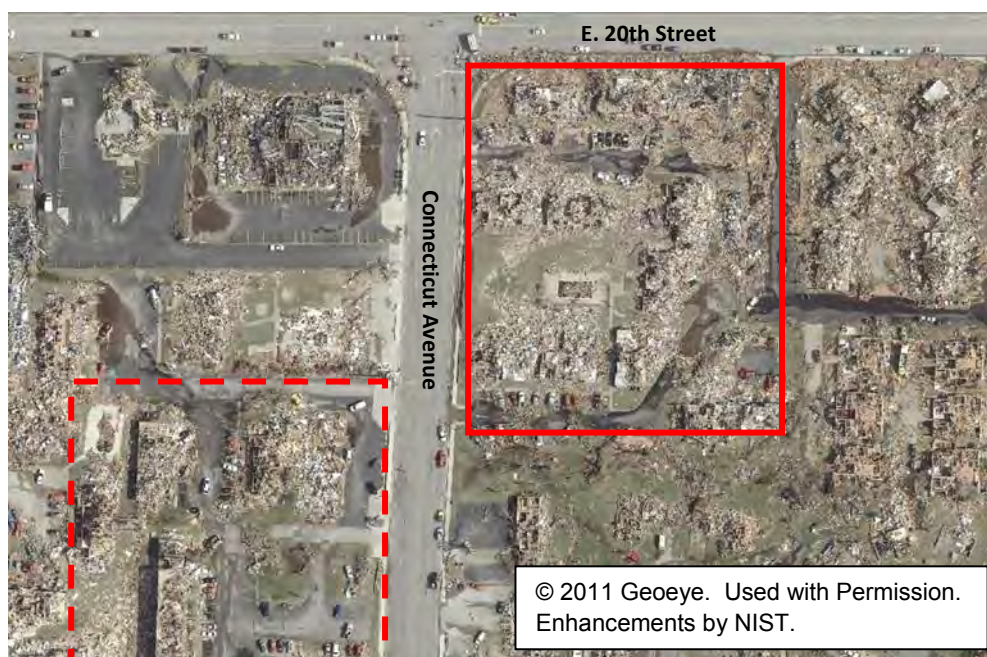
NIST found that 12 people died in three different apartment complexes as a result of the tornado. These three sites included three-story garden-style apartments located at 2001 Connecticut Avenue (identified by the solid red line in Fig. 4–37), two-story garden-style apartments located at 2034 Connecticut Avenue (outlined by the red, dashed line in the same figure), and two-story garden-style apartments located at 2020 Hampshire Terrace (shown in Fig. 4–38). At all three sites, occupants were exposed to wind speeds characteristic of EF–3 or EF–4 wind zones (i.e., estimated maximum wind speeds ranging from 136 mph to 200 mph, on average). All 12 fatalities occurred in apartment complexes that were rated as “demolished.” These complexes were primarily wood-frame structures, and were not equipped with underground or aboveground protection areas. Consequently, all of those killed were located above ground when the storm hit, and at least one was known to be located inside his apartment (floor level unknown).

Figure 4–37. Aerial photo showing damage to two apartment complexes in Joplin at 2001 Connecticut Avenue (outlined by solid red line) and 2034 Connecticut Avenue (within dotted line).

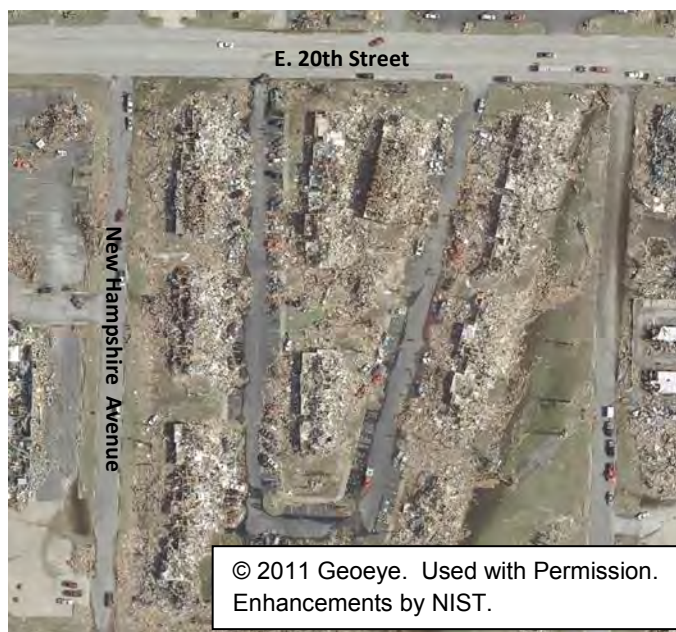
Figure 4–38. Aerial photo showing damage to the Hampshire Terrace apartments.

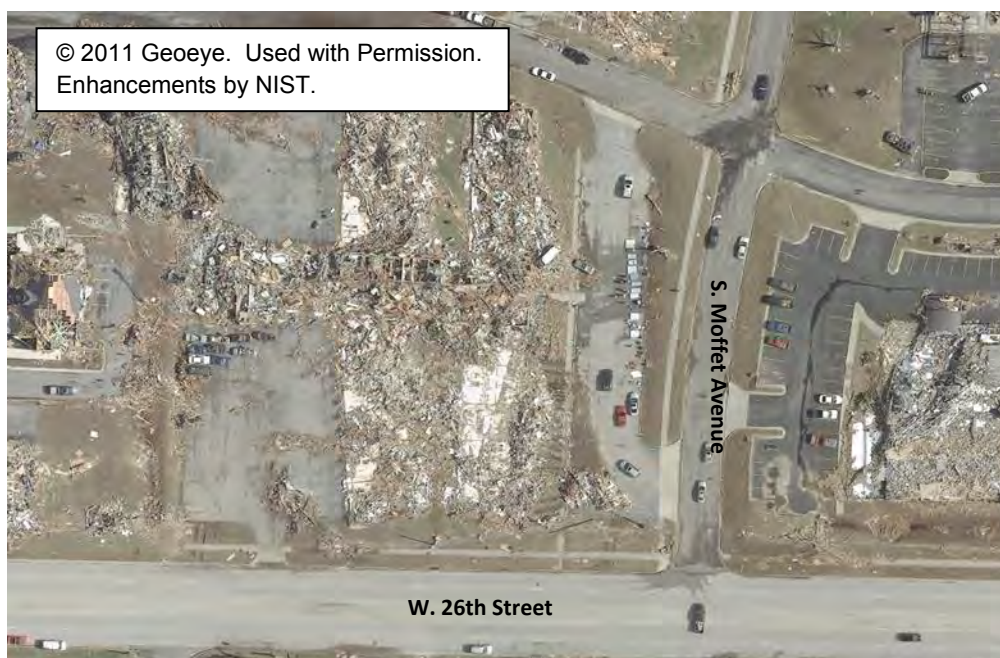
Nineteen individuals died in the Greenbriar Nursing Home. The structure was exposed to an estimated maximum wind speed of $170 \text{ mph} \pm 20 \text{ mph}$. The building was an unreinforced masonry structure. Damage to the structure, rated as “demolished”, is shown in Fig. 4–39. It is unclear where the 19 fatalities were located within the Greenbriar; however, there were also five individuals (from the CDC sample) located at the Greenbriar who sustained severe injuries and were located in the hallway, a bedroom, and a doorway inside the structure.

Figure 4–39. Aerial photo showing damage to the Greenbriar Nursing Home.
